GEOTECHNICAL ASSESSMENT REPORT

Date: 25th September 2015

Project No: 2012-195.2

**REPORT ON GEOTECHNICAL ASSESSMENT OF SLOPE STABILISING
McCARRS CREEK ROAD, CHURCH POINT**

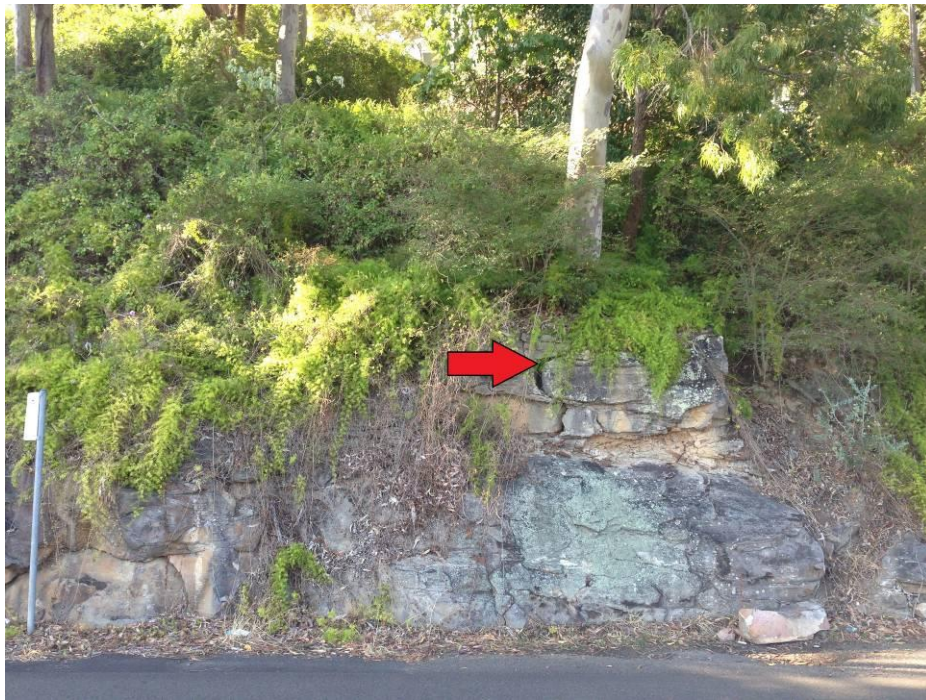
Section of rock detached along steep west dipping joint defect along with fractures in the bedrock, action of tree above providing separation, as viewed looking west.

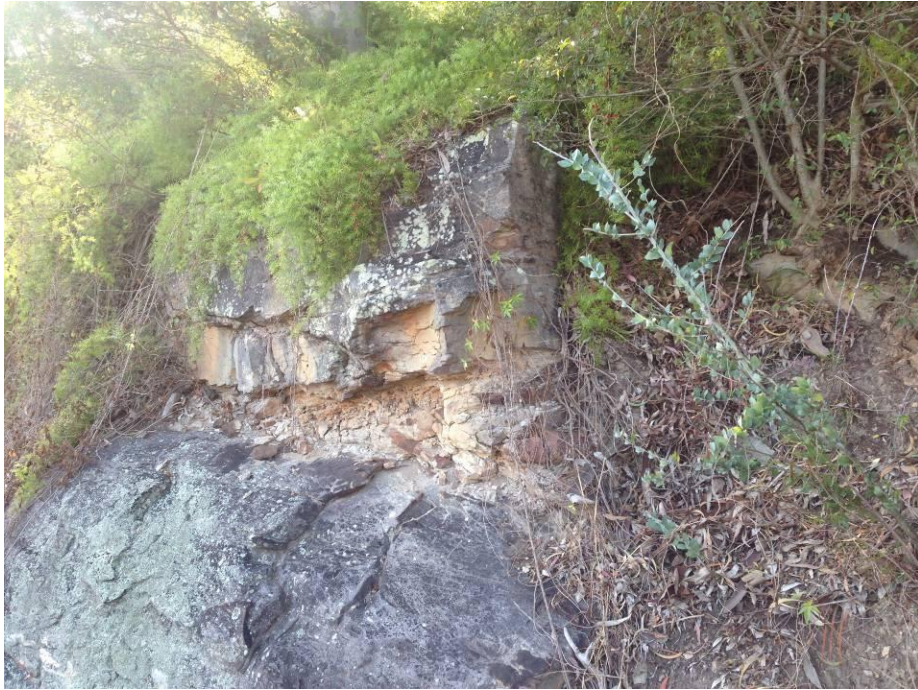
As viewed looking north, along excavation, section of detached rock with weathering at base along curved steeply west dipping joint and tree at rear.

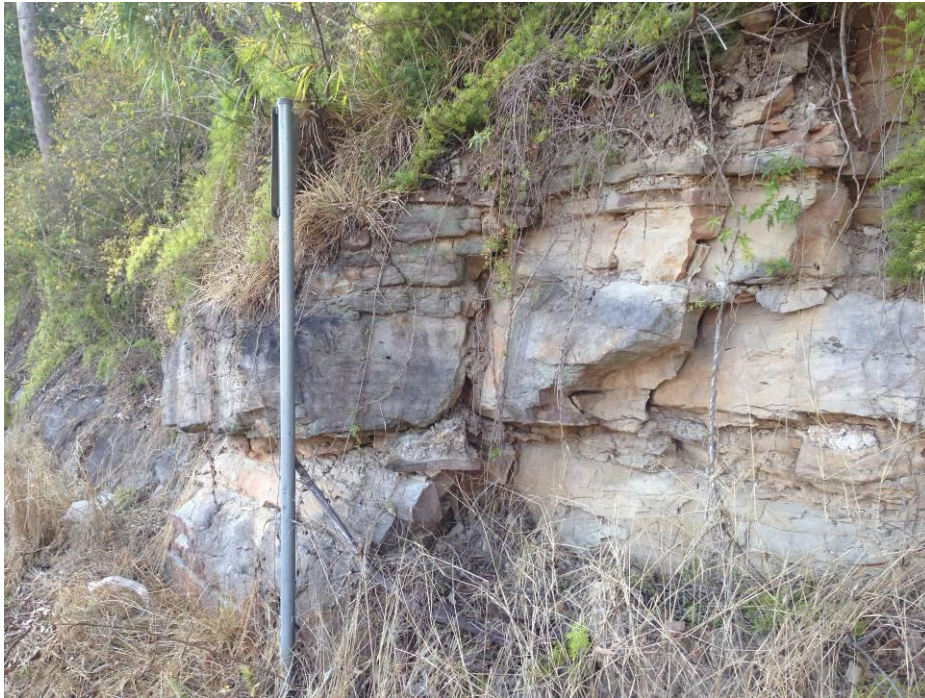
Very steeply west dipping joint defect separating bedrock and creating potential small scale ($<1.0\text{m}^3$) rock slides/falls

The inspection identified numerous joint and fracture defects within the existing excavation along the eastern side of McCarrs Creek Road. These have generally created potential small scale rock slide and topple hazards from detached fragments of rock and these can be managed via ongoing slope grooming and maintenance.

It is recommended that upon construction of the car parking area that low weed vegetation be cleared from the crest of the existing excavation and extending several metres upslope as a minimum. Following this work slope grooming should be undertaken under geotechnical supervision to remove existing potential landslide hazards. It is expected that this slope grooming may need to occur on an occasional but ongoing basis over the life time of the carpark. Further detailed geotechnical assessment of larger scale rock blocks that cannot be removed by grooming processes should also occur prior to use of the car park for assessment of the need for insitu stabilizing measures (i.e. excavation/rock bolting etc).

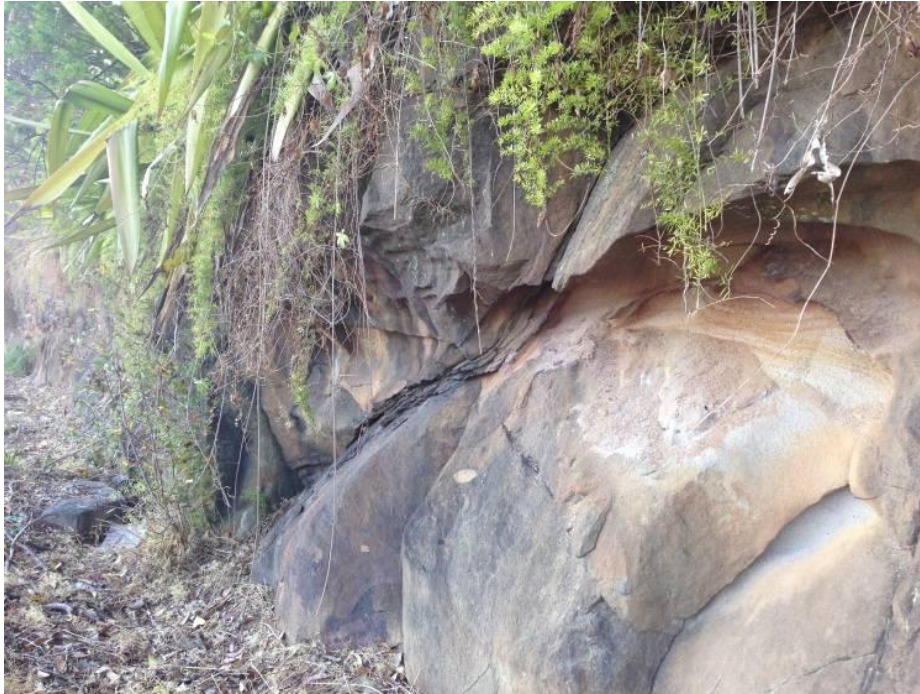
Steeply west dipping joint defects creating larger scale (1-5m³) rock sliding hazard.

There are some steeply west dipping joint defects which dip out of the excavation face, and along with the sub-vertical oblique joint defects have created potential larger scale (up to 5m³) blocks of rock that present more significant rock slide hazards. These may require more significant excavation or stabilizing measures.

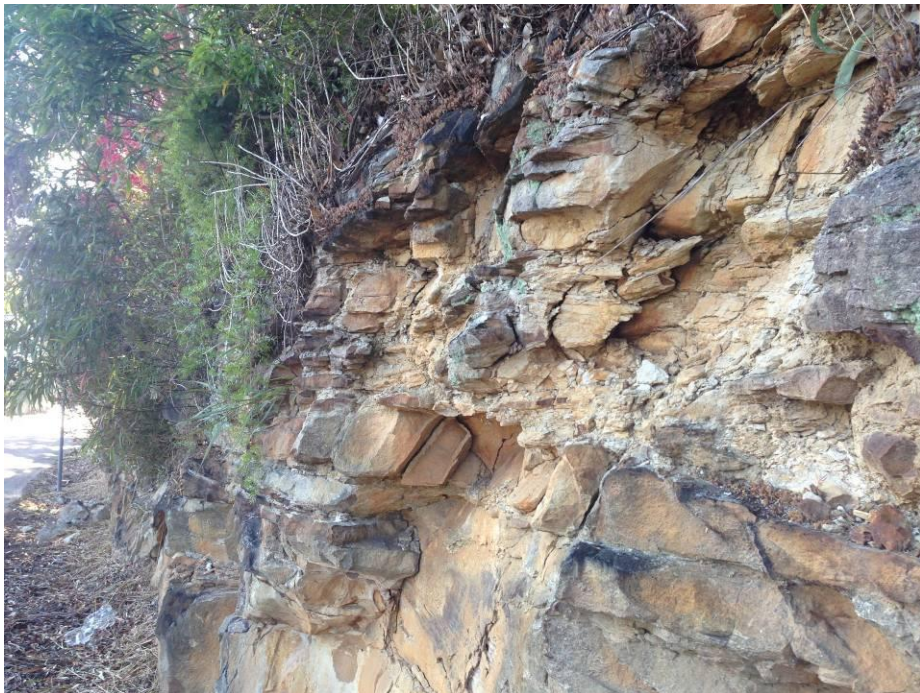
Thinly bedded sandstone bedrock intersected by fractures and steep west dipping joint defects creating highly fragmented rock mass.

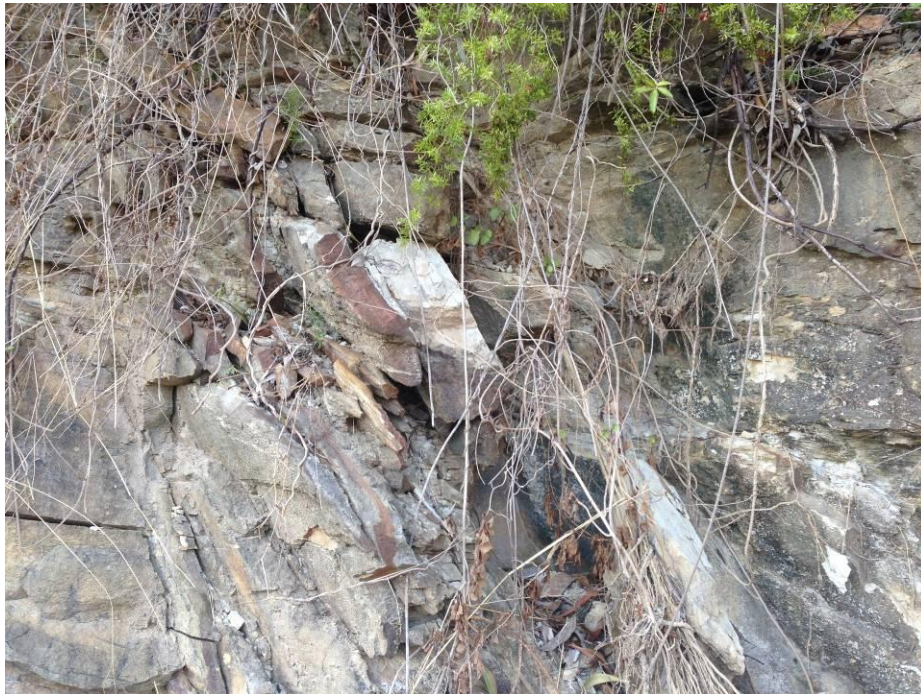
Concentration of sub-vertical joint defects striking oblique to excavation creating numerous small scale detached sections of rock.

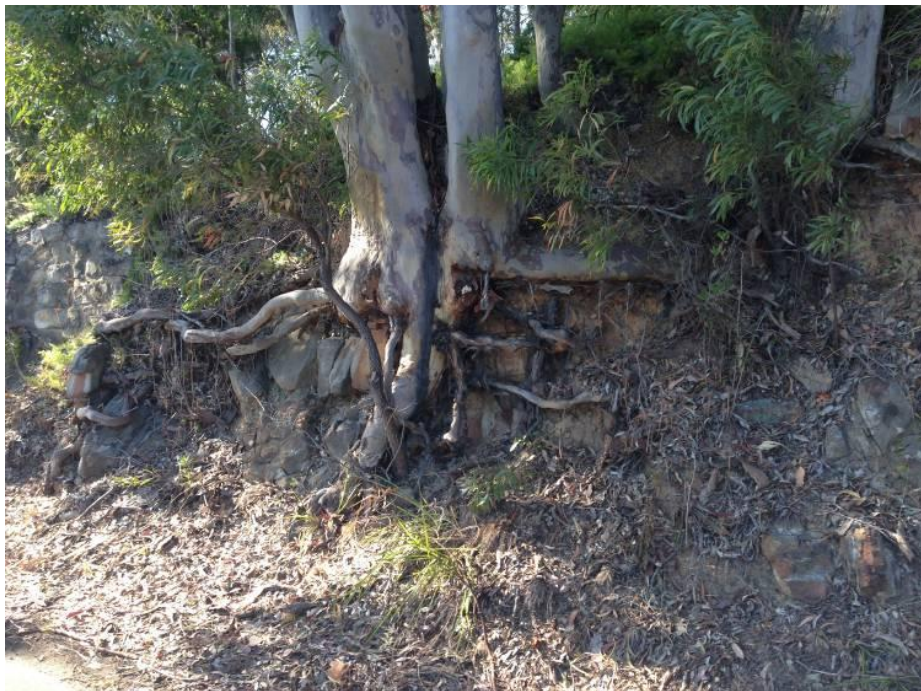
Tree undermined by soil and rock erosion

A detailed inspection of the slope above the existing excavation was not possible due to the extensive vegetation. However there were no signs of erosion or previous land sliding. Several trees within the excavation face/crest should be assessed by an arborist and will likely require removal.
