Report on
Geotechnical Assessment

Dalwood Home Site
21 Dalwood Avenue, Seaforth

Prepared for
NSW Ministry of Health

Project 73029.01
May 2019

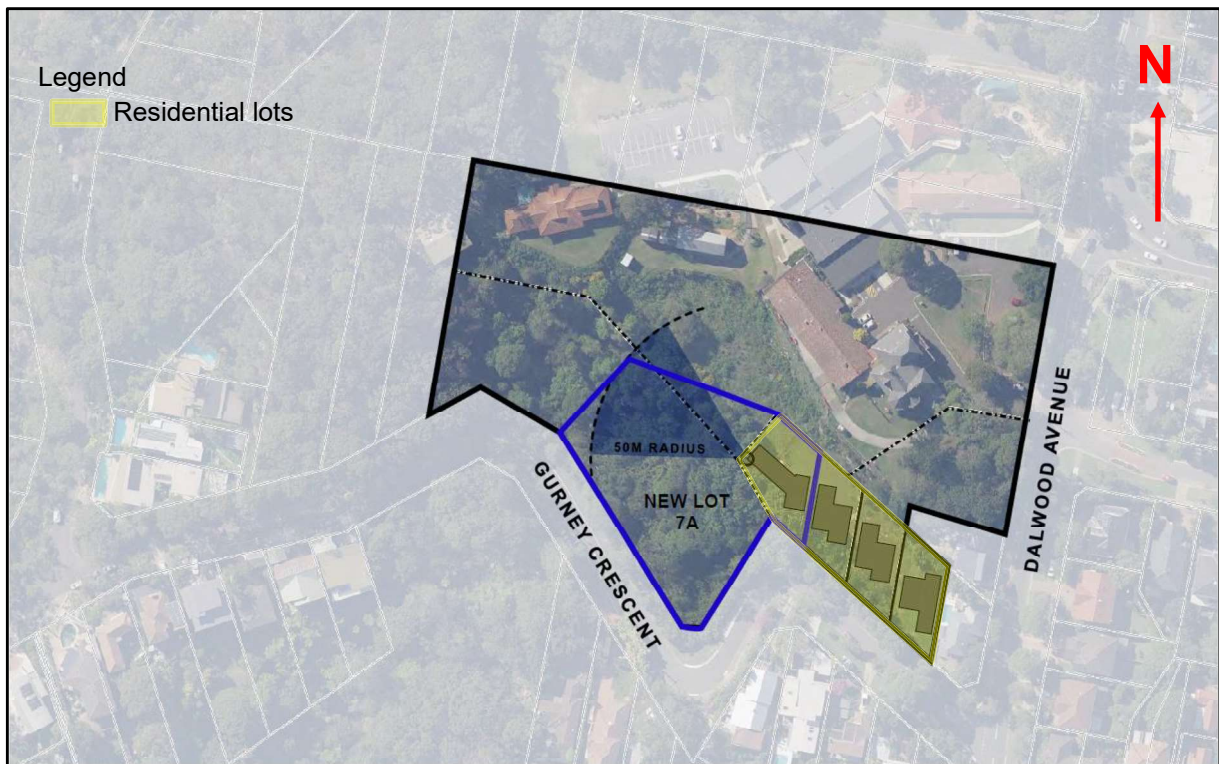
Figure 3: Residential Lots

These lots on the southern side are located on a rock ledge at the base of a sandstone cliff. Rock is expected to be close to the surface which is considered good founding conditions, but hard excavation conditions for installing underground services and levelling the ground surface. In terms of “AS 2870 Residential Slabs and Footings”, the individual lots would probably have a site classification of Class A due to the presence of rock close to the surface.

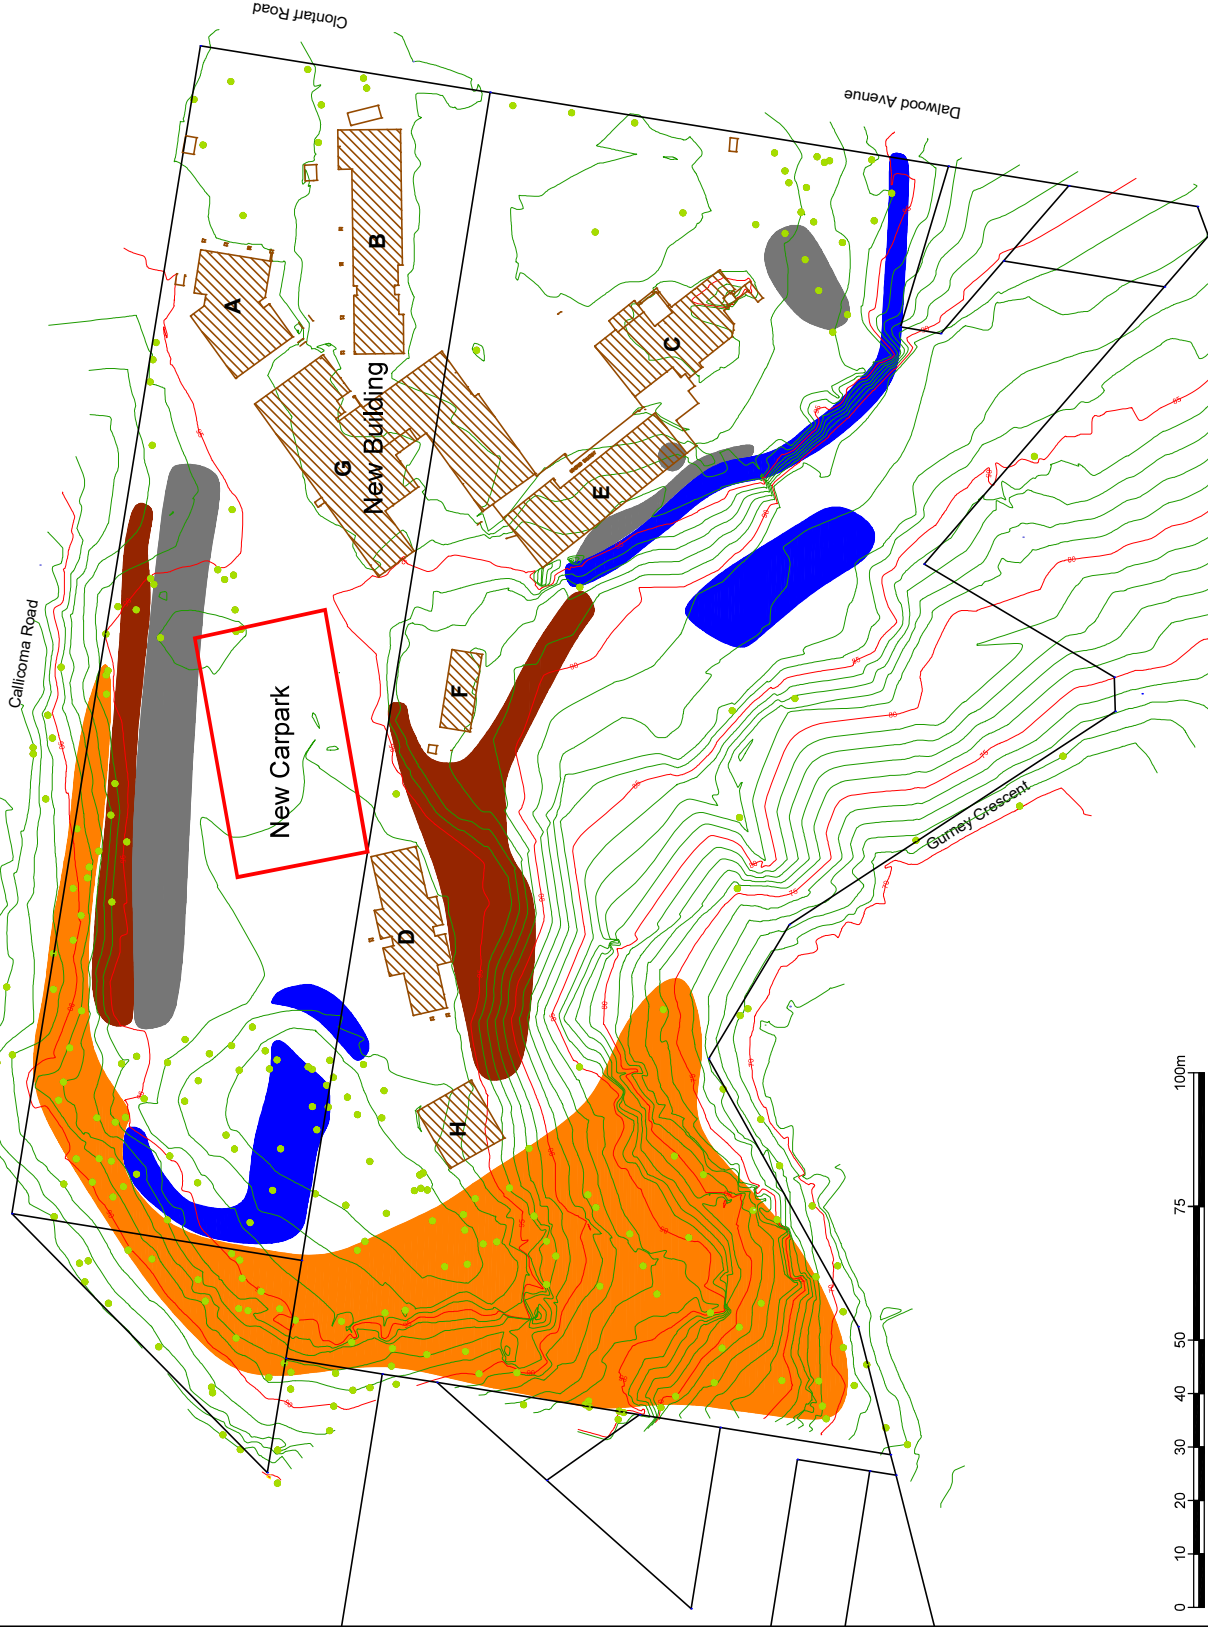
Some of the features mentioned above are marked on Drawing 4 in Appendix B.

There are some areas of filling on the site generally associated with previous development and some of them are shown on Drawing 4. There are also three cross sections of the site showing the surface levels which are reproduced in Drawing 6.

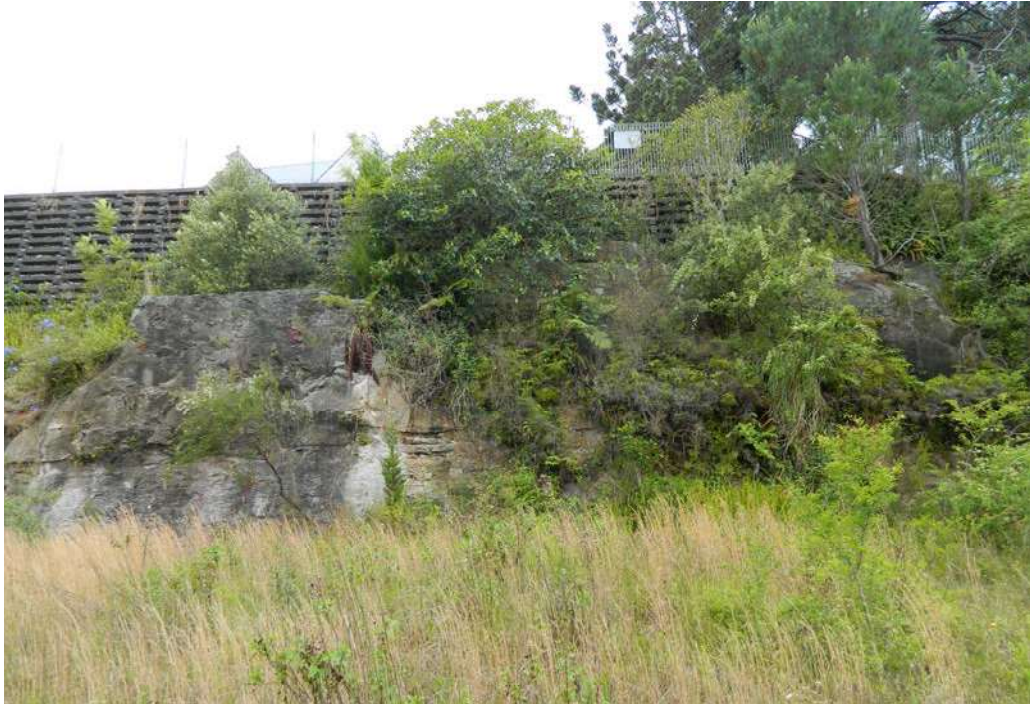
- There are several sandstone outcrops on the site including:
 - a 6 m high cliff at the back of the Dalwood Home building which extends to Dalwood Avenue at the eastern end of the site (see Photo 1 in Appendix C);

Photo 1 – View of sandstone cliff at back of Dalwood Home

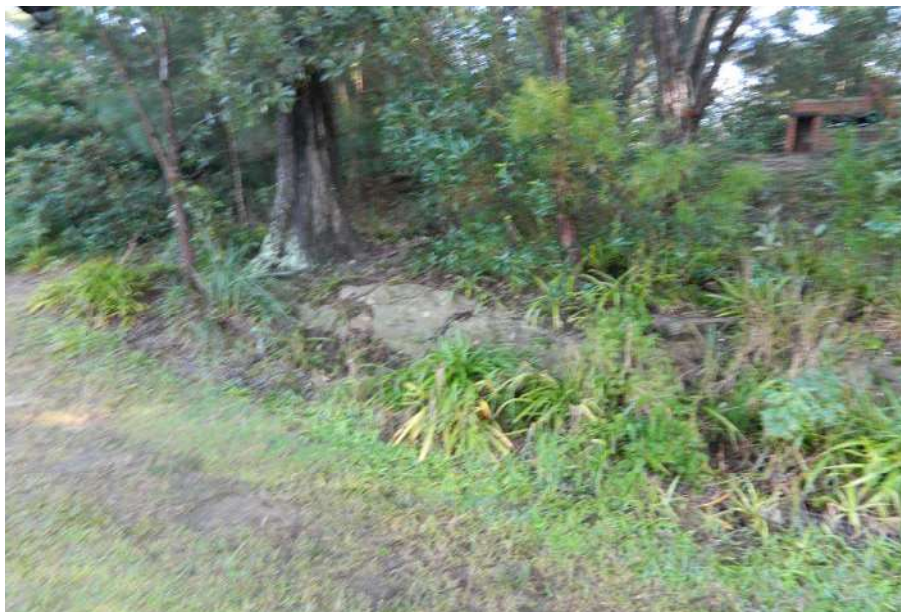
- at the back of the Family Care Centre in a small cutting (Photo 2);
 - a flat vegetated area at the western end of the site (Photo 3);
 - a cliff at the western end of the site (Photo 4); and

Photo 2 – View of outcropping rock at back of Family Care Building

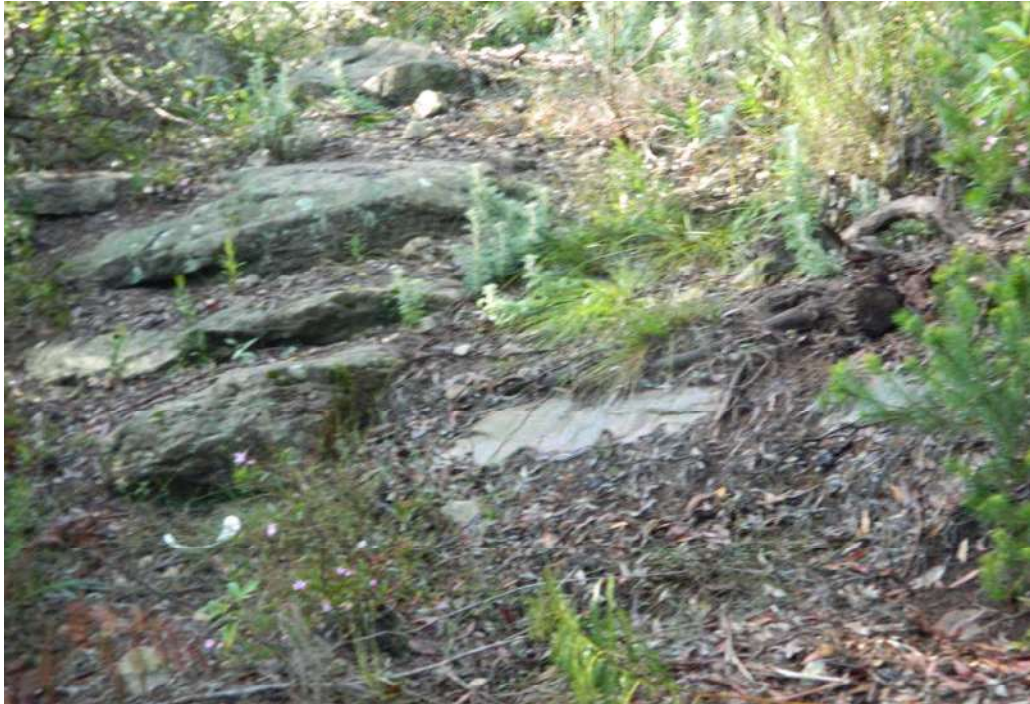
Photo 3 – View of outcropping sandstone at western end of site

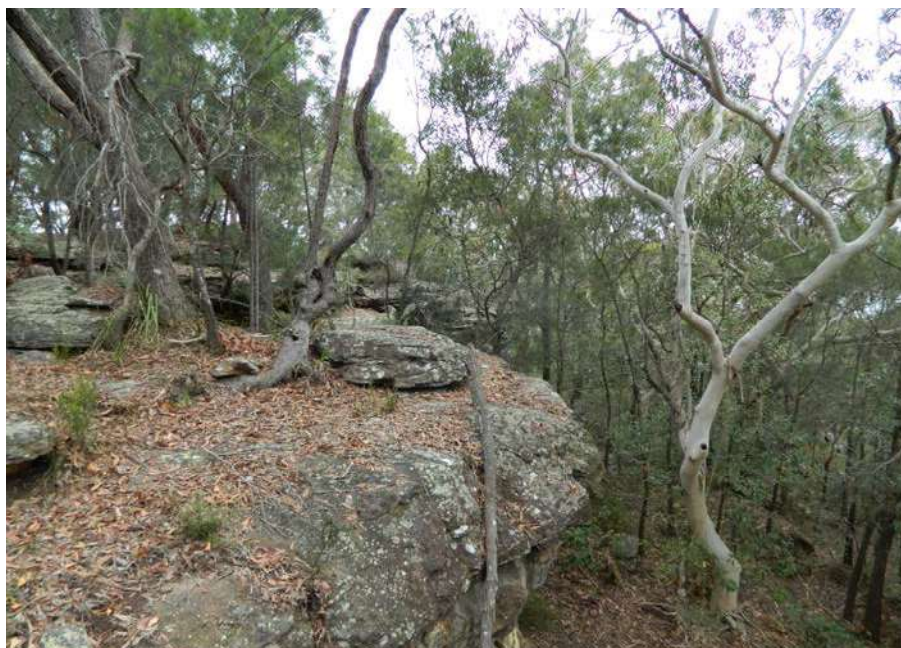
Photo 4 – View of sandstone cliffs within vegetated area

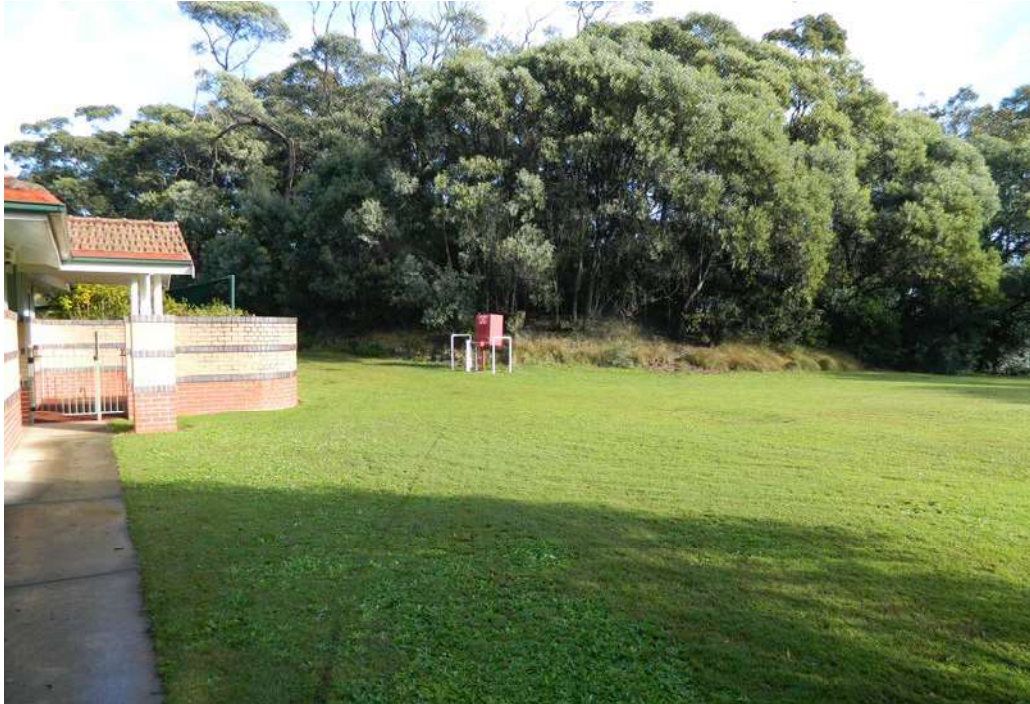
- possibly more cliffs in the heavily vegetated section of the south-western corner of the site.
- Filling has been used to provide or expand relatively level areas. Such locations include the area behind Dalwood Home on top of the cliff where there is a crib wall behind crib wall in Photo 1, the open lawn area towards the northern boundary (near Photo 5), and the area south of the Family Care Centre (Photo 6).

Photo 5 – Open lawn near northern boundary

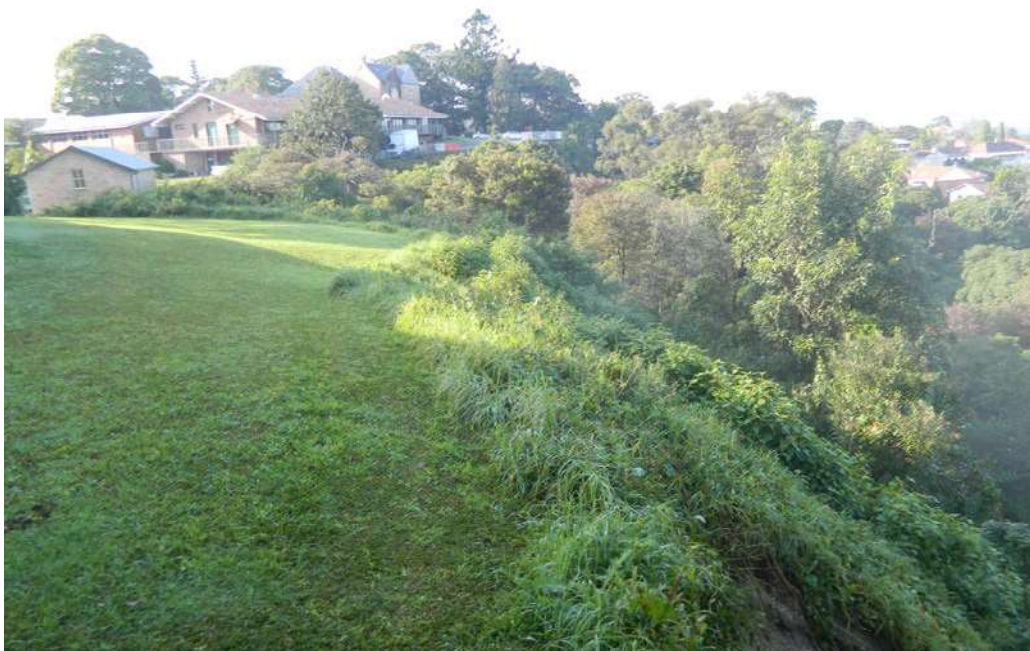
- Associated with some filled areas are relatively steep slopes on the edge of the filling. These include the area south of the Family Care Centre and the filling near the northern boundary.

Photo 6 –Filled slope near Family Care Centre

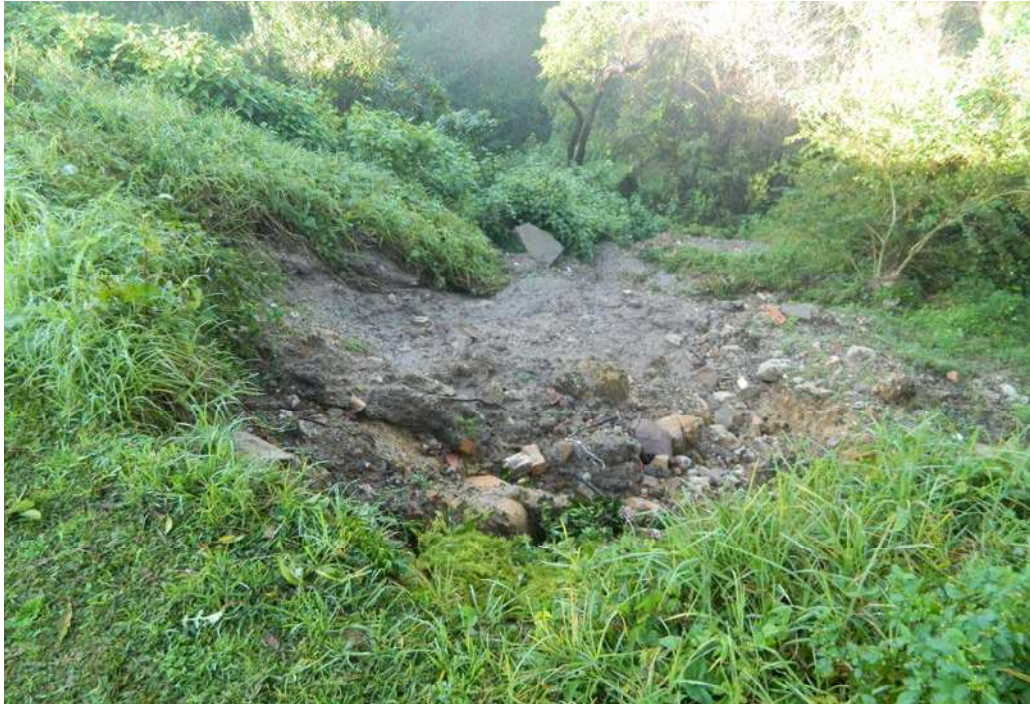
- In the steep slope in filling near the Family Care Centre, a landslide had occurred leaving a severely disturbed scar (Photo 7).
- The western and much of the southern portions of the site have been left undeveloped and are generally covered in heavy vegetation on flat to moderate slopes (Photo 8).

Photo 7 – Landslide at back of Family Care Centre

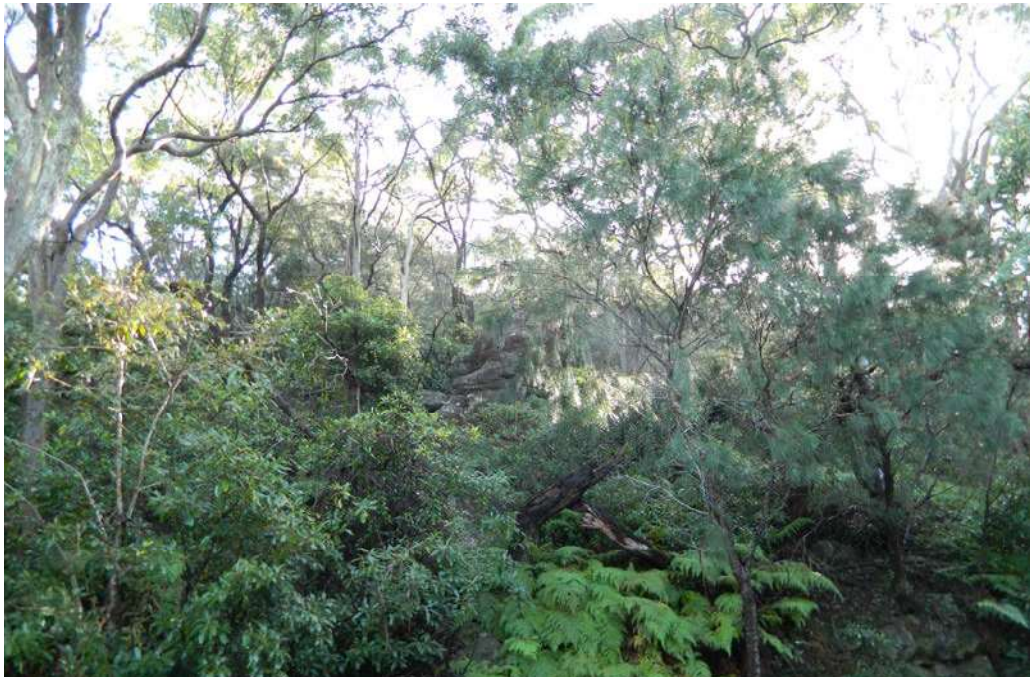
Photo 8 –Heavy vegetated natural slope at western end of site

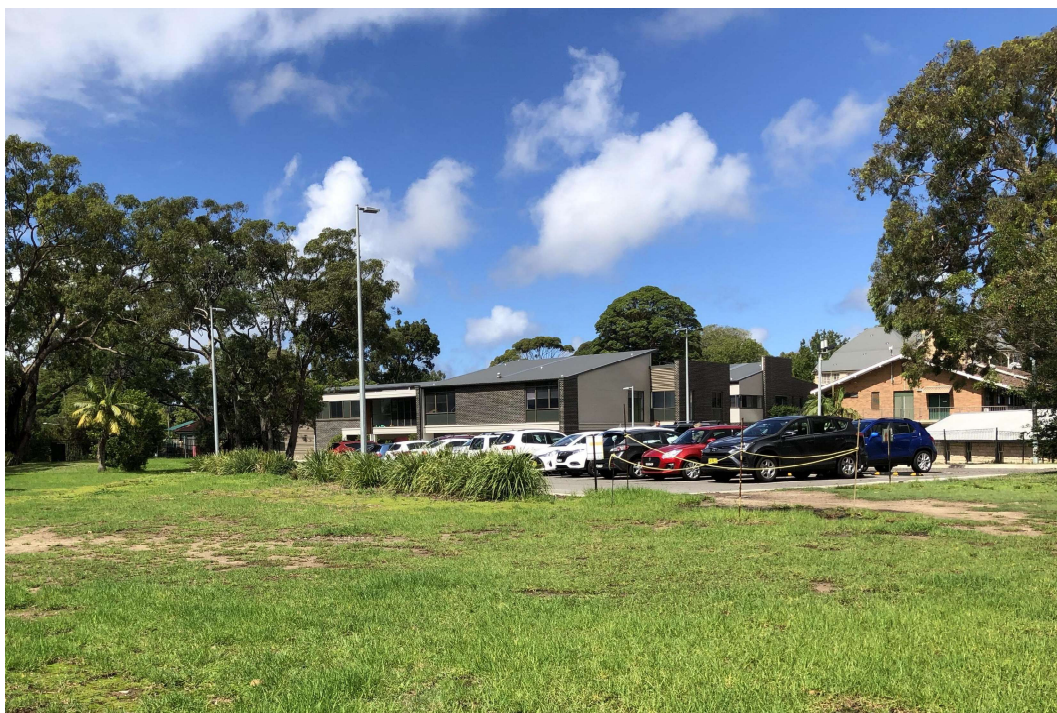
- The 21 March 2019 site visit was carried out to observe the areas to the north of Buildings D, F and G and the “surplus lands” located to the south of the site. The site features described above are generally unchanged except for a new carpark located to the northeast of Building D and a new Building G located to the east of the new carpark. (see Photo 9 in Appendix C). Heavy vegetation was observed in the surplus lands with rock outcrops visible from the road (see Photo 10 in Appendix C).

Photo 9 – New Carpark and New Building G

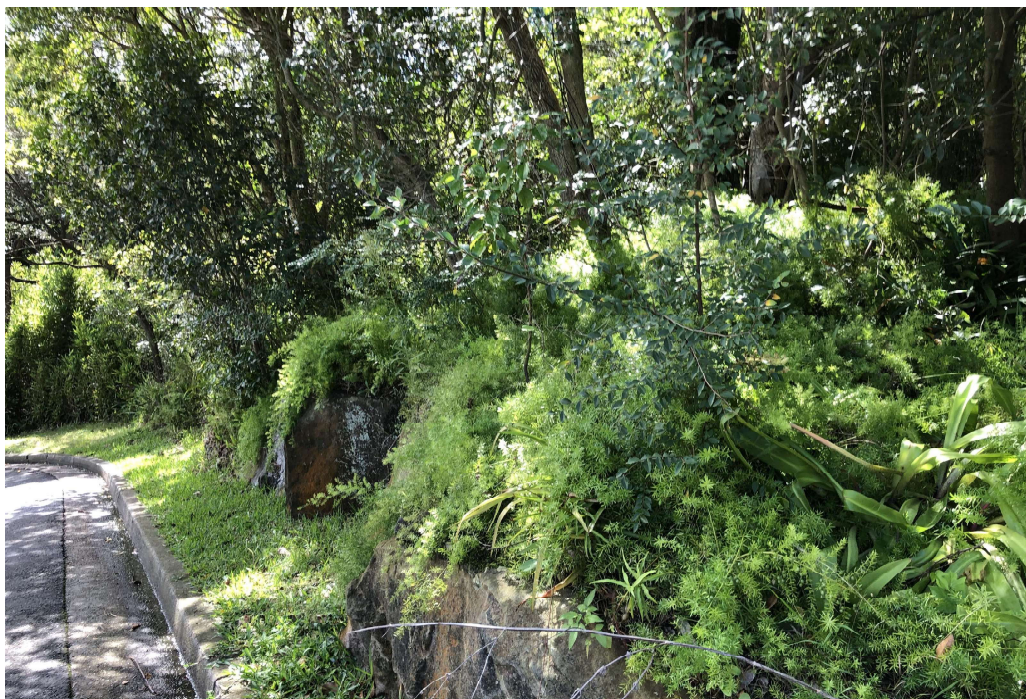
Photo 10 – Heavy vegetated with sandstone outcrops along Gurney Crescent
