15 January 2018

AQUATIC ECOLOGY SURVEY FOR PROPOSED BOATING ACCESS

FACILITIES AT ROWLAND RESERVE PUBLIC BOAT RAMP

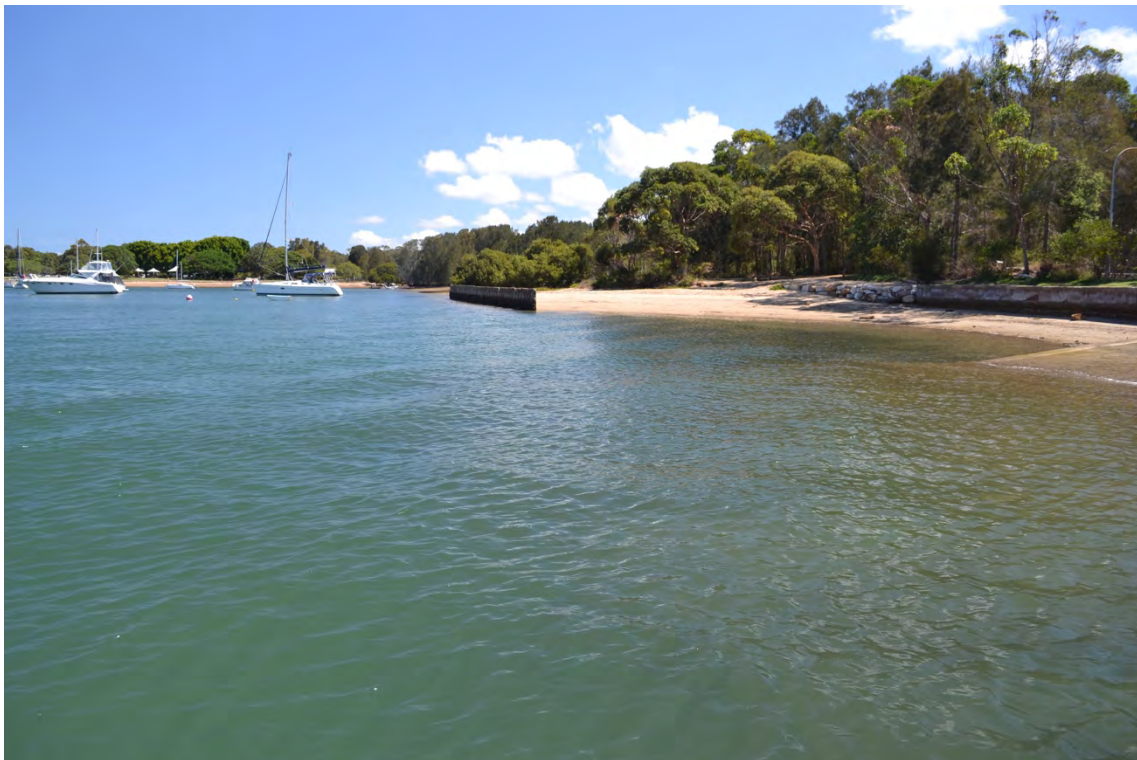
Figure 2 View south of Southern Ramp showing sandy beach and sandstone seawall plus mangroves in the distant background.

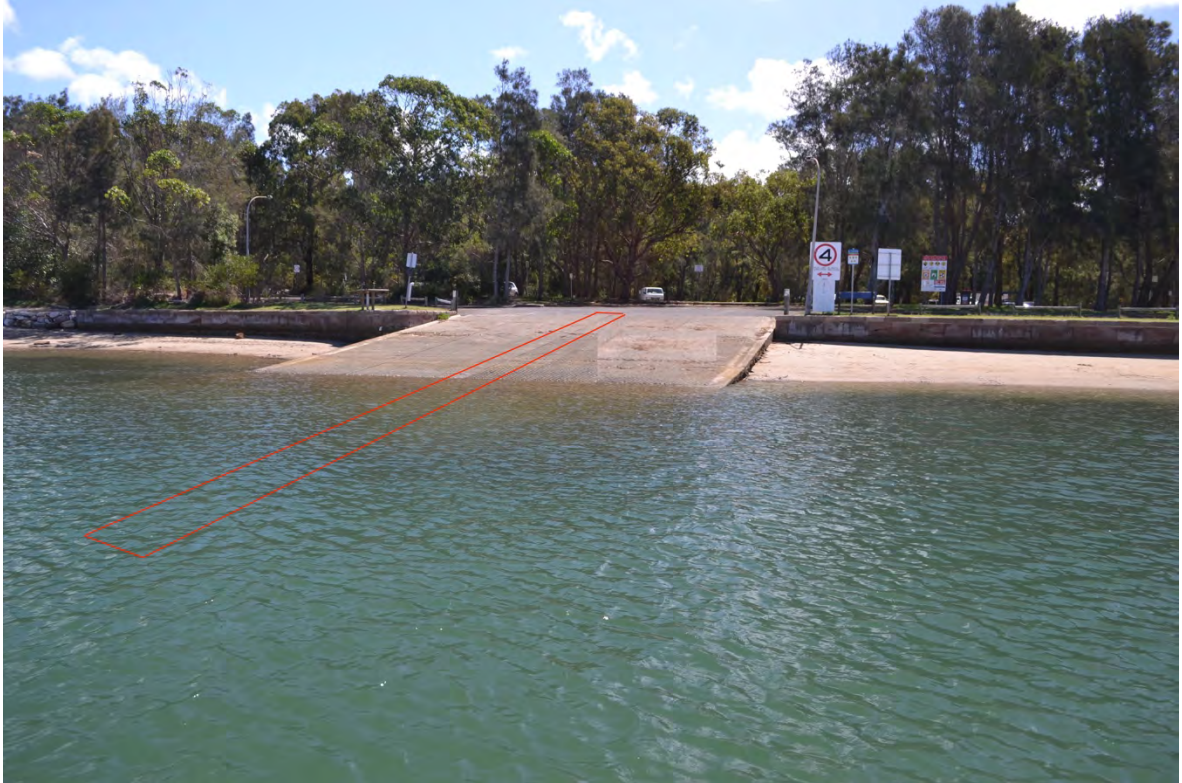
Figure 3 Southern Boat Ramp showing approximate location of central access pontoon structure. Dark patches around the ramp is a solid bed of *Caulerpa* pest algae.

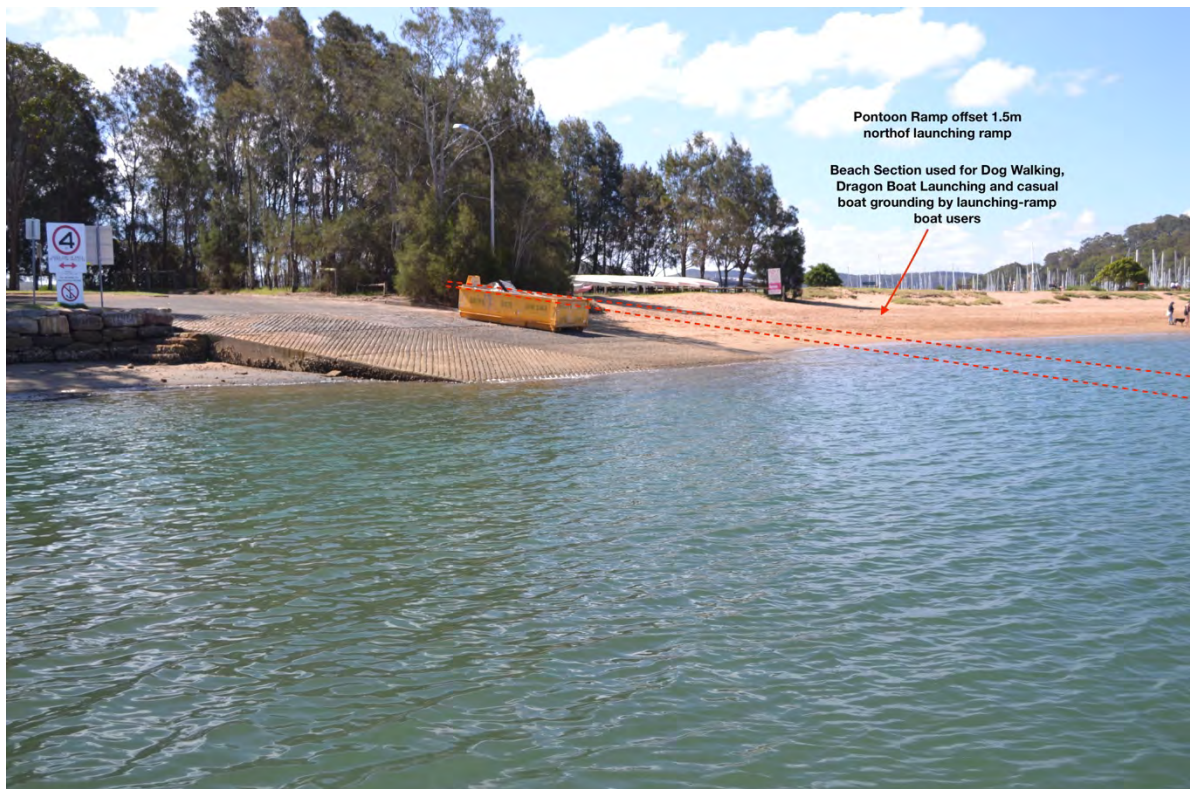
Figure 4 Northern Boat Ramp showing approximate location of north-side access pontoon structure adjacent and offset 1.5m from the northern edge of the ramp. There is also a *Caulerpa* pest algae bed around this ramp.

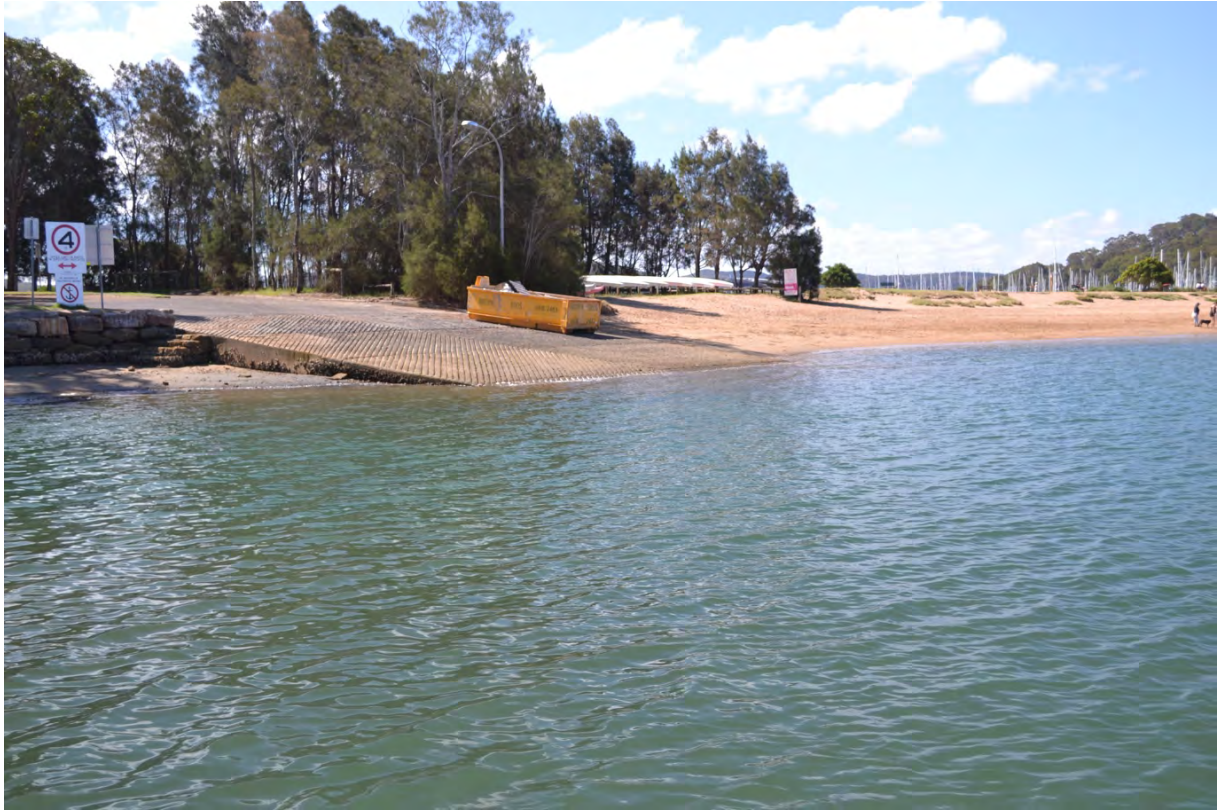
Figure 5 View of North Ramp and beach area to the north of the ramp.

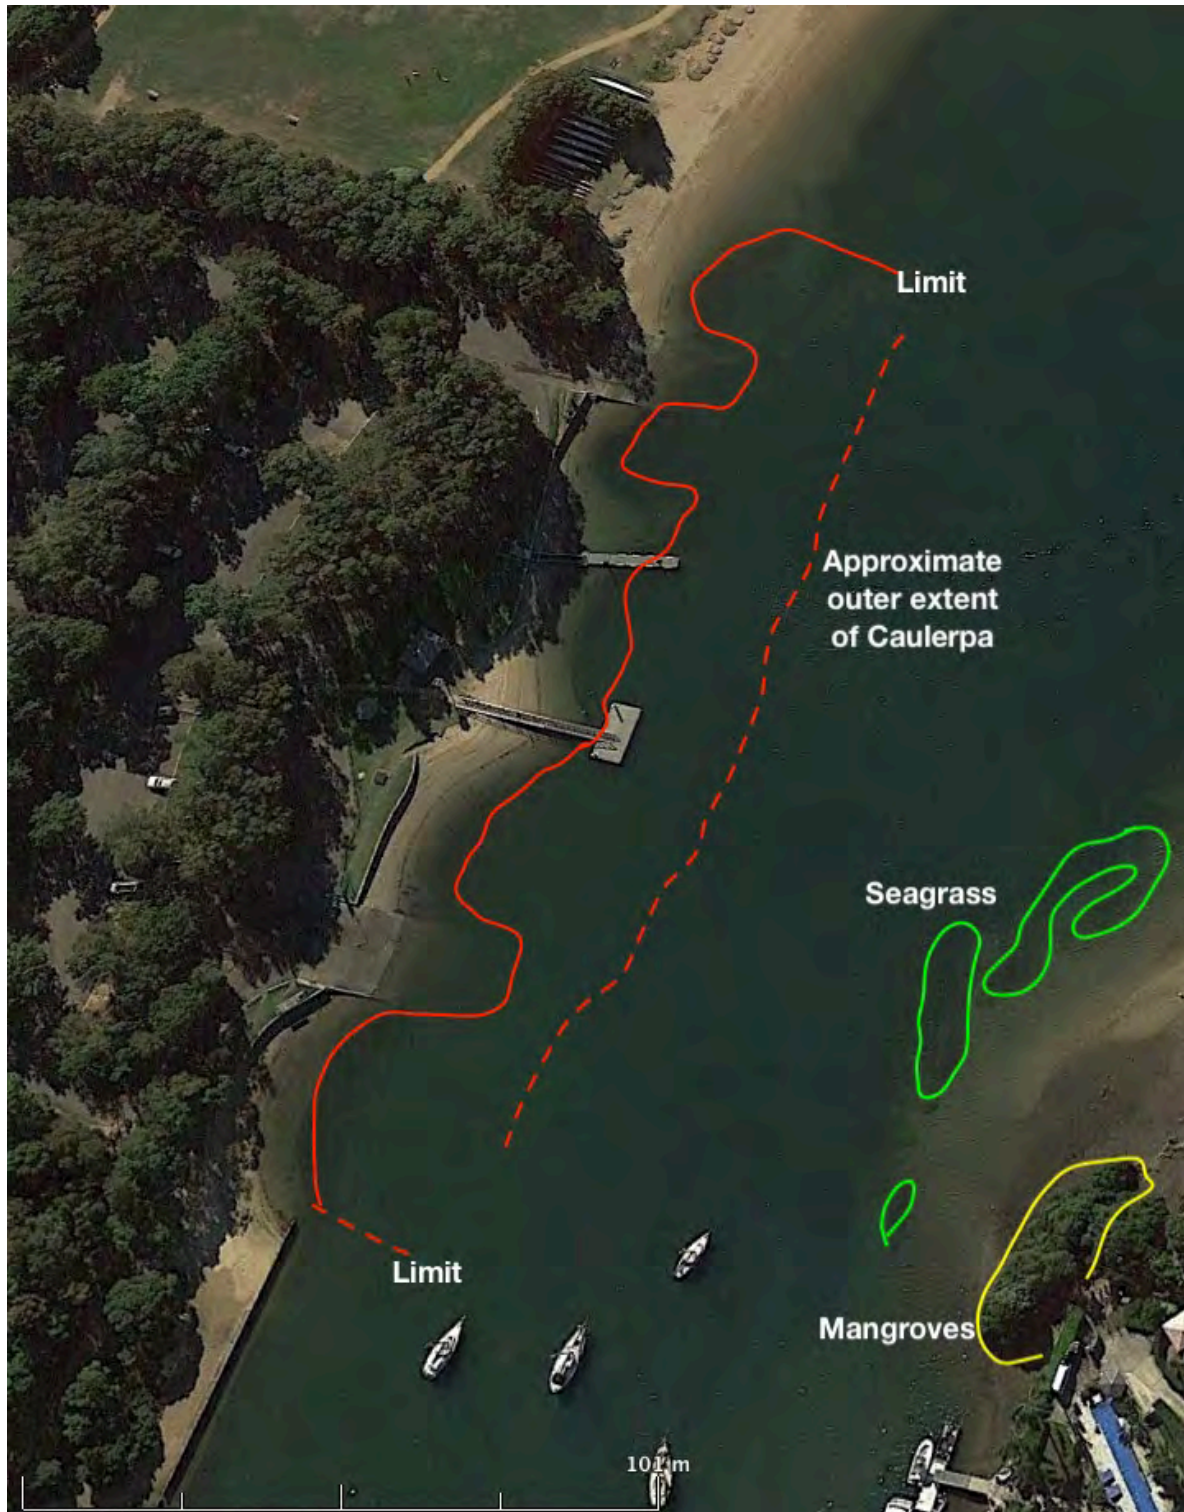
- The sub-tidal sediments support a range of benthic (sediment dwelling) fauna such as molluscs, polychaete worms and crustaceans.
- The sub-tidal seabed at the front of and on either side of the two ramps supports a monoculture of *Caulerpa taxifolia* (Figures 8 and 9). As noted in Figure 7 this habitat extended north and south between and beyond the existing ramps.

- There were no seagrass species (*Zostera* or *Posidonia*) in the survey area. A specific search for the last seagrass species previously located between the south ramp and public pontoon wharf existing pontoon in 2011, which was described as “a mix of *Caulerpa* with a very sparse and patchy cover of paddle weed (*Halophila ovalis*)”. No *Halophila* was found for this survey. The seagrass indicated along the opposite shore (Figure 7) is *Halophila ovalis* (MPR survey, November 2015).

Figure 7 Google Map Aerial Photograph Dated 3 May 2016 with marine vegetation limits shown. “Limit” indicates the south and north extent of the random swim survey. Whilst the outer extent of *Caulerpa taxifolia* infestation is approximate, based on sight lines back to the ramps and pontoon, the *Caulerpa* bed does extend to the outer limits of the proposed pontoons (i.e., at least 12m off-shore from the bottom of the concrete ramps).

- There will be no stockpiling of demolition or construction materials on the seabed.
 - No vessel is to be moored with anchor or other bottom tackle located in the inshore *Caulerpa taxifolia* beds, as indicated on Figure 7.

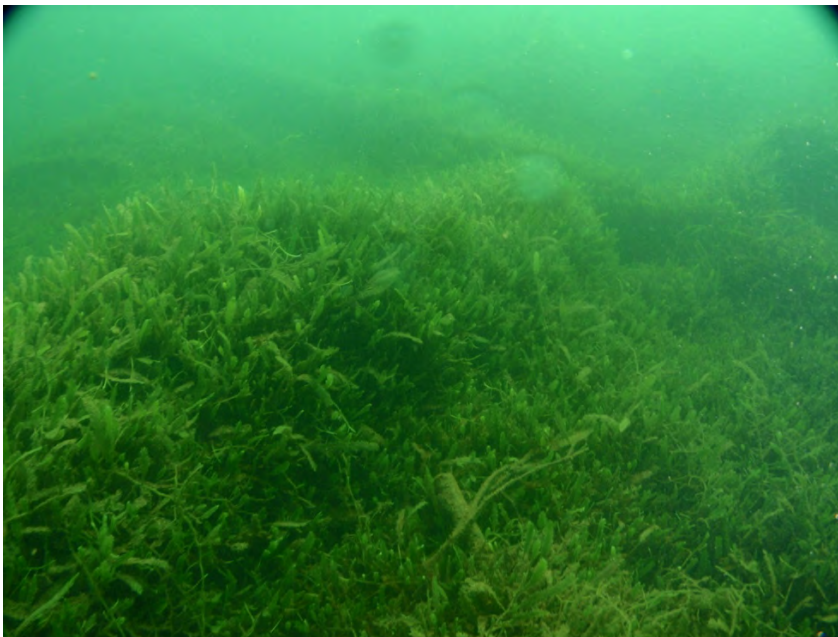
Figure 8

Dense and even bed of *Caulerpa taxifolia* overgrowing debris off-shore from the southern ramp

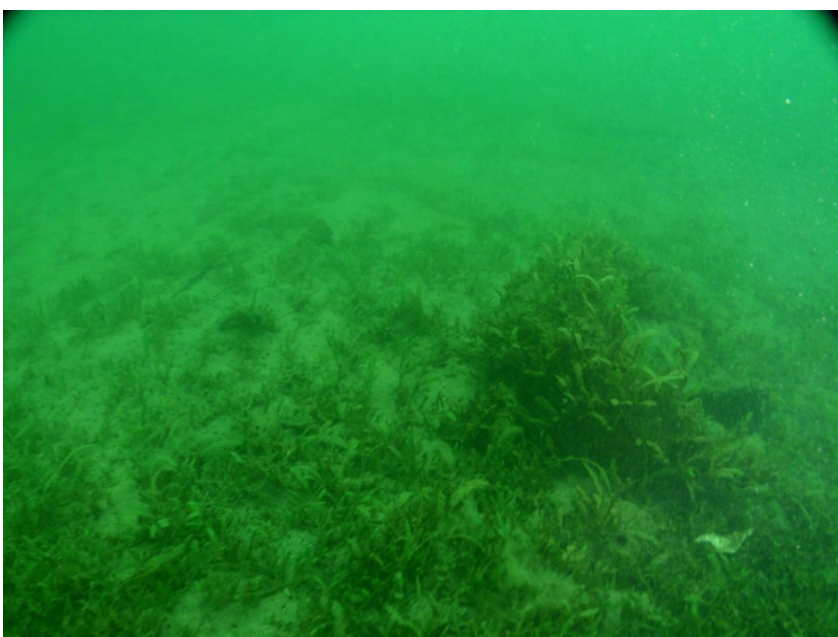
Figure 9

Patchy *Caulerpa taxifolia* bed in sandy habitat and over debris off-shore from the north ramp

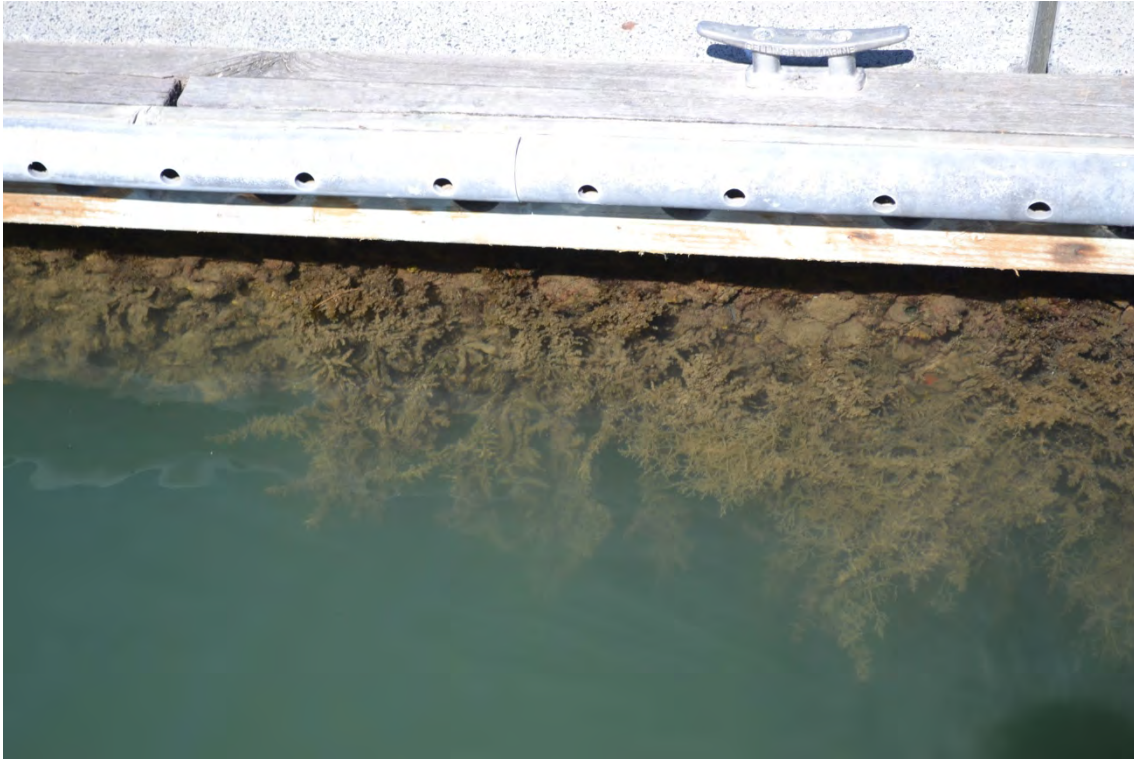
- The existing pontoon wetted surfaces support a mixed biota including fringing green and brown algae, dominated by *Sargassum*, bryozoans and tunicates (Figures 10 and 11).

Figure 10 View of Public Wharf pontoon edge showing the thin band of fringing algae and tunicates in the shallow sub-tidal and *Sargassum* algae plus bryozoans on the deeper sub-tidal edges.

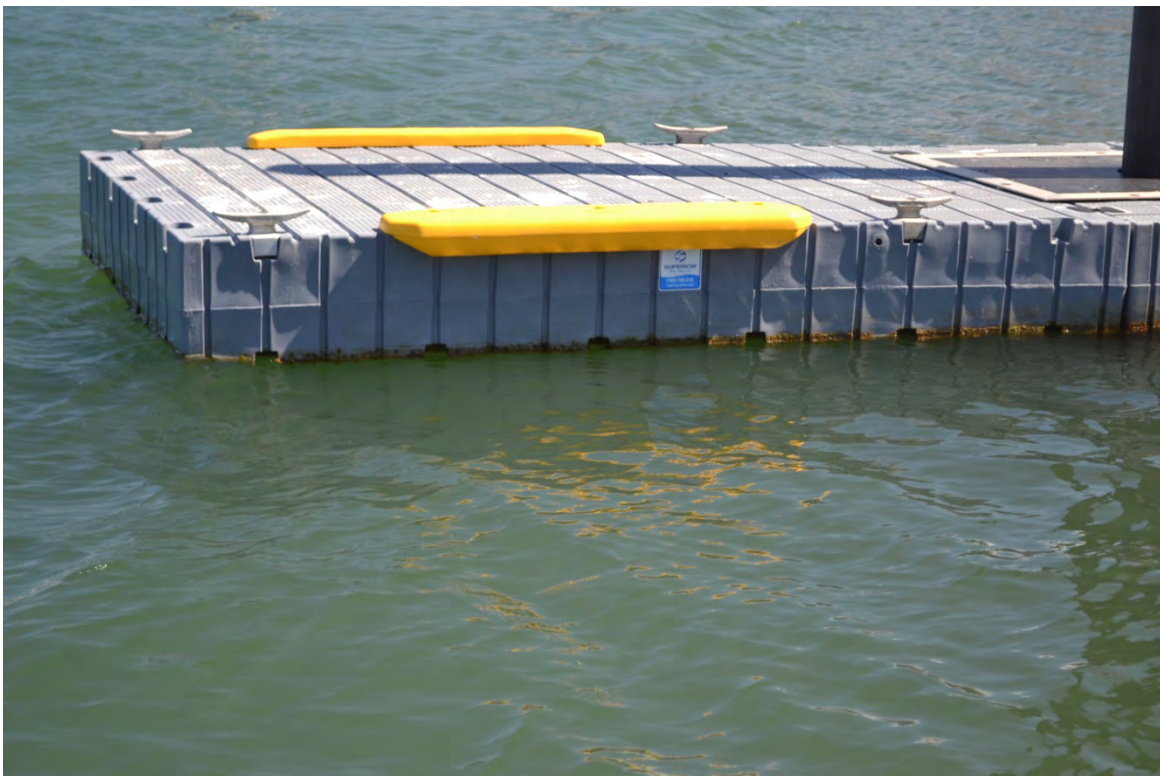
Figure 11 View of Marine Rescue Pontoon showing thin band of brown and green fringing algae. There are long-stranded soft bryozoans hanging from underneath the pontoons.
