Arboriculture Impact Statement & Site-Specific Preliminary Plan of Management

December 2023

Thomas Stephens Reserve

2105 Pittwater Road, Church Point NSW 2105

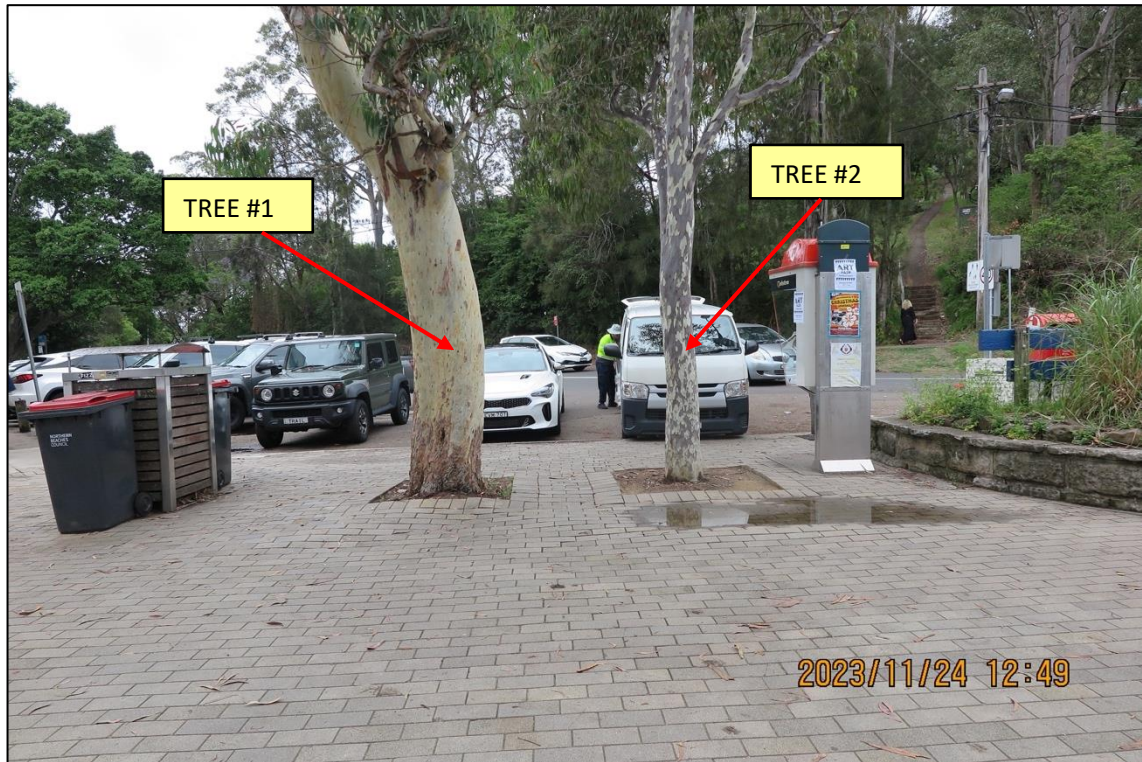
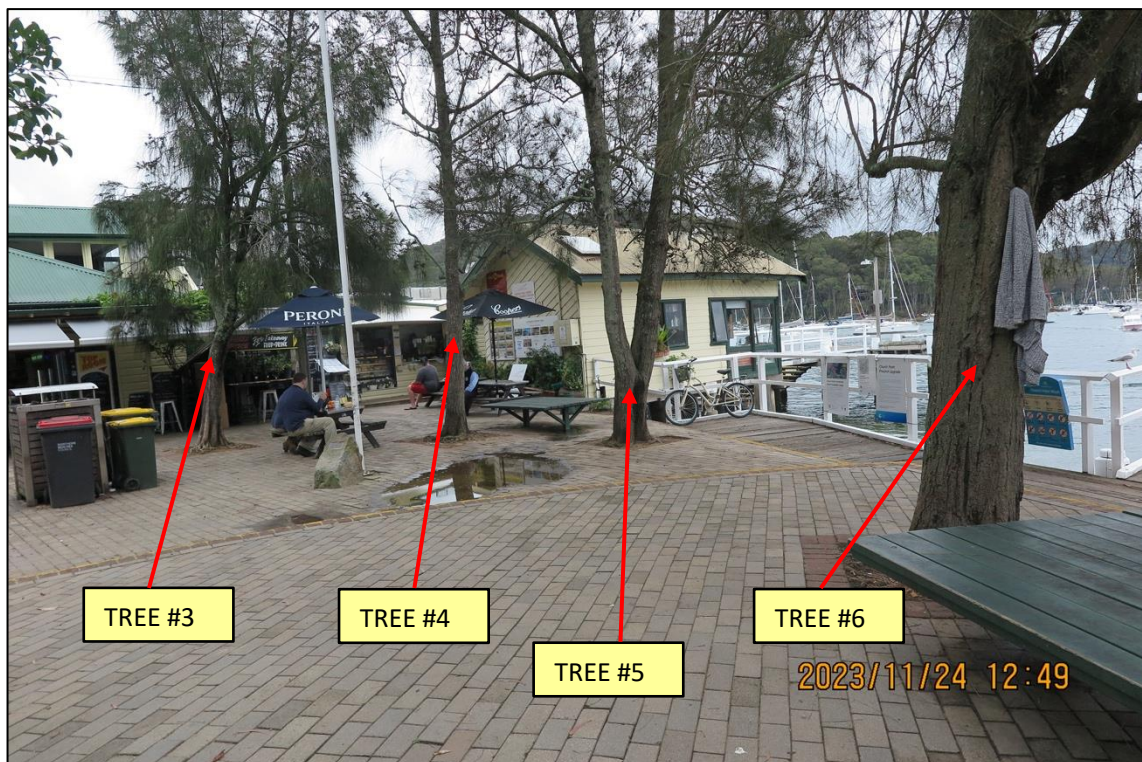
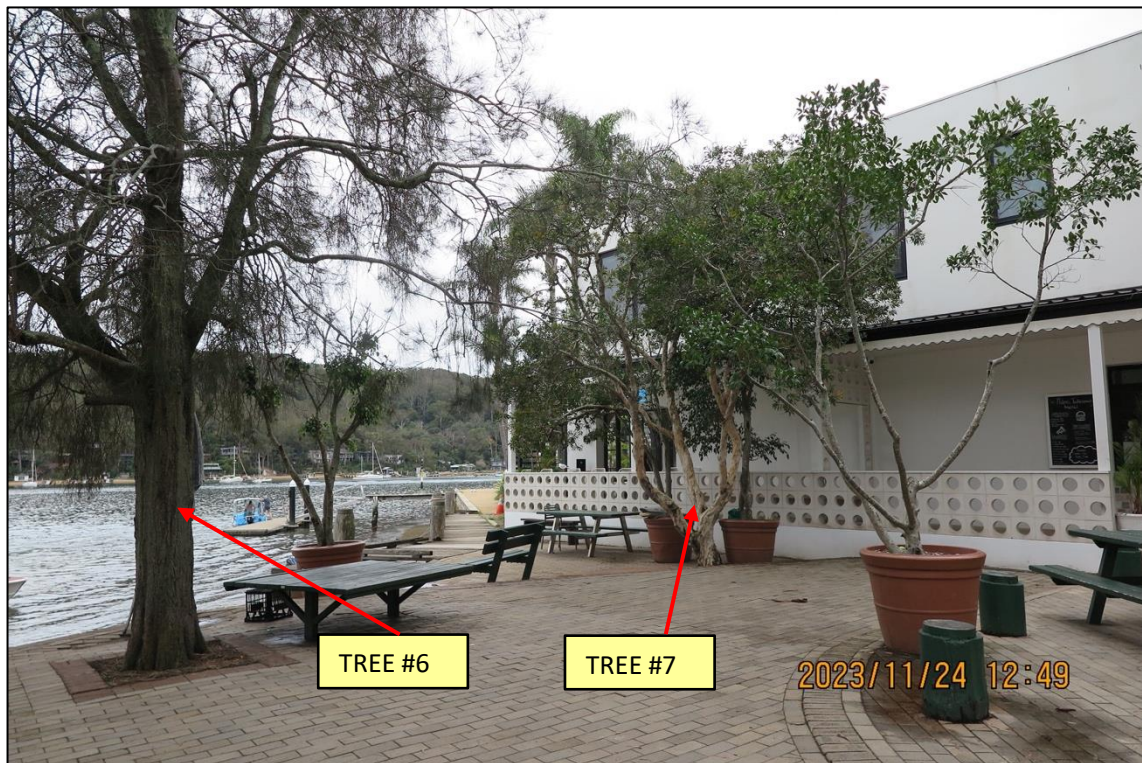
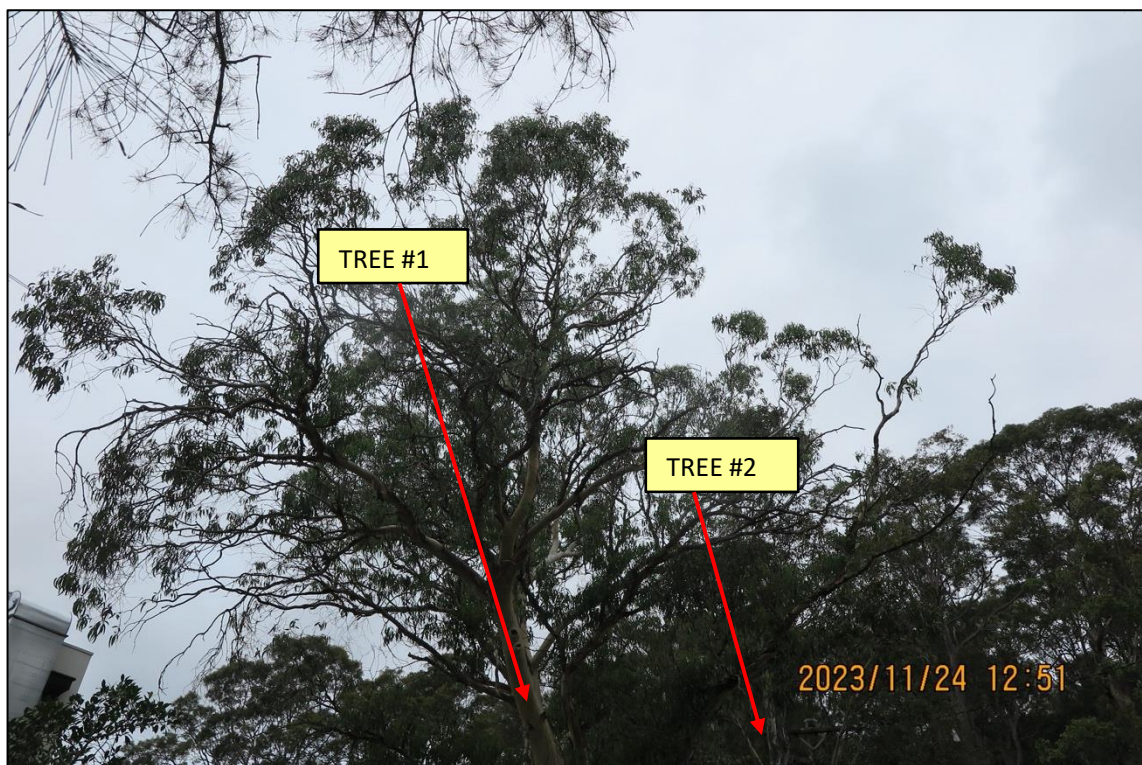
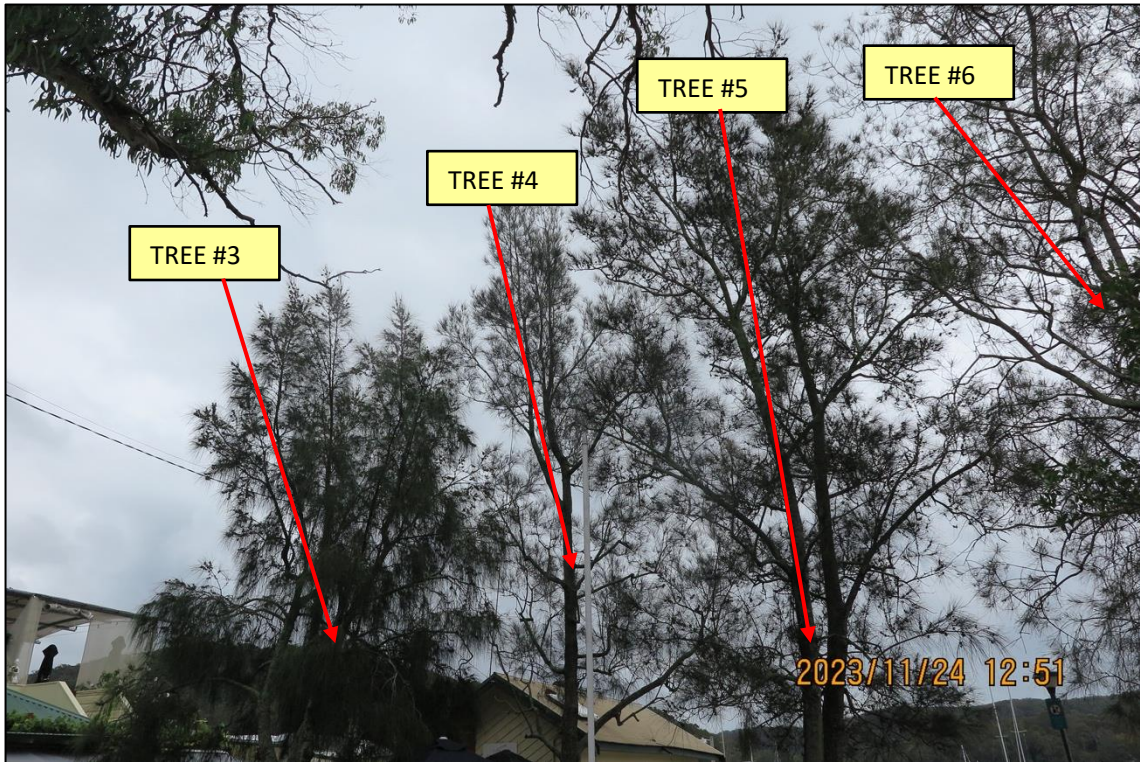
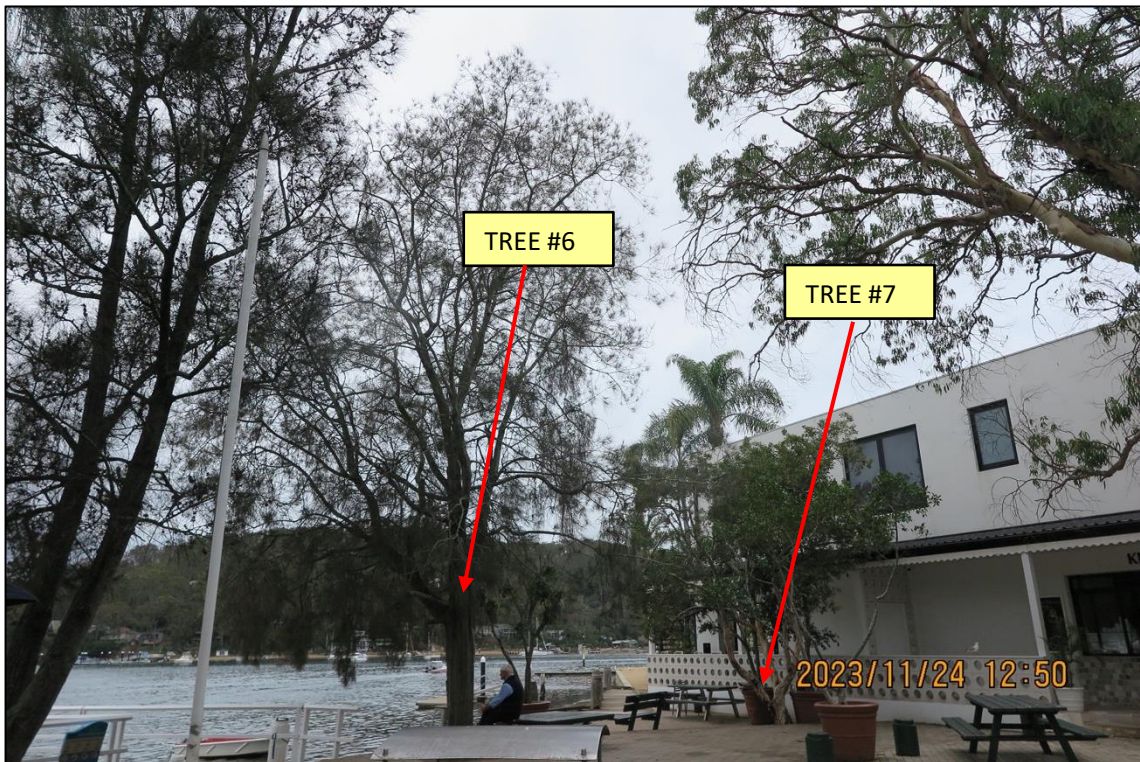
FIGURE 7 ABOVE & PREVIOUS PAGE PHOTOGRAPHS ILLUSTRATES THE SEVEN (7) TREES OR GROUPS OF TREES DISCUSSED TREE'S LOCATIONS & SITE FEATURES

The proposed works significantly breaches individual tree TPZ total surface areas for TREE #1, TREE #2, TREE #3, TREE #4, TREE #5 and TREE #6. (By our calculations, all discussed trees TPZ total surface areas are breached by more than twenty percent i.e., 20%).

TREE #1 displays a significant number of dead branch tips. By our interpretation, experience & review of literature, 'dead branch tips' are very often an indicator of 'live root' dysfunction. Taking this into account, as well as acknowledging this species of tree does not naturally occur near 'salt laden' winds, our opinion is this tree regardless of any proposal for development has at best only a short Useful Life Expectancy

TREE #3, TREE #4, TREE #5 and TREE #6 are described as the most impacted upon (below ground level) on the basis their 'live root' systems will be damaged when rebuilding the existing sandstone seawall.

On this basis, we support replacing TREE #1, TREE #2, TREE #3, TREE #4, TREE #5, and TREE #6.

Prior to the commencement the commencement of any works including demolition & the construction works TREE #7 require installation of TPZ temporary 'temporary Tree Trunk Guard.

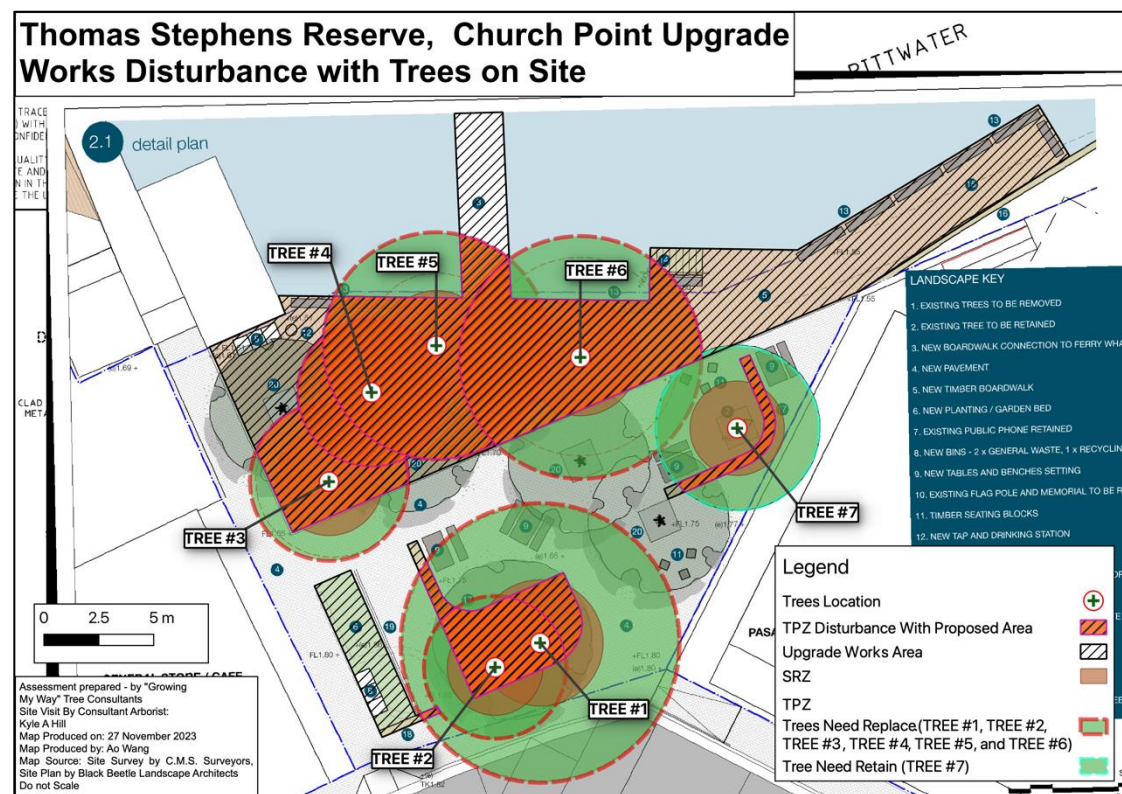
TPZ / SRZ TREE DISTURBANCE DIAGRAMS

TREE #7 has been assessed, relative to the proposed works as able to be viably retained, managed & protected. (By virtue of way less below ground level disturbance, i.e., less than ten percent (10%) of TPZ total surface area being breached.)
