northern
beaches
council

Options and Feasibility Report Long Reef Boardwalk & Bridge Replacement

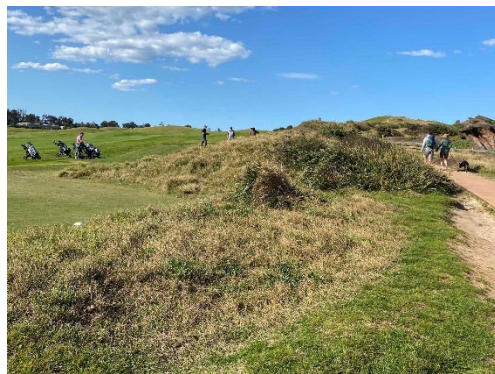
The boardwalk is located next to Long Reef Golf Club. Two golf tees are located approx. 8 - 10m northwards of the boardwalk (refer Figure 1). There is no fence or barrier between the golf tees and existing boardwalk, with a resultant potential risk of walkers being hit by stray golf balls. While council confirmed they do not have a record of a golf ball strike on this site, a mis-hit golf ball strike could occur. Golf ball strike risk is currently managed by council with advisory measures only (i.e. limited advisory warning signage for walkers to be aware of golf ball activity) which offer some level of protection to coastal walkers in proximity to golfers using the Long Reef Golf Club course. Council's intention is to consider opportunities as part of the boardwalk replacement to reduce golf ball strike risk if possible.

Figure 1: Golf tees close to trail

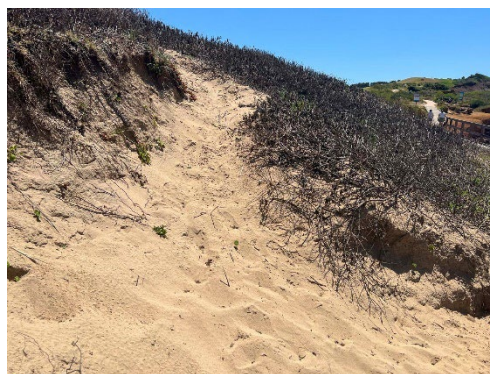
Long Reef beach is subject to significant instability and coastal erosion. Natural coastal processes have recently resulted in significant weathering and erosion of soft rocks, soils and sand dunes on Long Reef headland. Many of the steeper areas are actively eroding with the subsequent loss of remnant vegetation (refer Figure 2).

Figure 2: Sand track in dune

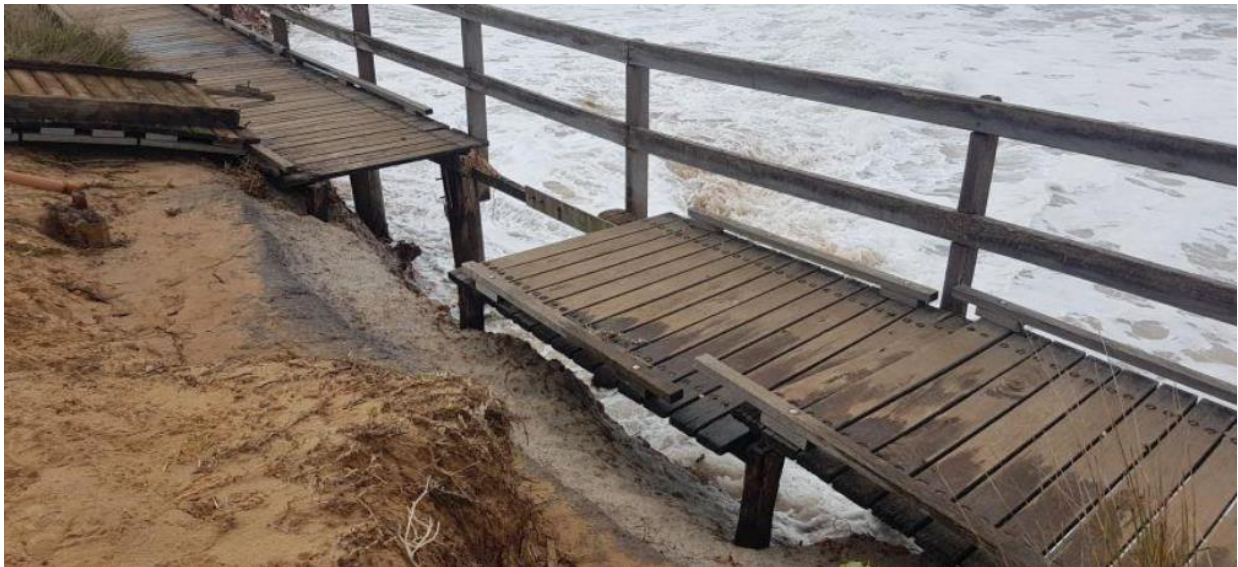
The Water Research Laboratory (WRL) of the School of Civil and Environmental Engineering at UNSW Sydney was engaged by Northern Beaches Council (NBC) to provide coastal engineering advice in relation to a proposed upgrade of the Long Reef walkway which was damaged during a storm on 24-25 August 2021 (Figure 1-1 and Figure 1-2).

Figure 1-1 Photograph 1 of 2 of damage to Long Reef walkway: 25 August 2021 (Source: NBC)

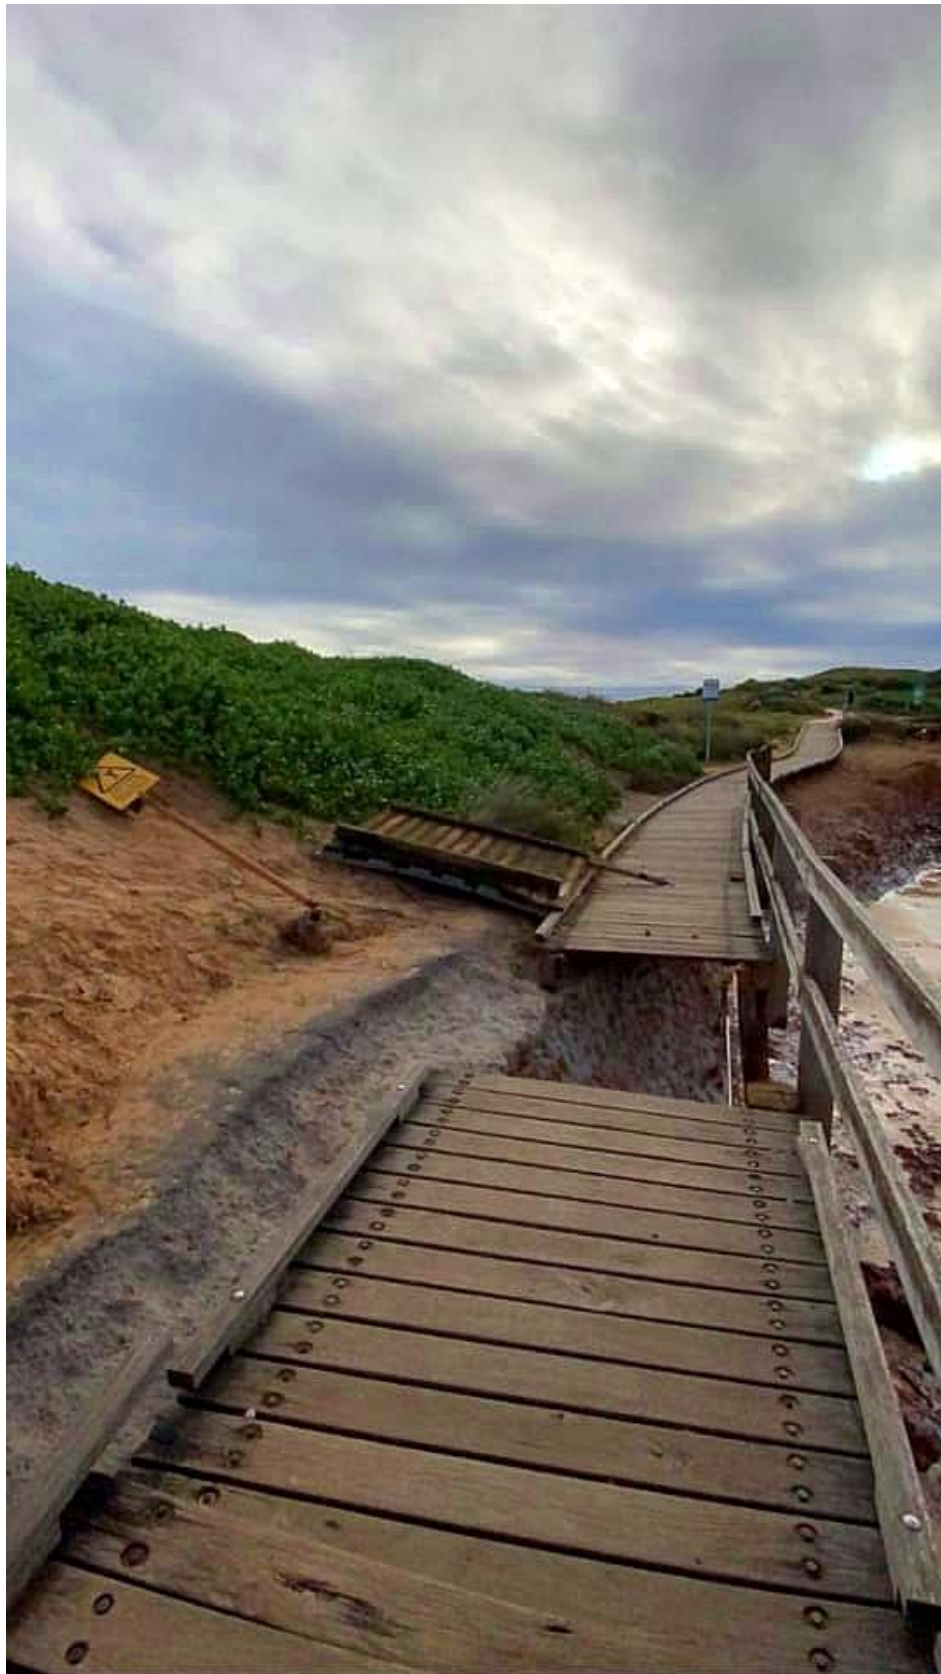
Figure 1-2 Photograph 2 of 2 of damage to Long Reef walkway: 25 August 2021 (Source: NSW SES)

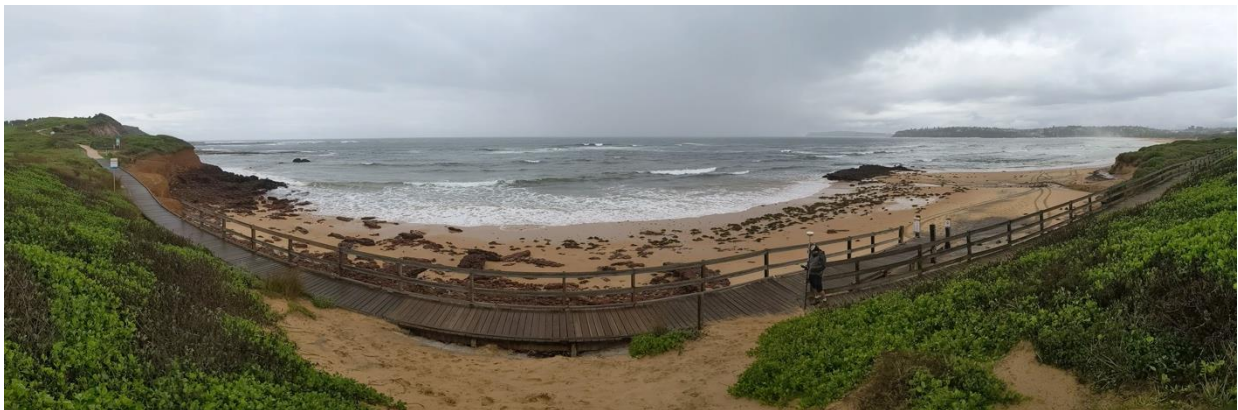
On the day of the site visit, the beach fronting the section of the Long Reef walkway, which was the focus of this study, was observed to be in a relatively eroded state (Figure 3-1 and Figure 3-2). This was further confirmed by conducting a review of historical aerial imagery back to 2012 (images not shown for brevity). The upper part of the beach located directly beneath and in front of the walkway was predominantly devoid of a sand veneer, with soft bedrock and rock shingles/pebbles exposed down to around approximately 0.5 m AHD.

Figure 3-1 Photograph of beach looking seaward taken from the top of the dune

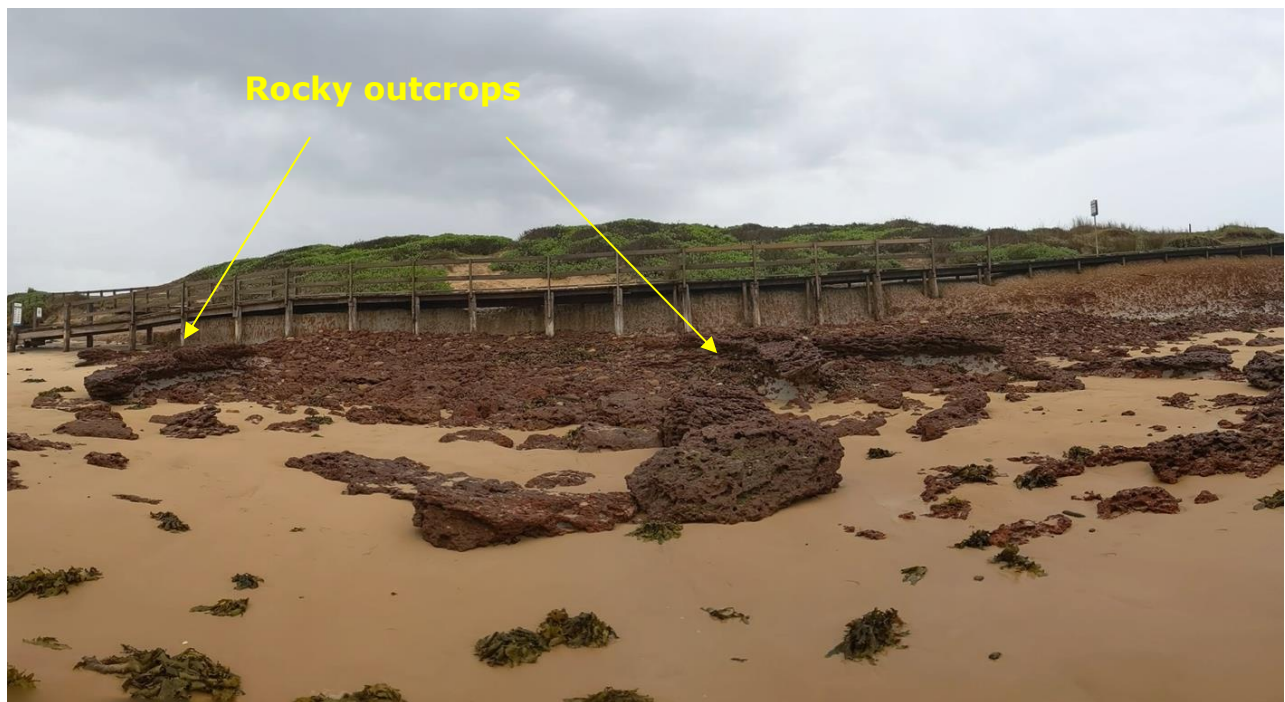
Figure 3-2 Photograph of beach looking landward taken from the edge of the swash zone (approximately +0 m AHD). Note rocky outcrops which may focus wave runup.

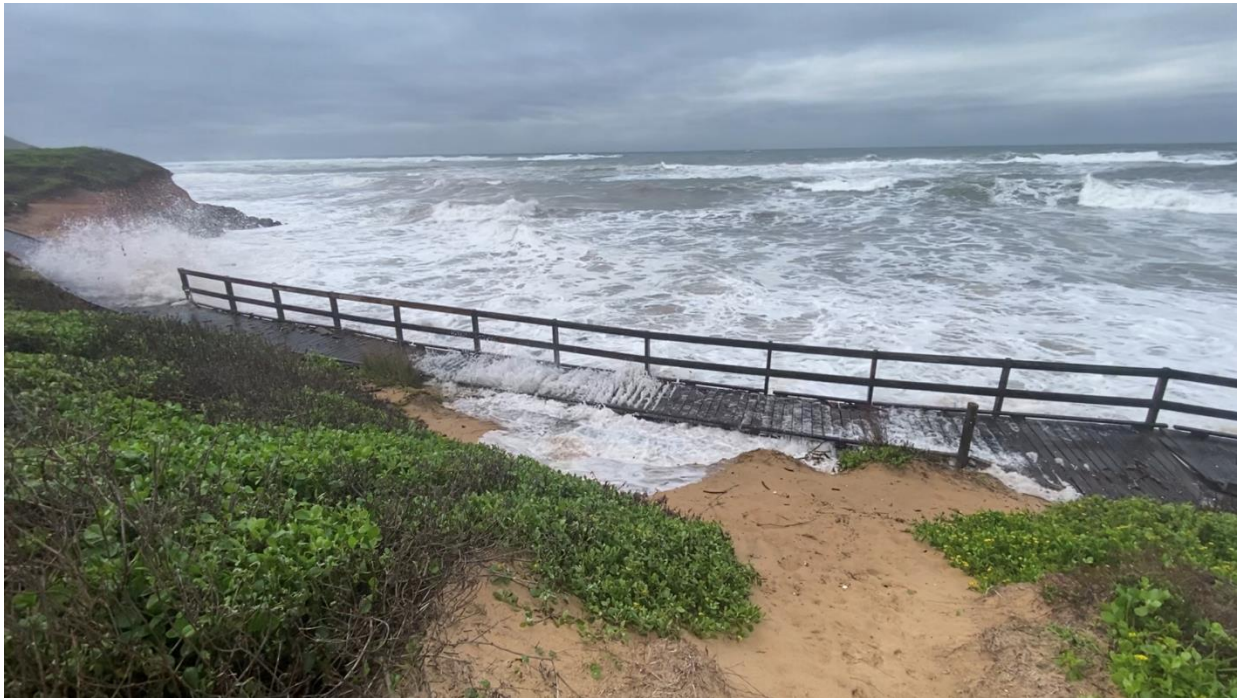
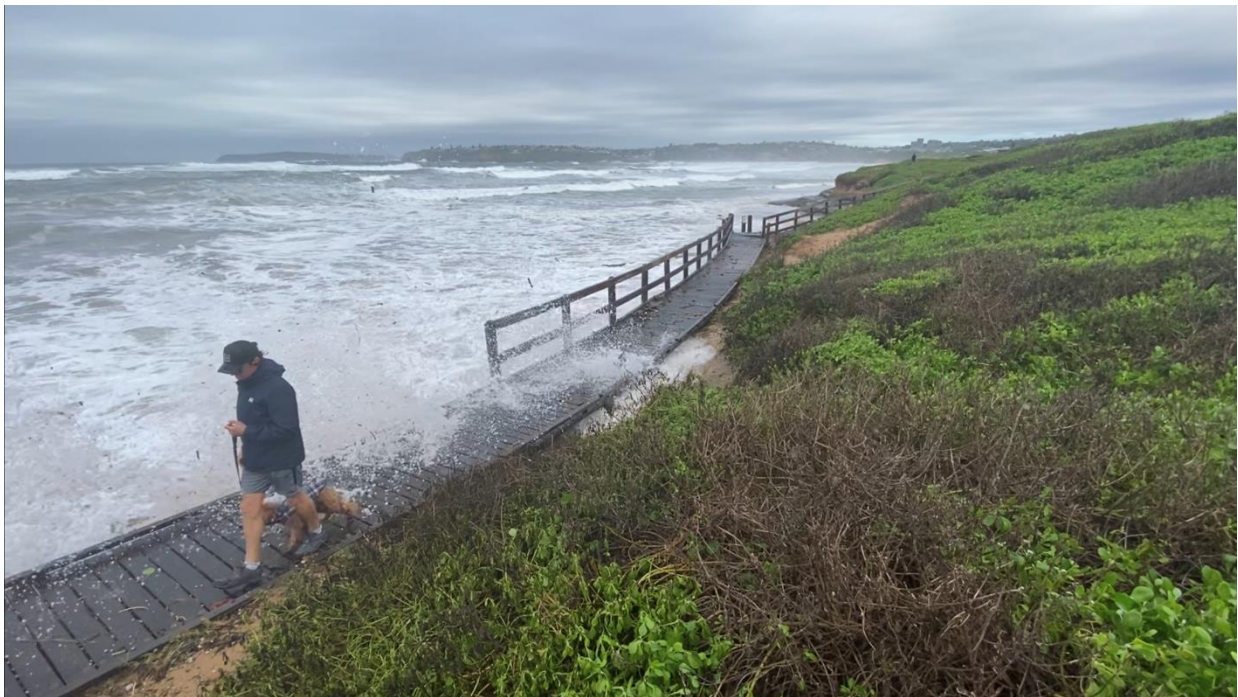
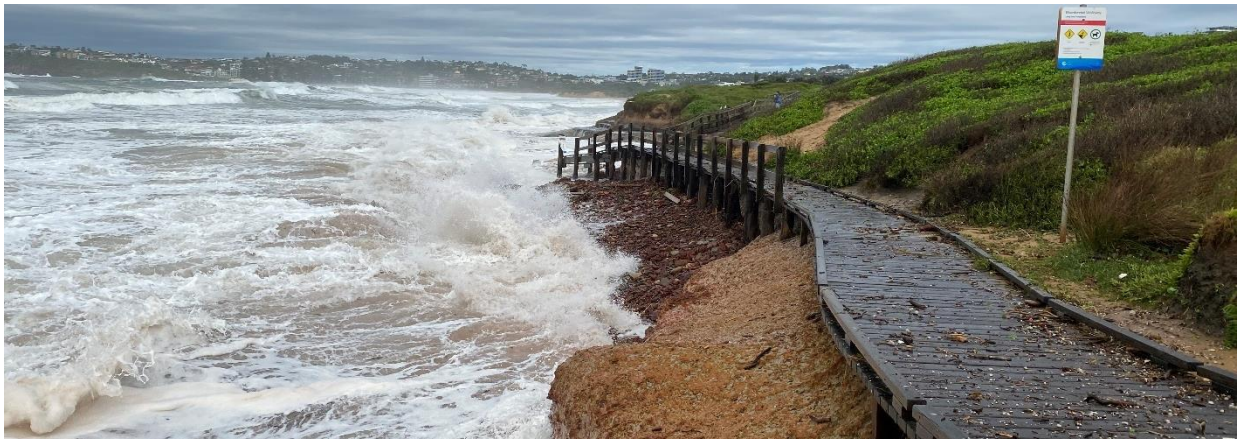
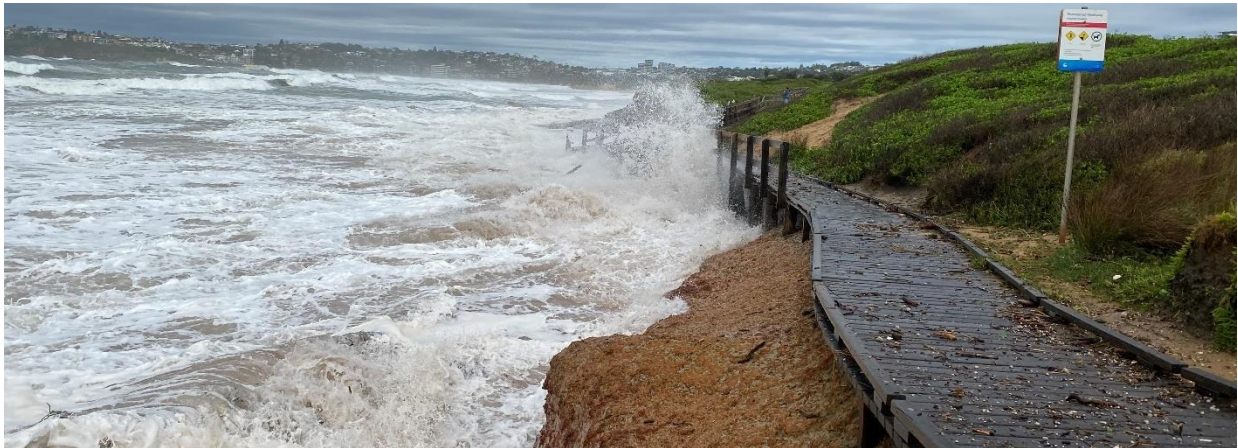
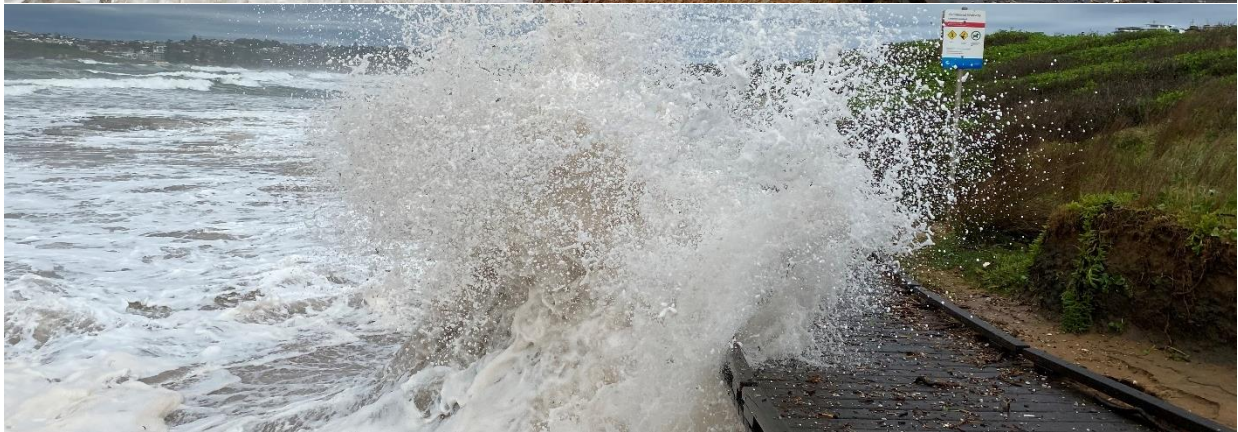
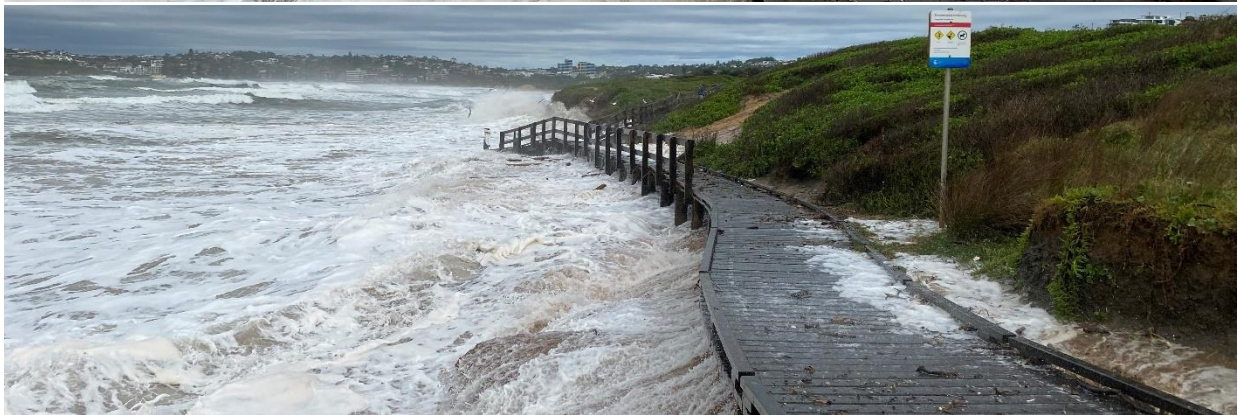
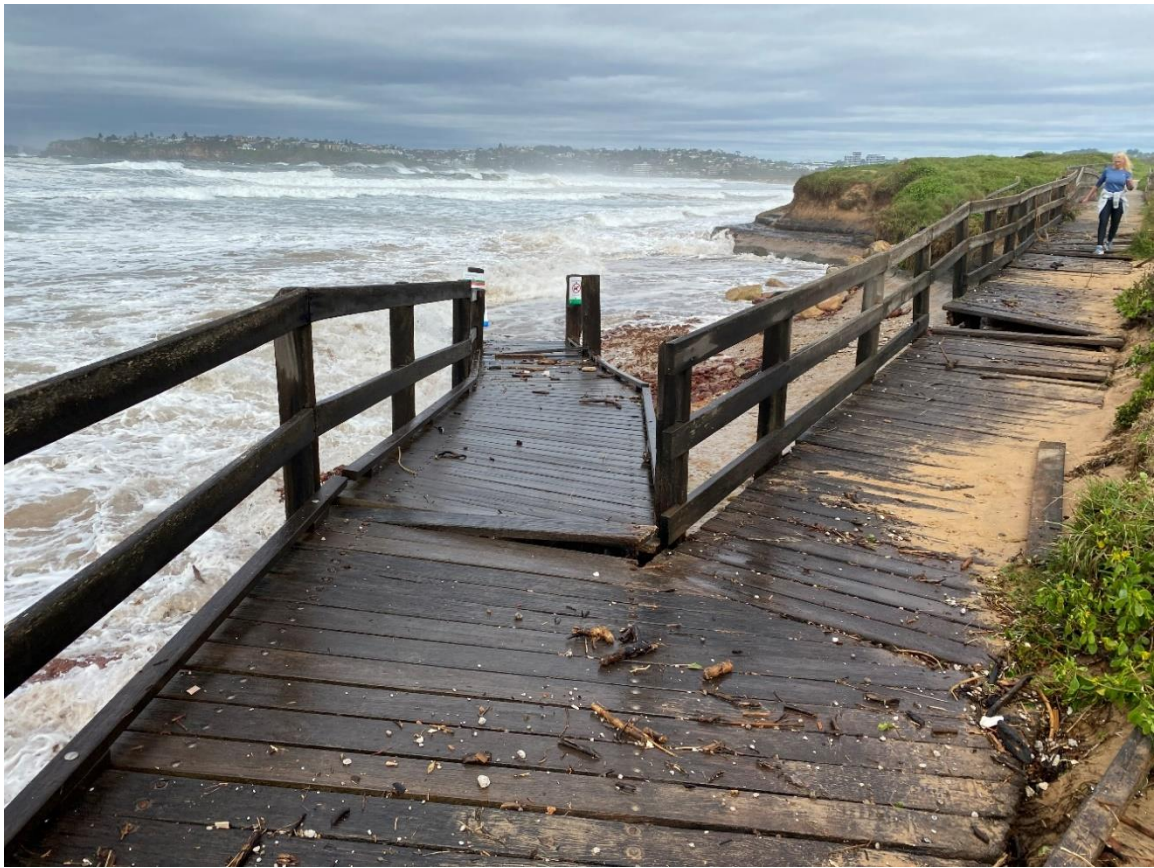
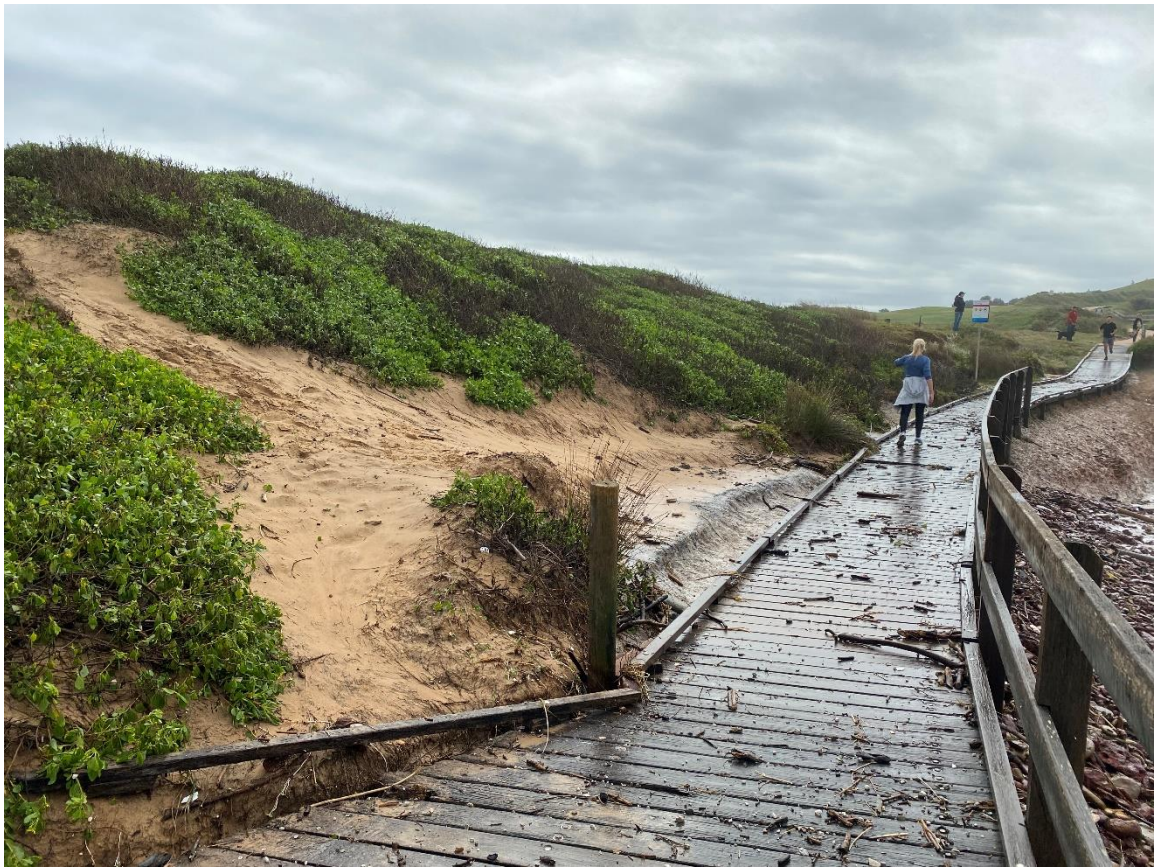
The following photographs were taken by Ian Coghlan around high tide (09:45 AEDT) on 2 April 2022 during the 1-2 April storm event to document damage to the Long Reef walkway and wave runup and overtopping over it.

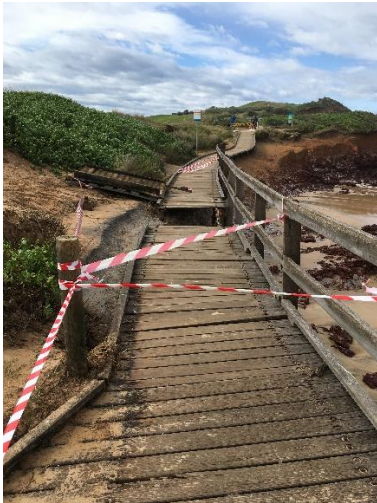
In August 2021 large swells caused significant damage to the foreshore boardwalk at Long Reef headland. This boardwalk is part of the Long Reef Headland loop track and is subjected to a high volume of use by the community. The boardwalk is being repaired in late August to ensure that it is serviceable for the short term (9-12) months.

Figure 1 - Damaged decking August 2021

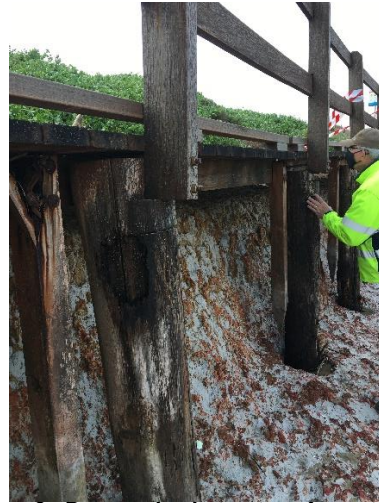
Figure 2 - Damaged substructure August 2021

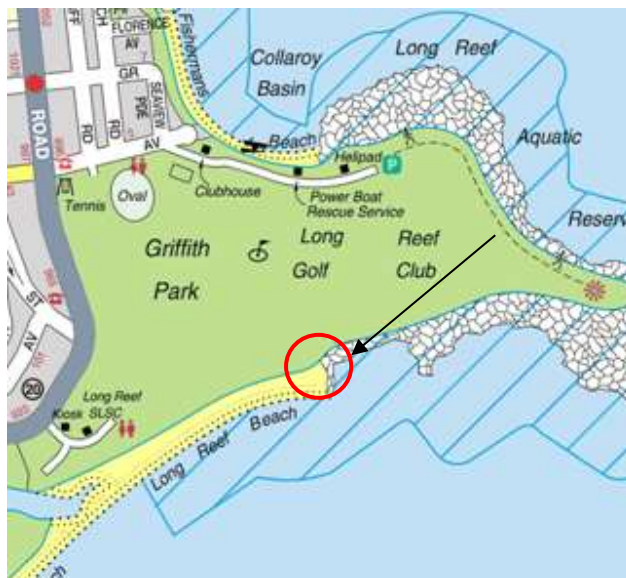
Poor, eroding badly

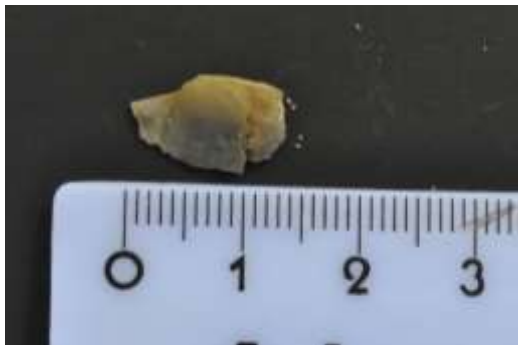
DSC-3241 flake found eroding from deposit

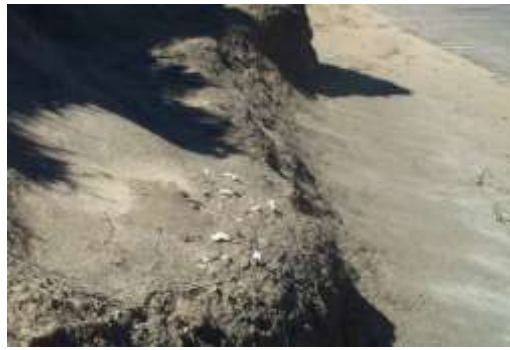
3381 Shell exposed by sea.

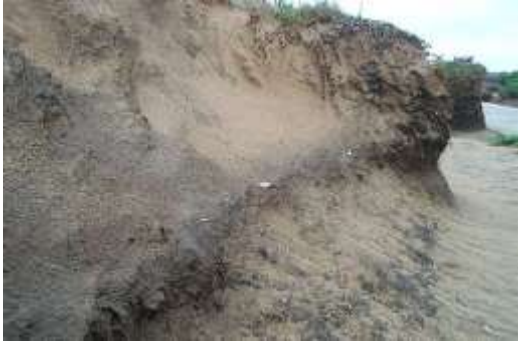
1632 Eroding bank.

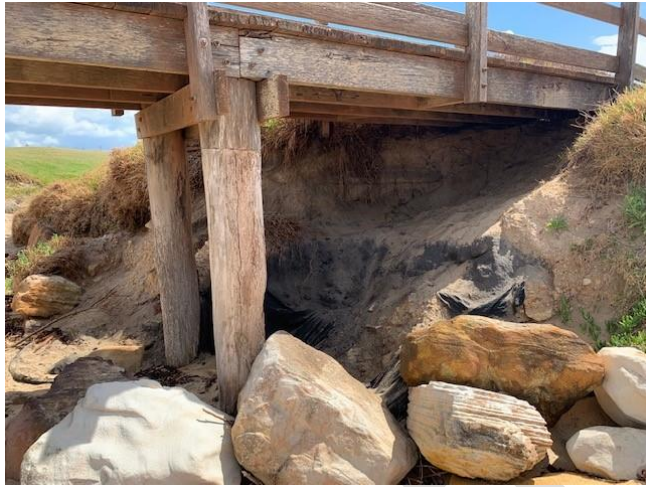
Photograph 4: Rock armoring at northern end of bridge

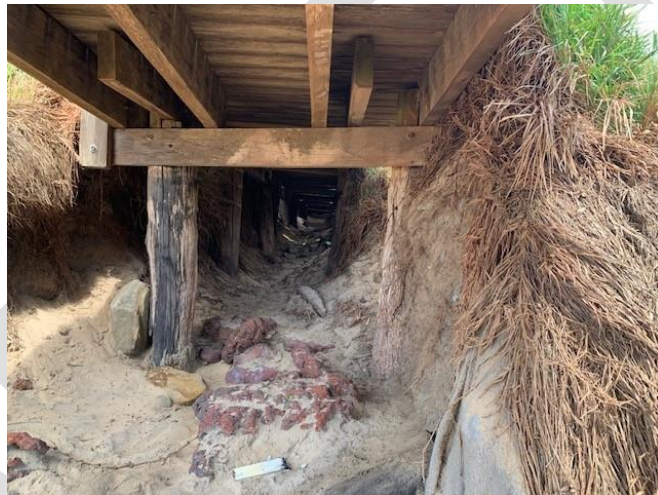
Photograph 5: Scouring of sand dune below southern end of bridge approach

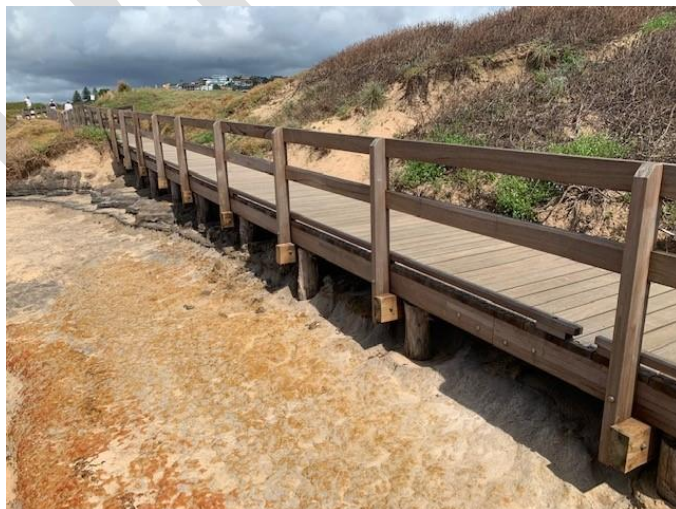
Photograph 6: Scouring of sand adjacent to boardwalk, exposing reddish clay material
