# MARINE POLLUTION RESEARCH PTY LTD

## AQUATIC ECOLOGY SURVEY FOR NARRABEEN LAGOON BOARDWALK

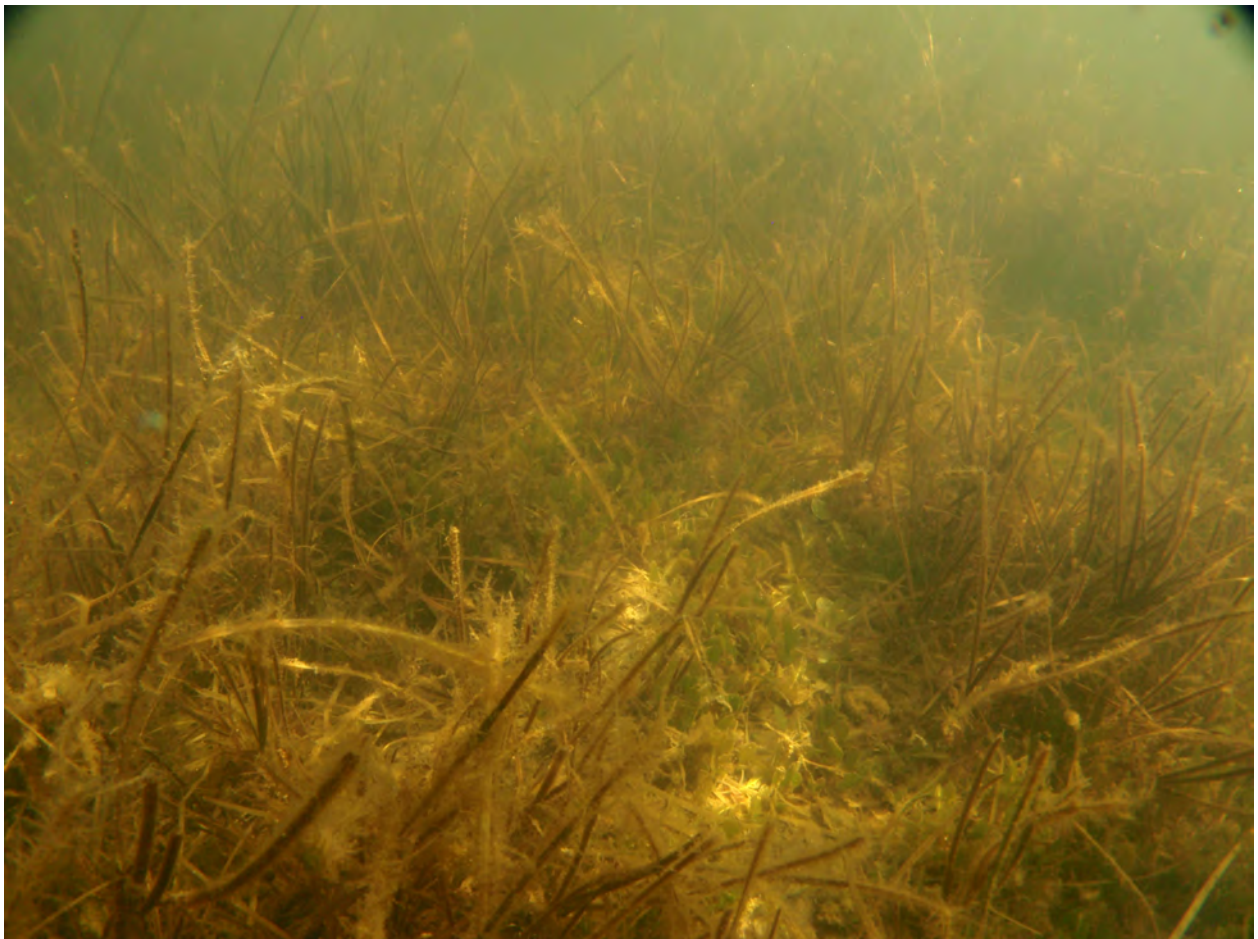
Underwater view of mixed *Halophila* and *Zostera* bed offshore from proposed Boardwalk alignment.

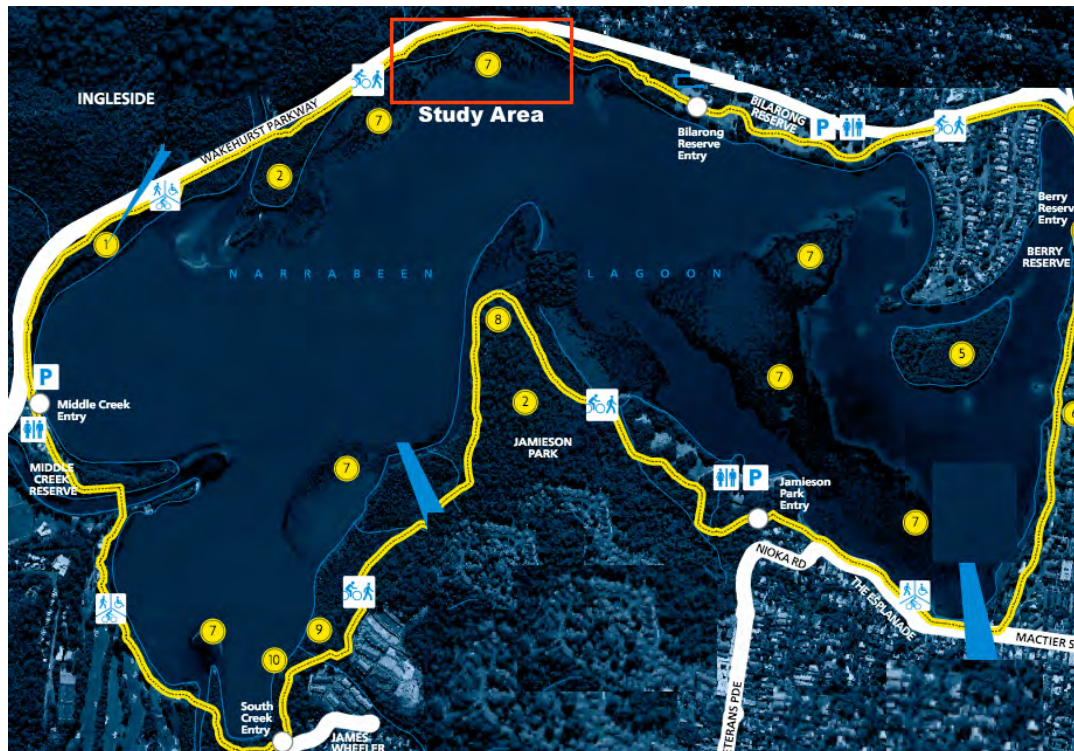
Figure 1 Aerial view of Narrabeen Lagoon Trail showing location of section of track to be replaced with Boardwalk (source map: Council on-line Narrabeen Lagoon Trail Brochure).

A portion of the northern boardwalk between the Bilabong Reserve entry and the Deep Creek bridge is currently located immediately alongside Wakehurst Parkway (see Figures 1 to 4) and widening or relocating this section of the trail to afford a safe distance between the roadway and the trail users is limited by the narrow section of foreshore sensitive she-oak forest habitat along this part of the trail. In essence, for the trail to be made conforming and safe would require the removal of a continuous stand of she-oaks and associated foreshore habitat which is considered unacceptable from both environmental and ascetic points of view.

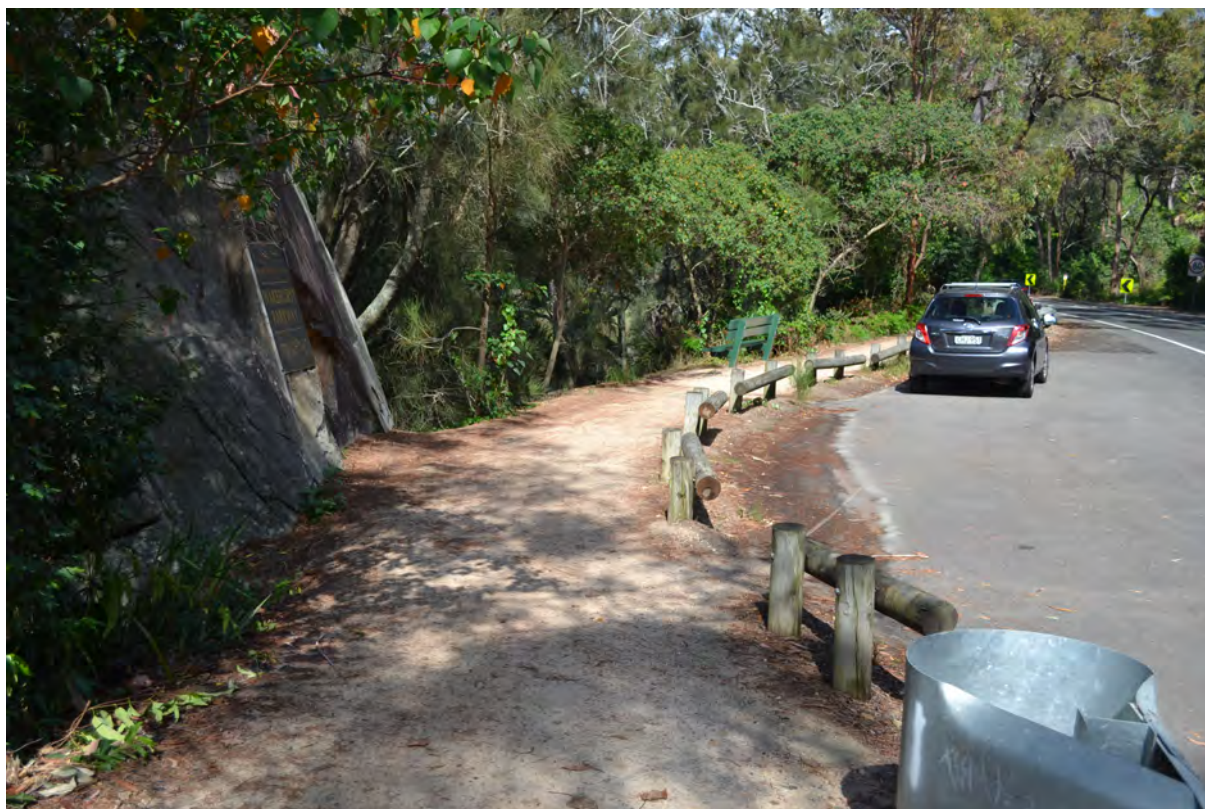
Figure 3 Proximity of walkway to Wakehurst Parkway (looking west at Parkway Memorial).

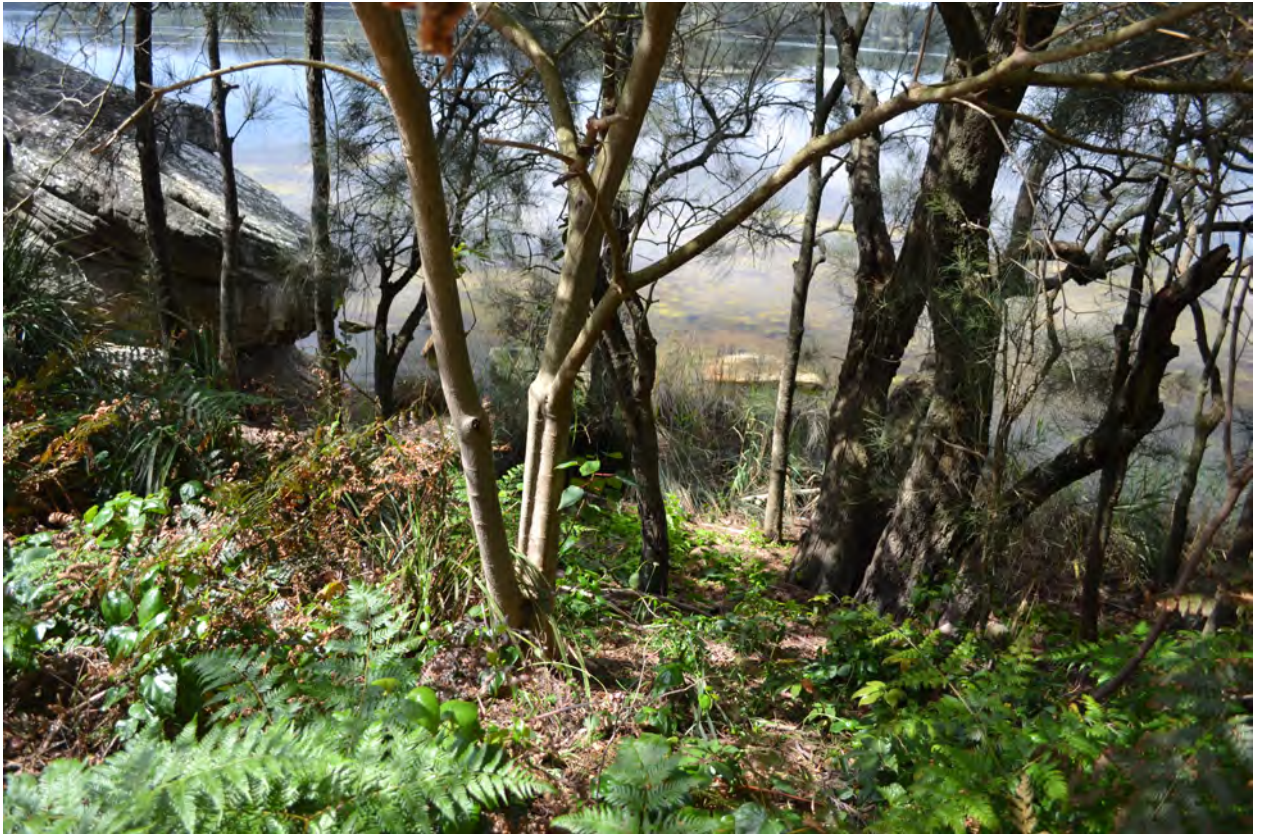
Figure 4 View south to waters edge from walkway (from bench in Figure 3) showing the narrow foreshore dominated by swamp-oak forest habitat.

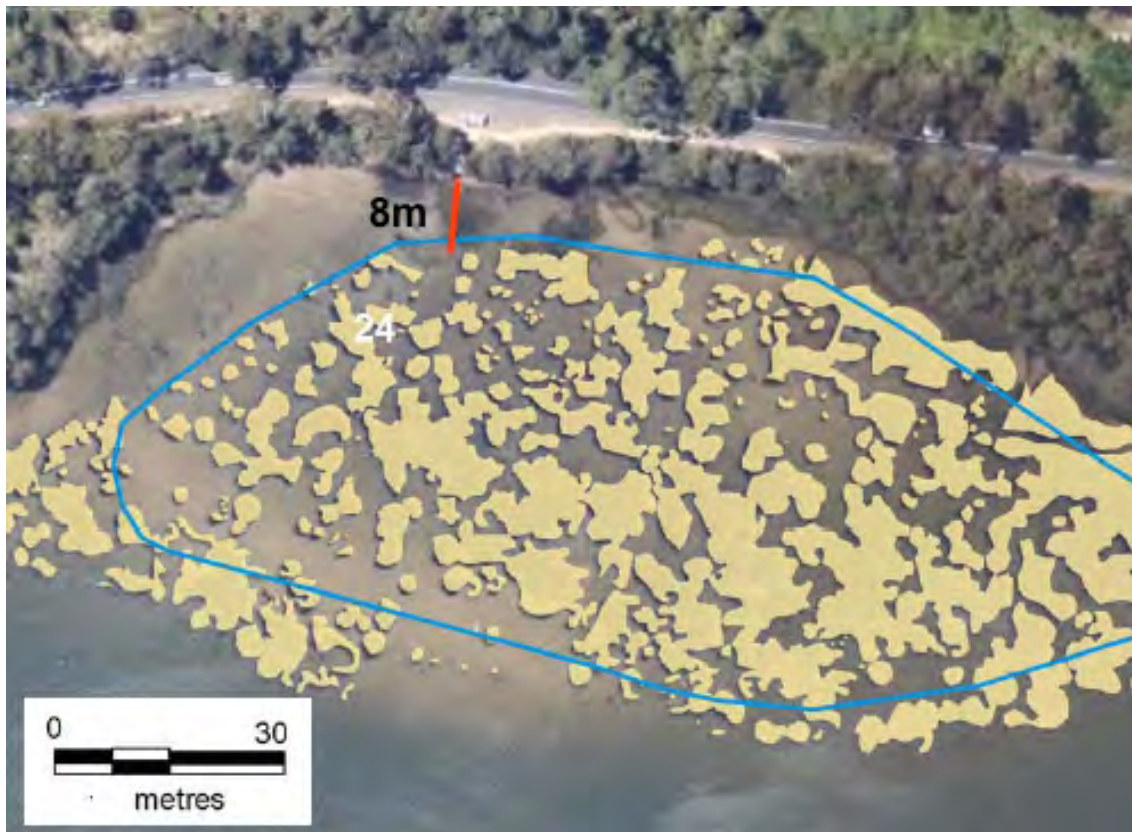
Figure 6 Portion of Figure 9 from CEL (2013) showing *Zostera* seagrass distribution in Area 24 that encompasses the present study area. See **Appendix B** for the full CEL (2013) Figure 9.

Cardno Ecology Lab (CEL 2013) provided an updated summary plus validation study of seagrass mapping in Narrabeen Lagoon in relation to areas identified as potential dredging sites. They found that Area 24 (which encompasses the study area for this present study) supported  $8822\text{m}^2$  *Zostera* seagrass in the total study area of  $17910\text{m}^2$ , i.e., 49.3% cover (see their Figure 9 produced in full in **Appendix B** to this report). Their mapping also indicated that the *Zostera* seagrass patches were located some 8m offshore in the present study area (see Figure 6 below).

Comparing the CEL (2013) mapping against the Astute Surveying survey it would appear that the CEL (2013) inshore limit for seagrass growth is around the 0m AHD contour on the Astute Surveying plan.

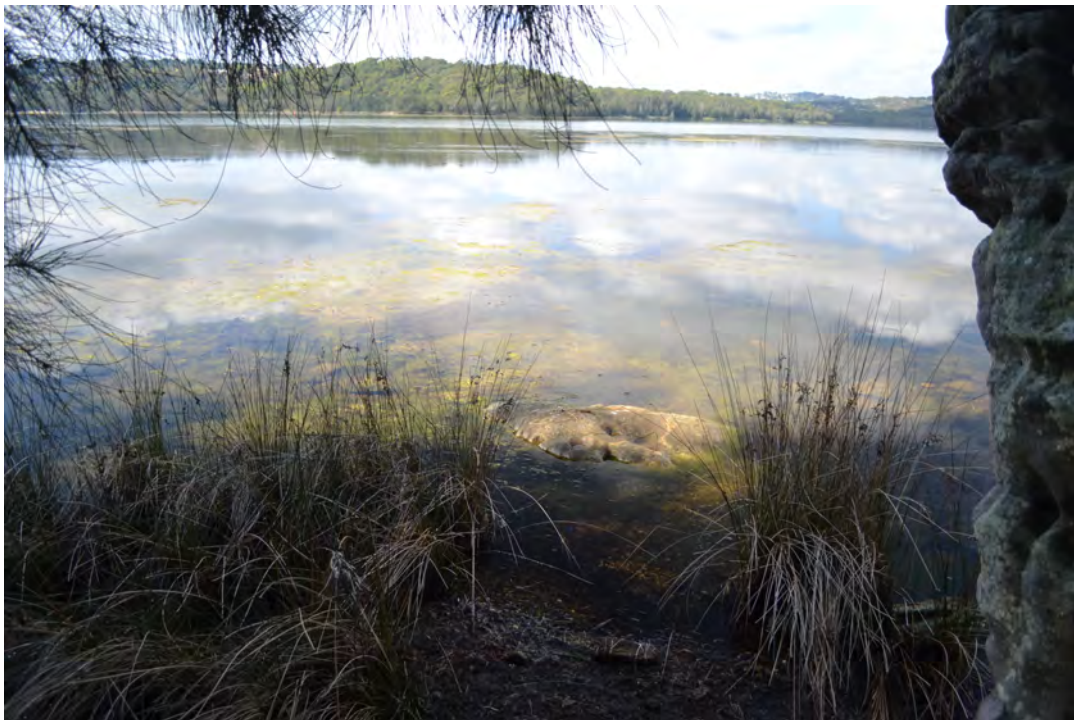
Figure 7 View south over the inshore shallows showing the algae smothered seagrass patches offshore.

MPR staff made several combined snorkel and walkover surveys to map out the main inshore ecological habitats for the proposed boardwalk. A preliminary inspection of the location was made on 10<sup>th</sup> November 2016 in the company of Ms Stack from Council, and a preliminary swim-over was undertaken of 25<sup>th</sup> November 2016. This latter survey confirmed that there were scattered seagrass patches offshore from the study area foreshore with many of the patches smothered by algae (Figure 7). The survey also indicated that there was a very large seagrass wrack (accumulations of sloughed off seagrass blades and other organic debris) overlaying the inshore shallows and in most cases smothering the seabed (see also **Appendix C** Plates 1 to 4).

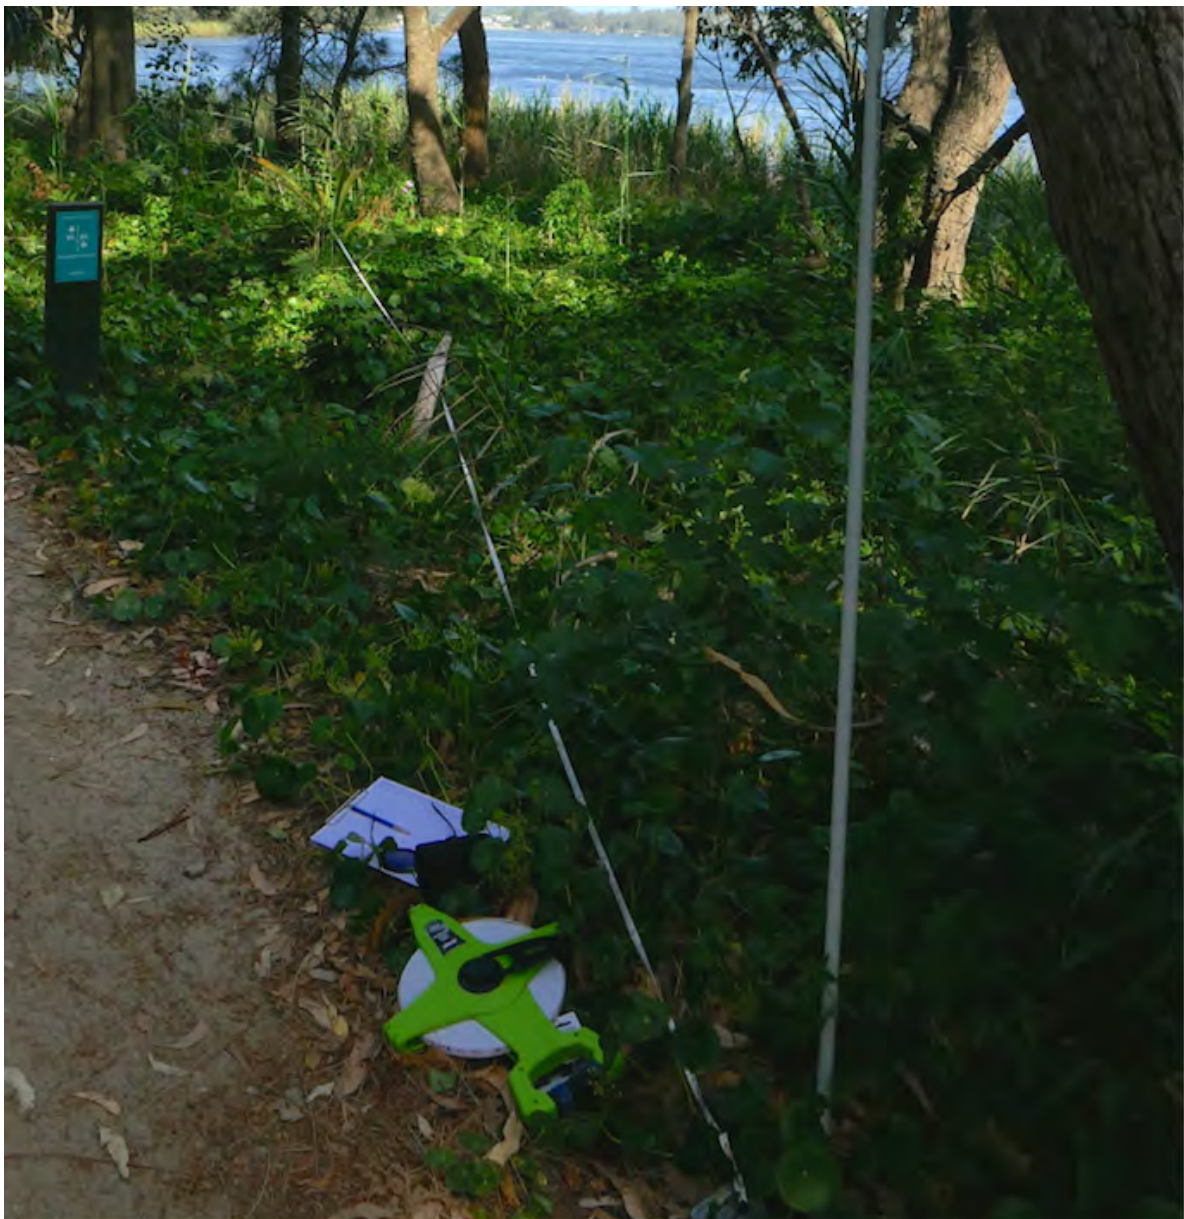
Figure 8 View along survey centreline from western end of the proposed boardwalk looking ESE over the riparian vegetation – see Table 1 for zonation and main plant species.

Figures 8 and 9 show views along the proposed boardwalk centre line at each end of the proposal. In terms of overall community zonation from the existing boardwalk to the fringing reed beds there is a loose transition from *swamp oak forest* through *saltmarsh* to fringing *reed swamp* communities at both ends of the proposal (Table 1).

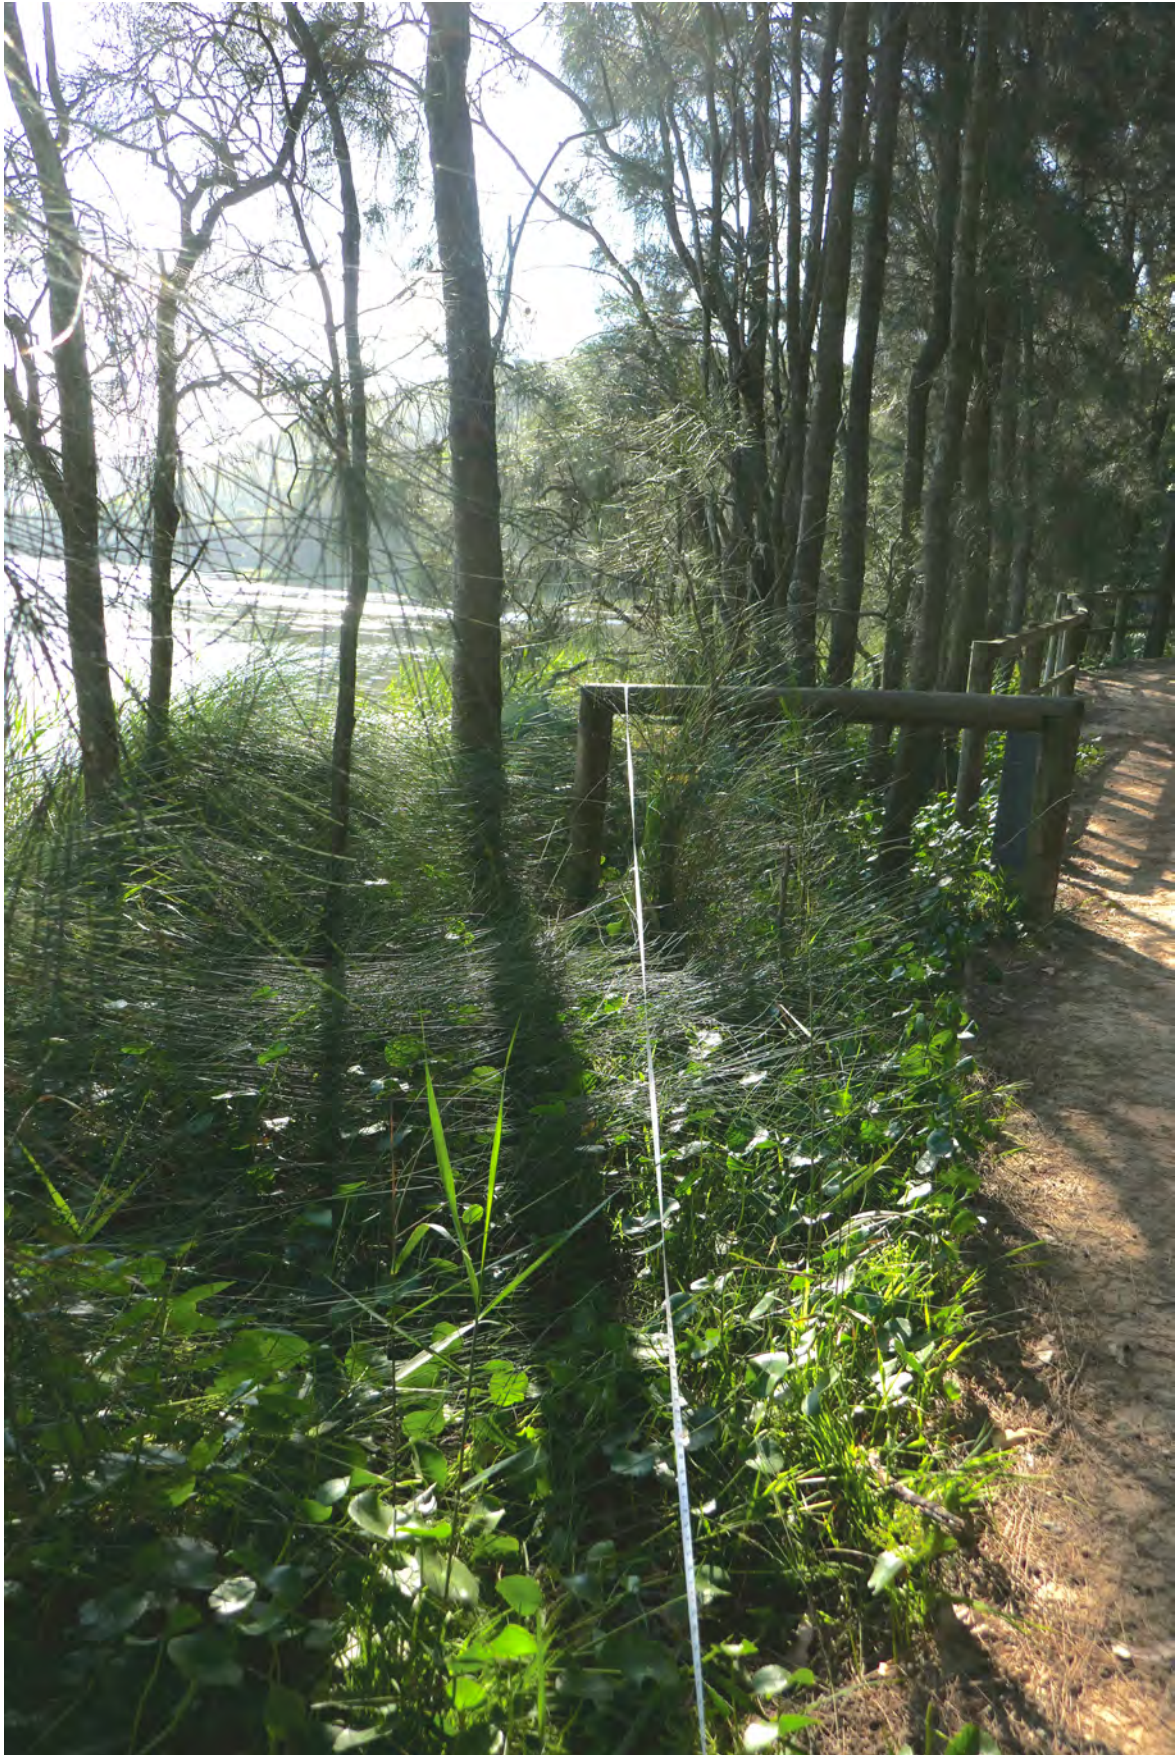
Figure 9 View along survey centreline from eastern end of the proposed boardwalk looking WSW over the riparian vegetation towards the fringing reed bed. See Table 1 for zonation and main plant species.

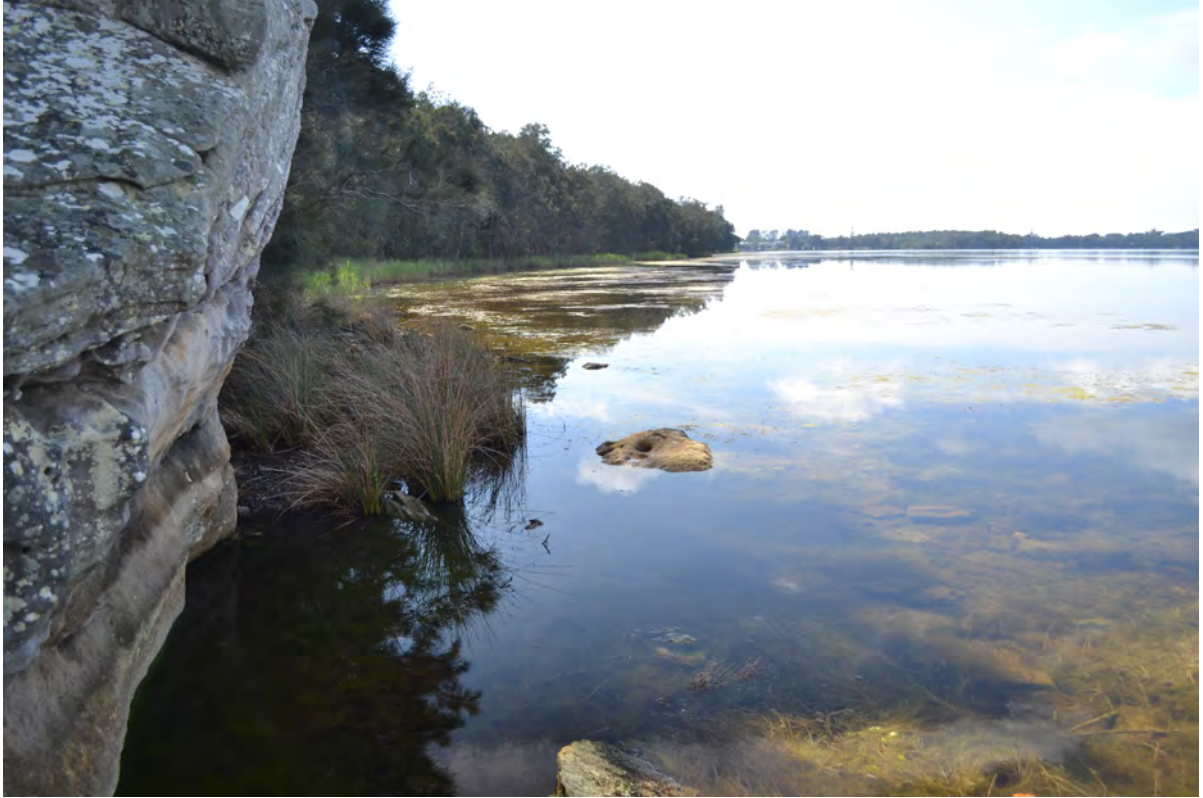
Plate 1 View of inner wrack habitat looking east from large rock adjacent Narrabeen Parkway parking bay.

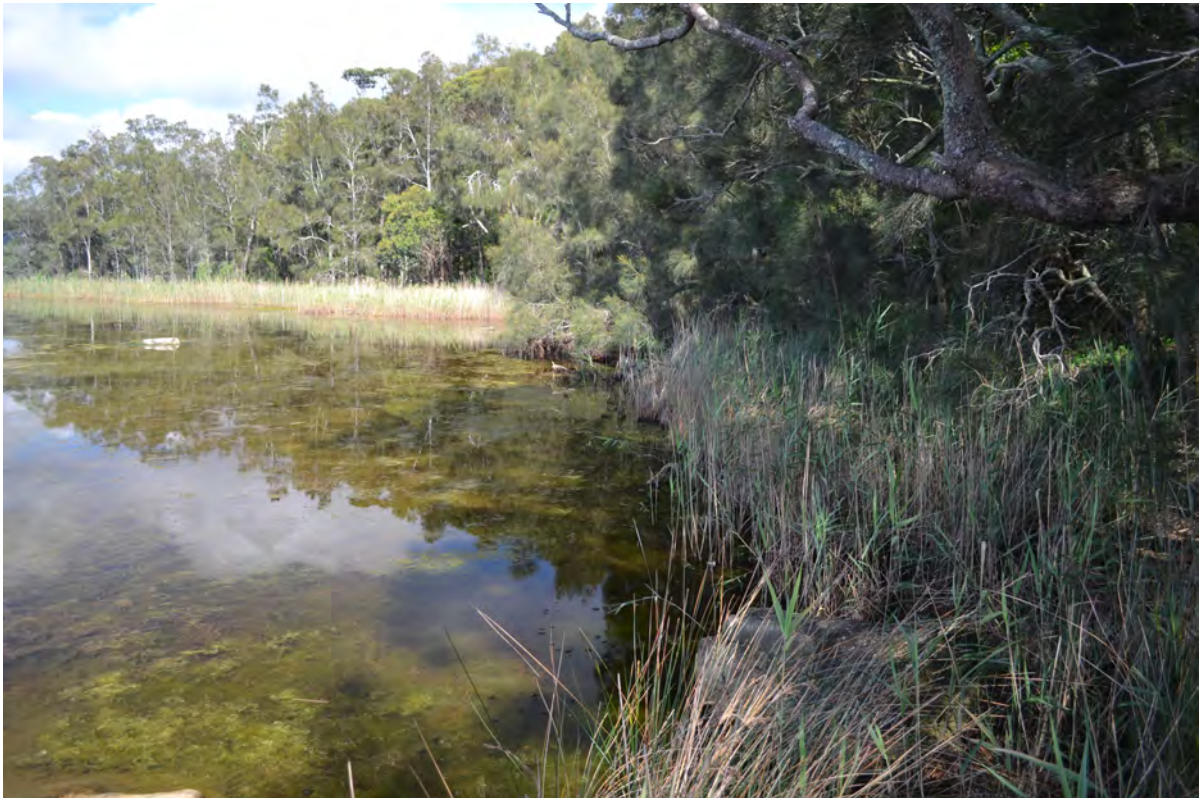
Plate 2 View of inner wrack habitat looking west from large rock adjacent Narrabeen Parkway parking bay.

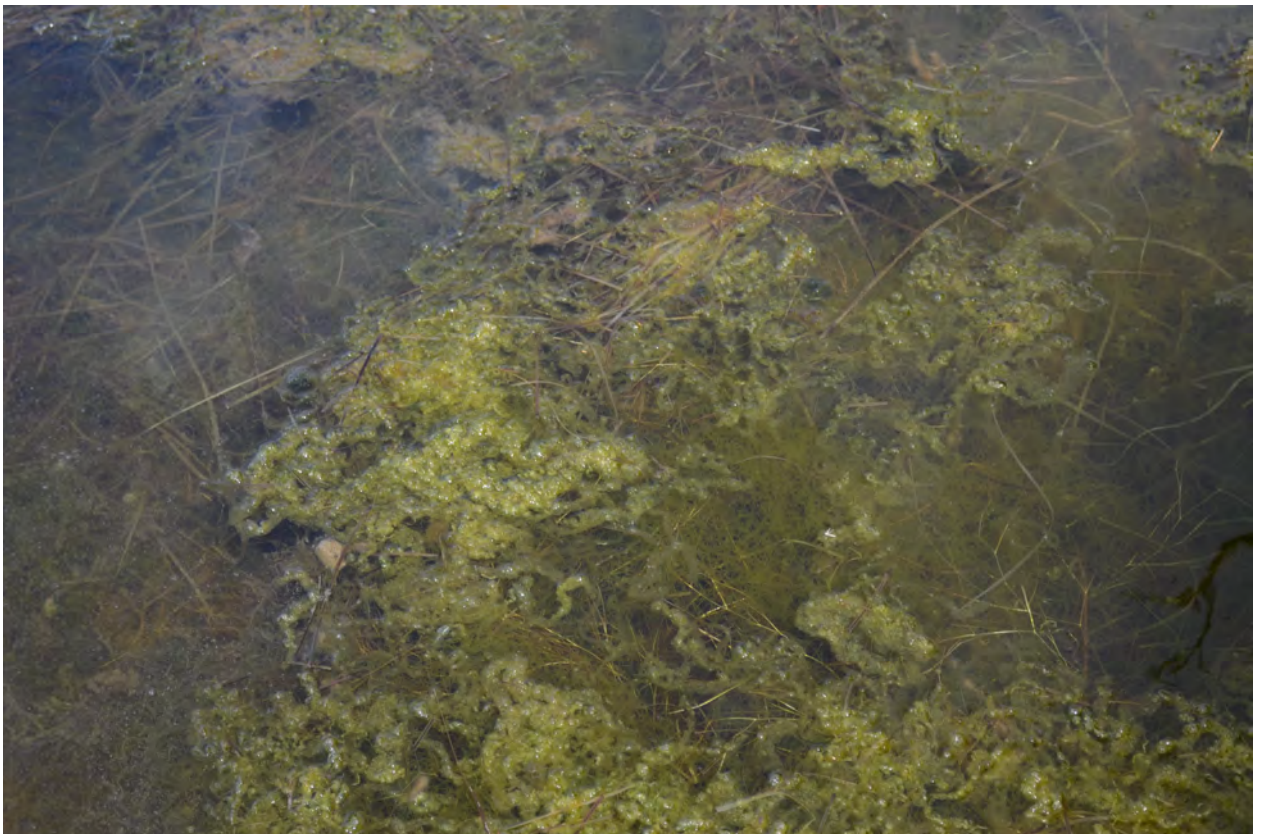
Plate 4 Close up of wrack showing *Ulva* (formerly *Enteromorpha*) *intestinalis* green algae growing over the wrack accumulations.

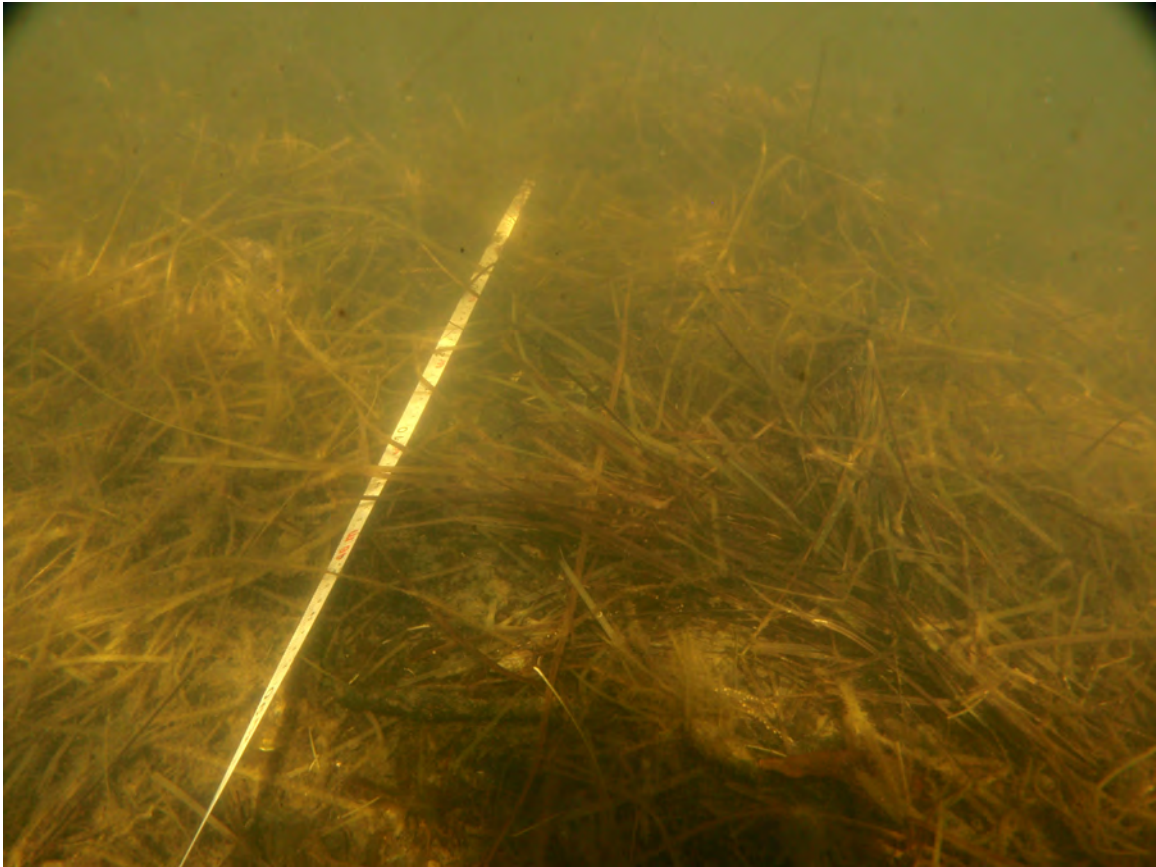
- The entire study area seabed (120m long by 7.5m wide) is smothered in the wrack material with live plants either totally or partially smothered (see also Plates 5 to 8 in **Appendix C**).

Plate 5 Transect tape laid over wrack deposits (inner shallow transect).

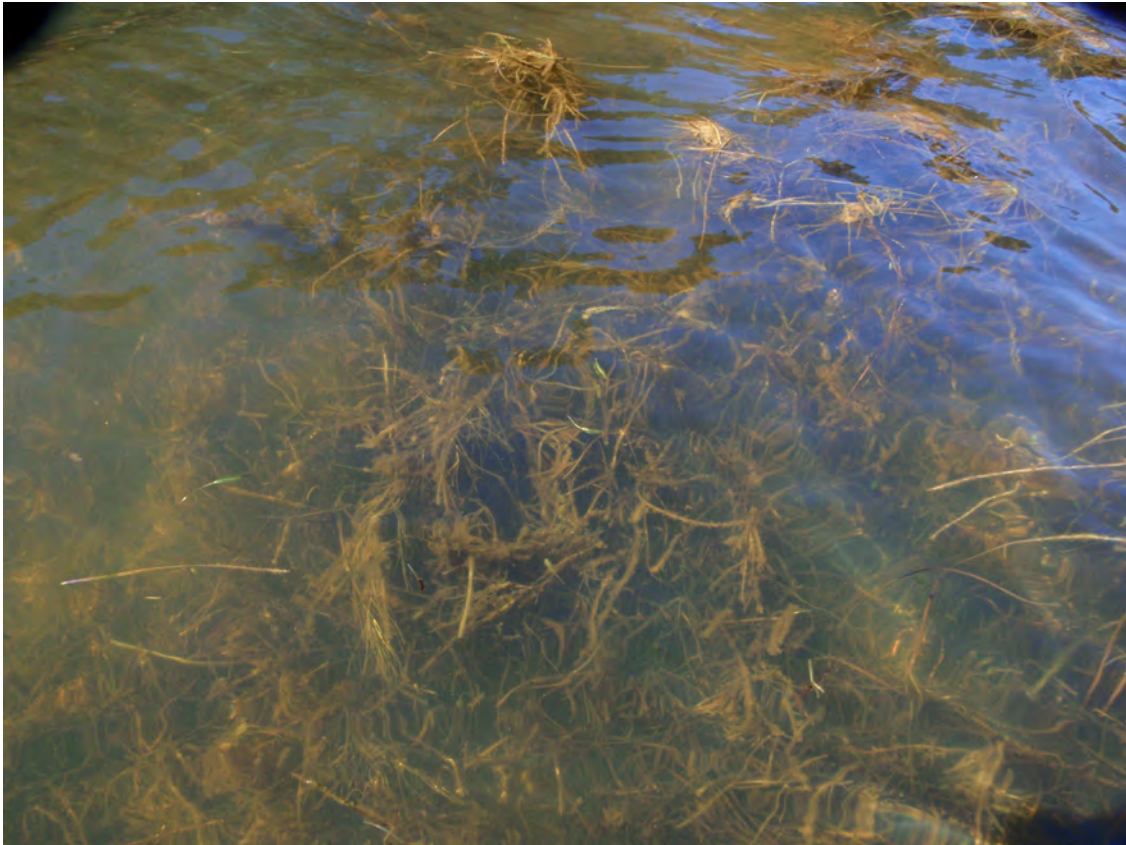
Plate 11 View from above the water of a *Ruppia* patch along the outer boardwalk transect.

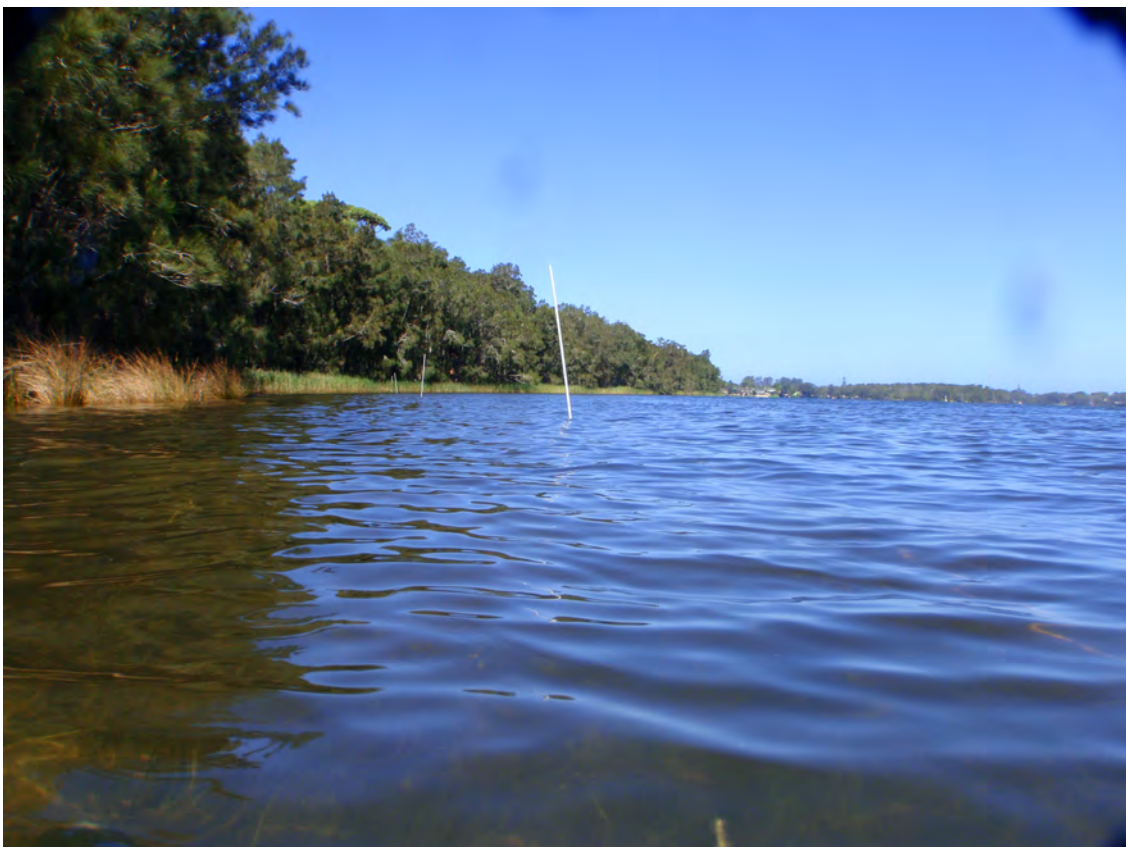
Plate 12 View from the water east along boardwalk centre line showing plastic poles set on the line to hold the transect tape in place for the survey.
