Northern Beaches Council

Addiscombe Road, Manly Vale
Interim Site Management Plan

December 2020

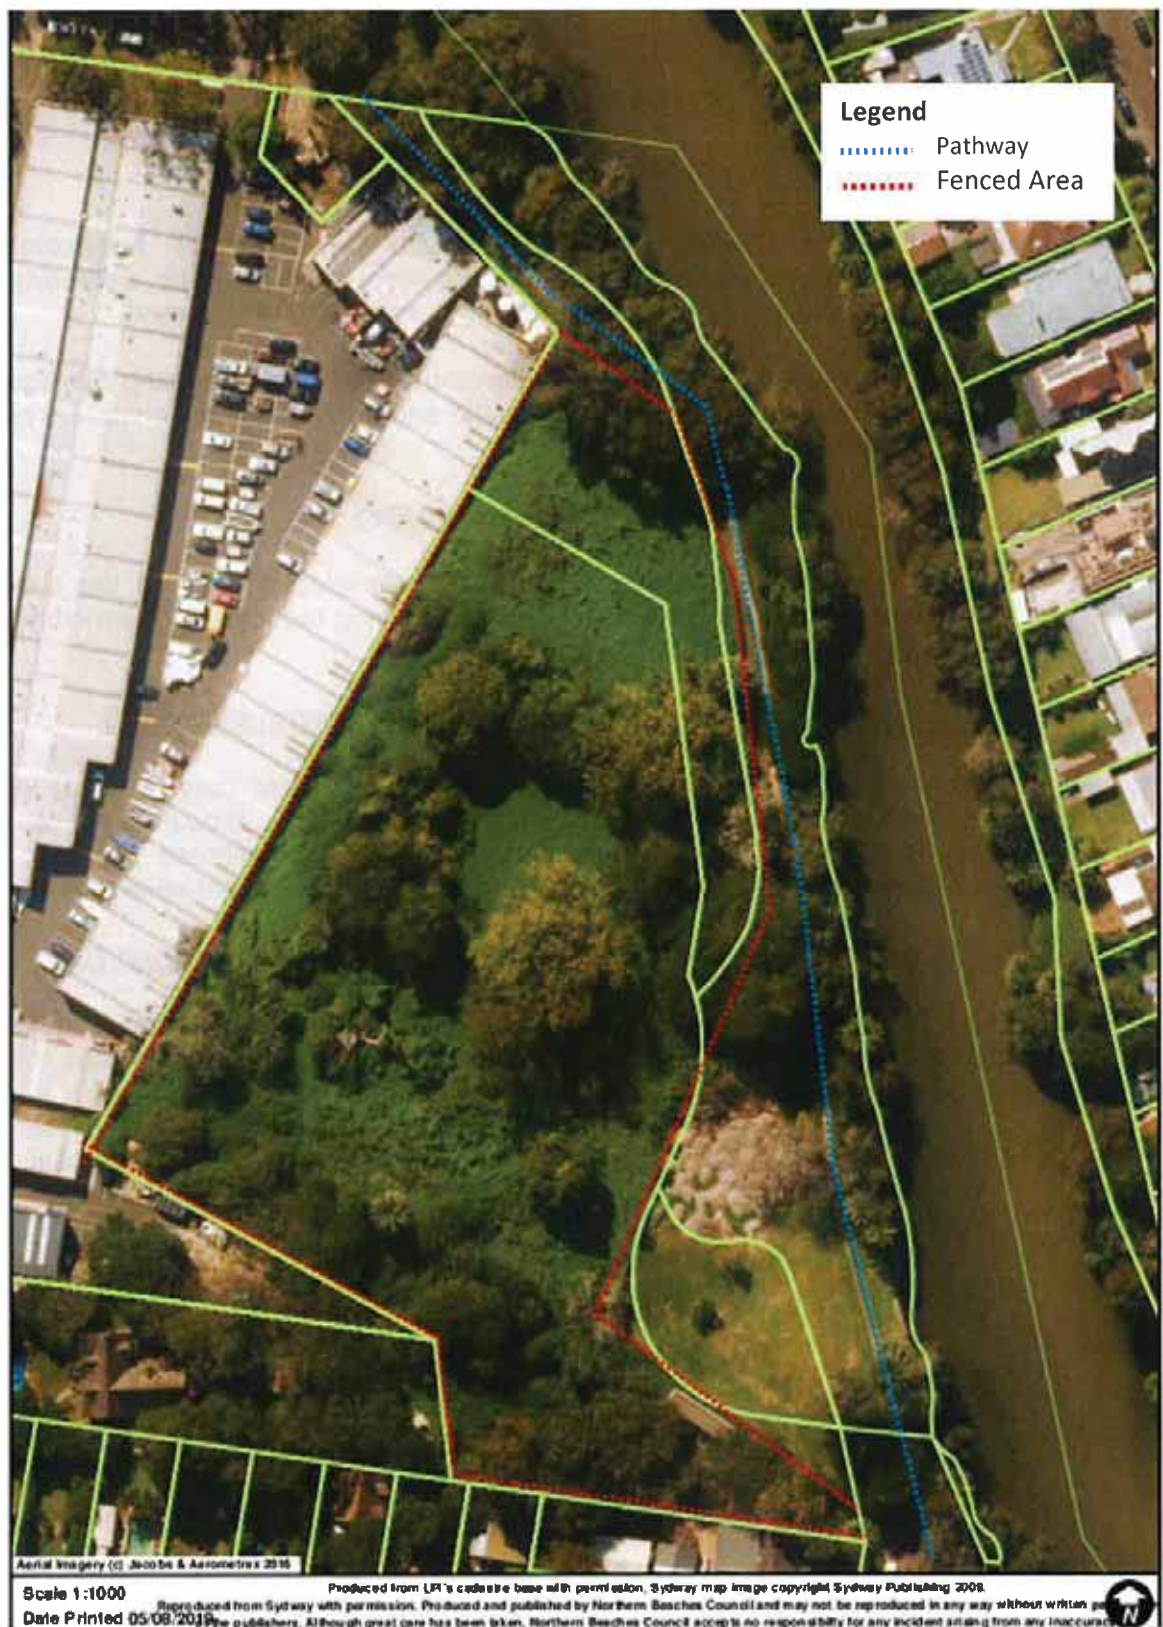
The informal pathway linking Campbell Parade to Addiscombe road (see figure 3) is used daily by commuters, to ensure commuter safety regular asbestos inspections will be undertaken by a licenced contractor.

Figure 3: Lots 1-4 (DP 818957) Addiscombe Road, Manly Vale. Fenced area and footpath.

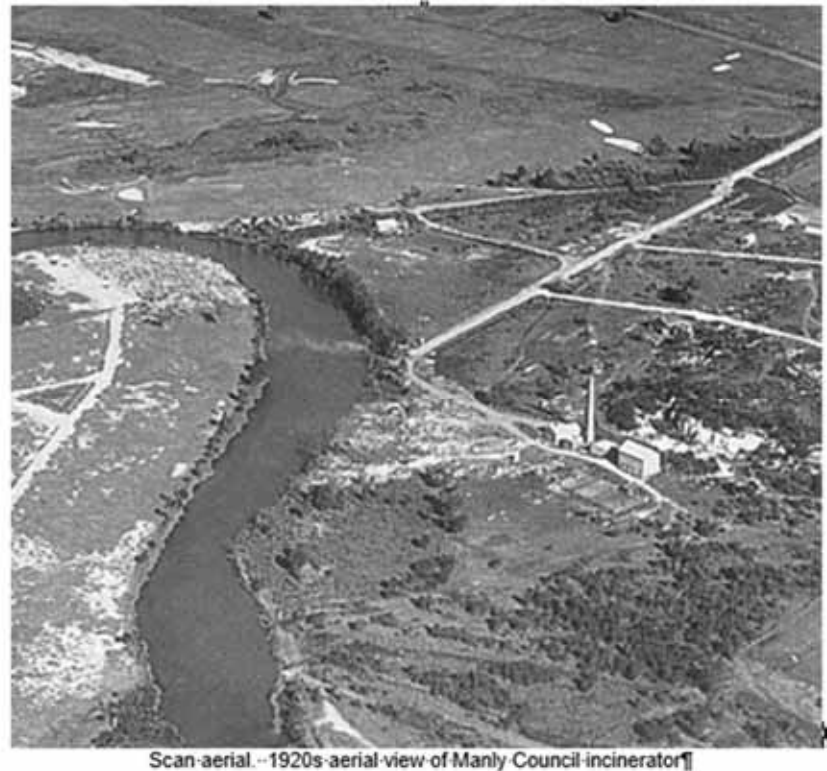
Photograph 1 Scanned aerial provided by Council – 1920's aerial view of Manly Council incinerator (facing south) showing Addiscombe Road leading to Manly Creek and the site.

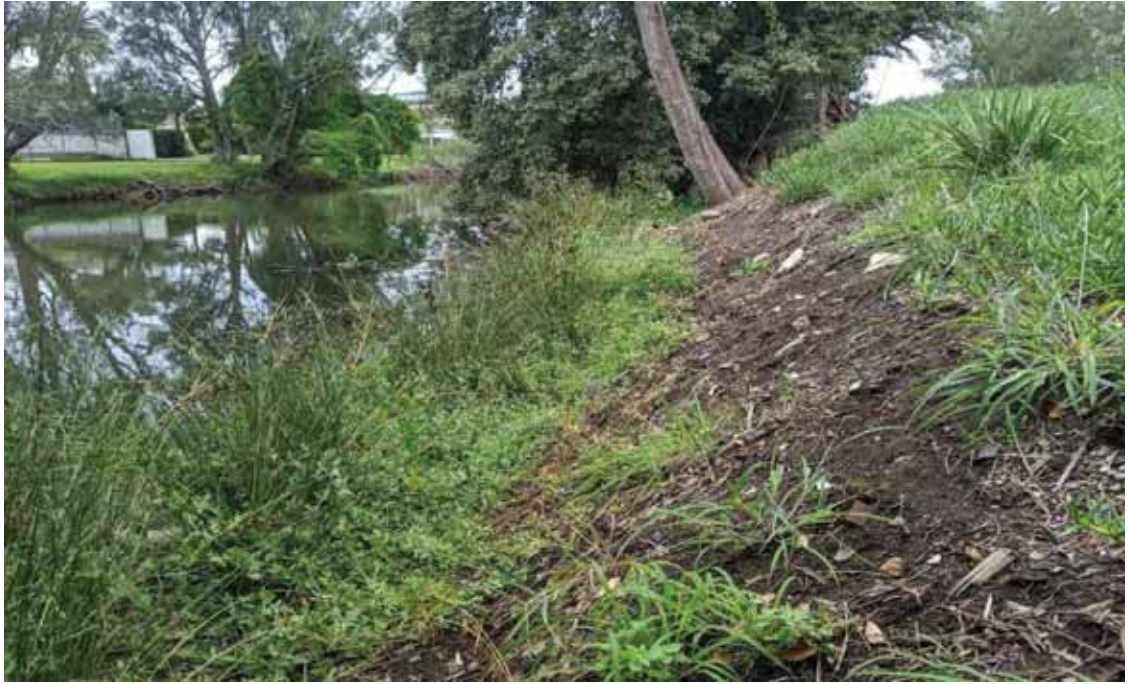
- Along the embankment of Manly Creek on the northern portion of the site, between groundwater wells MW03 and MW13. This is shown in [Photograph 2](#).

Photograph 2 Exposed waste on the embankment, between groundwater monitoring wells MW03 and MW13

Waste materials observed at these two locations included slag / clinker, ceramics, glass and potential asbestos containing materials (PACM). The PACM sighted was only at one location, on the embankment adjacent to Manly Creek.

In addition, GHD recommends that cover be applied to the footpath area as an interim measure for site management, to mitigate potential source pathway receptor linkages between exposed waste and site users (including potential asbestos fibers in dust). The interim cover layer shall comprise a high visibility marker layer at the base (such as orange geofabric), covered with a minimum of 100 mm of chemically and physically suitable material (such as crushed sandstone or mulch). Alternatively, a more formal hardstand could be used above the marker layer.

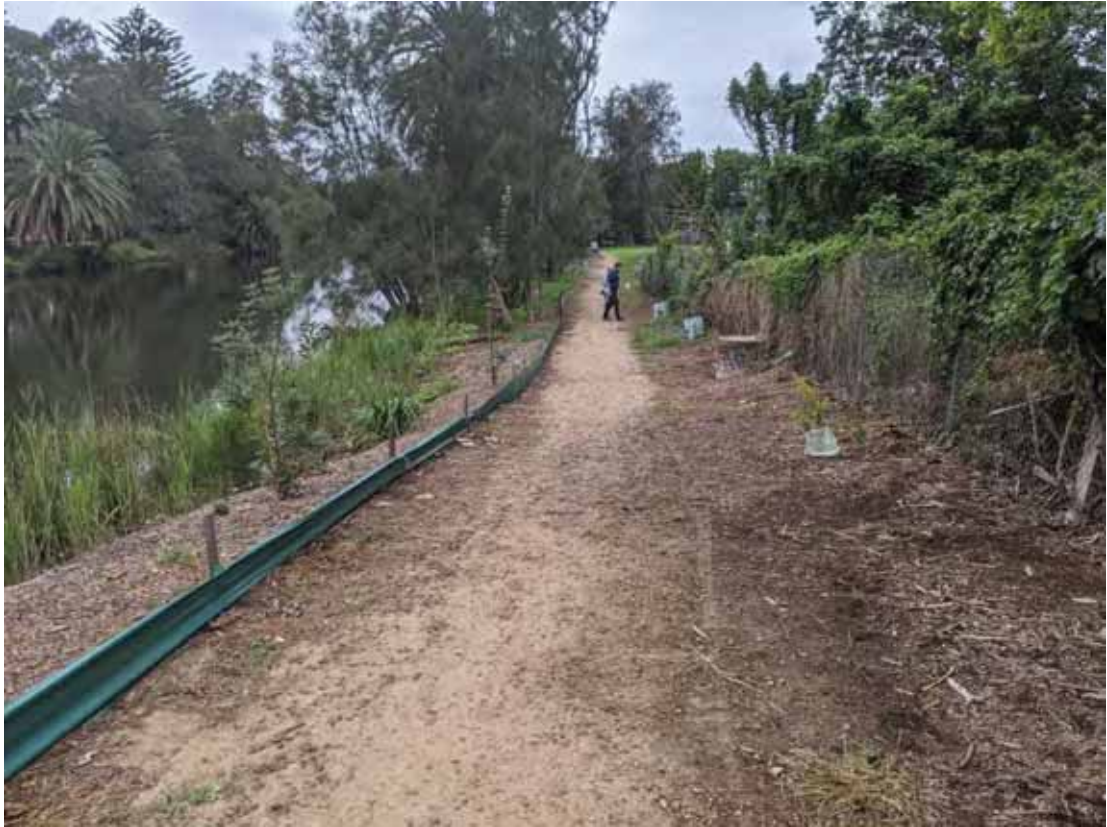
- The informal footpath continues to be in use by the local community. A number of runners and cyclists were observed during the site inspection; as well as dog walkers and families.
- A light sheen was observed on surface water in Manly Creek near the 'polluted water' sign adjacent to the site's northern boundary.
- Three existing groundwater monitoring wells were found in the central portion of the site. These are believed to be wells S6, BH1 and S10 based on their locations (refer Figure 2 in Appendix A).
- Council have installed sediment fencing and undertaken minor landscaping works (predominantly revegetating) along the eastern site boundary to limit surface water transport of sediments to Manly Creek. These are shown in Photograph 3.

Photograph 3 Facing south along the eastern footpath, showing the sediment fences installed on the eastern site boundary

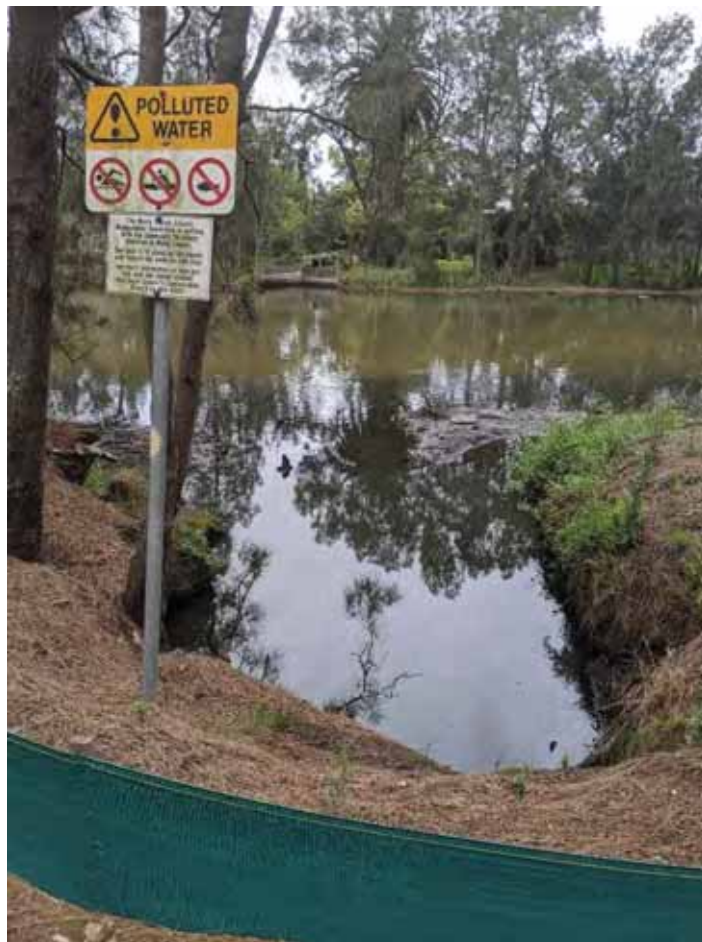
Photograph 4 Warning sign observed in February 2020 adjacent to Manly Creek at the northern end of the site, to minimise recreational use.

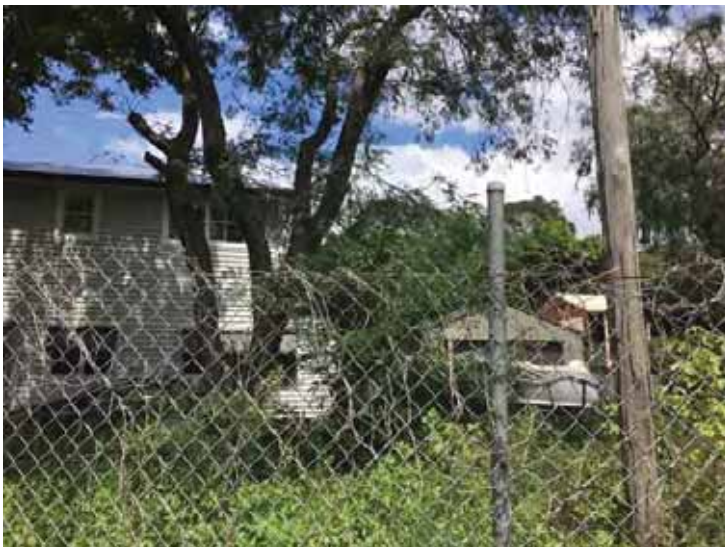
Part A

Fencing to be repaired (identified by letters which appear in the map)

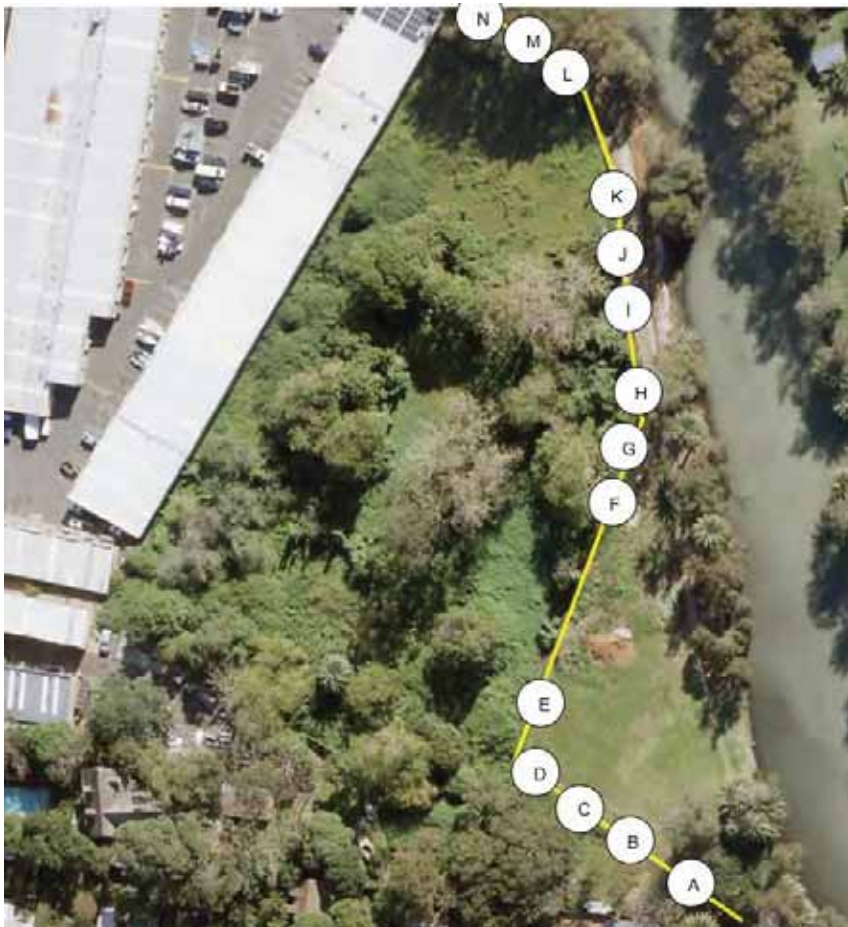
Map showing location of fence sections to be repaired

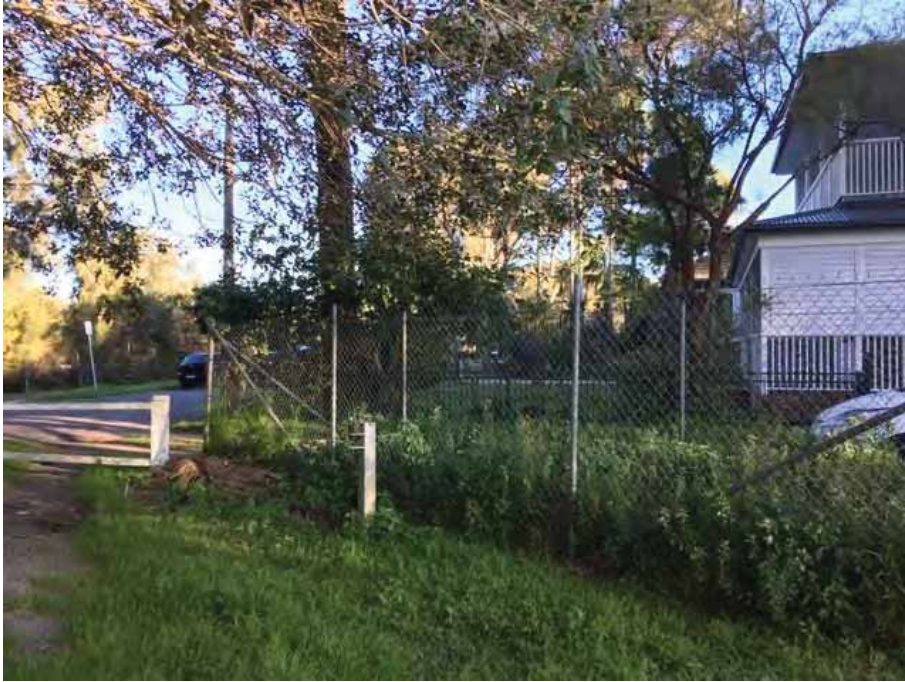
Part A

Repaired Fencing

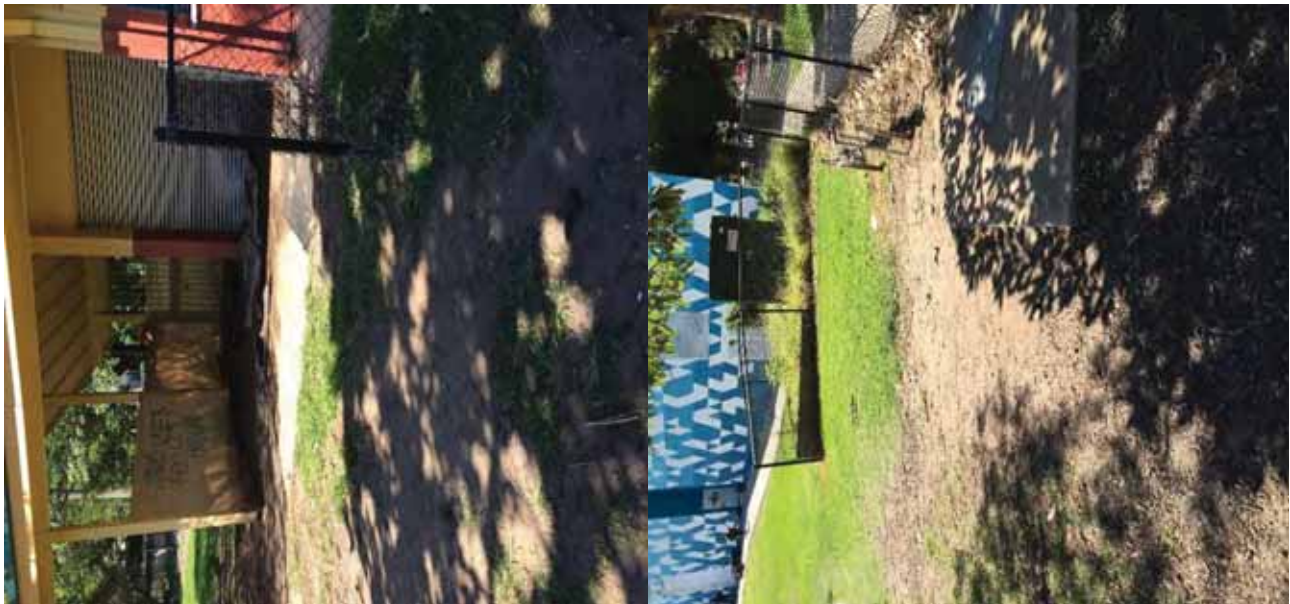
LM Graham Reserve

Only few small pieces asbestos found outside green keepers shed & toward aquatic centre just outside of field barrier.

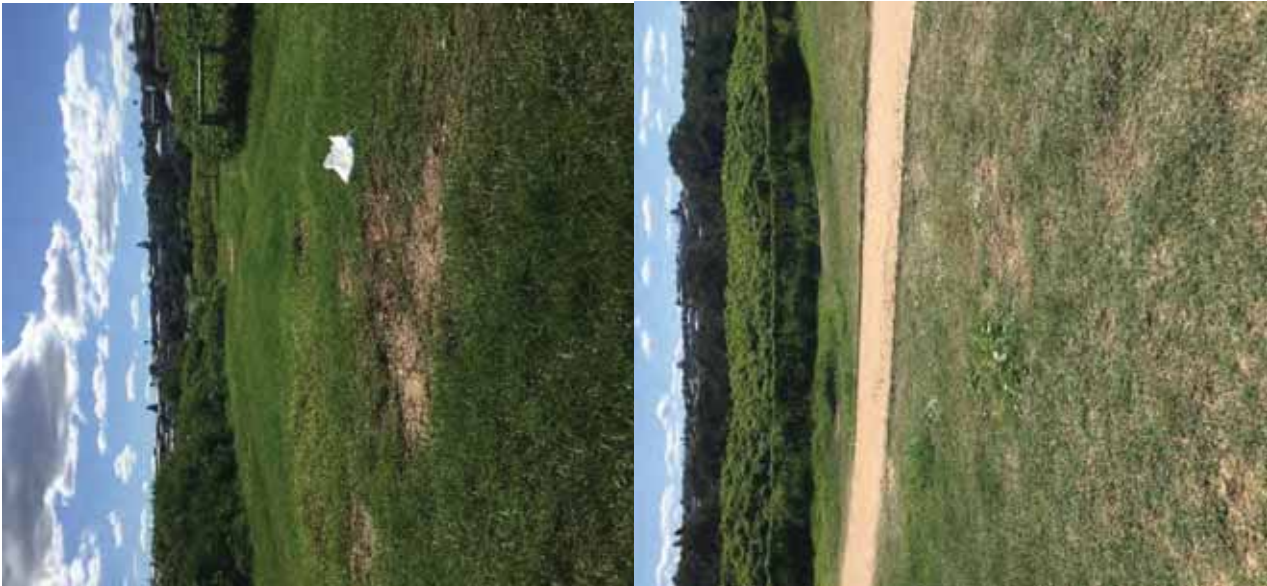
Curl Curl Dog Park

10kg glass picked alongside path & few areas in Dog Park. Also sandy patches in front of lagoon. Approx. 200/300g asbestos found spread over all areas

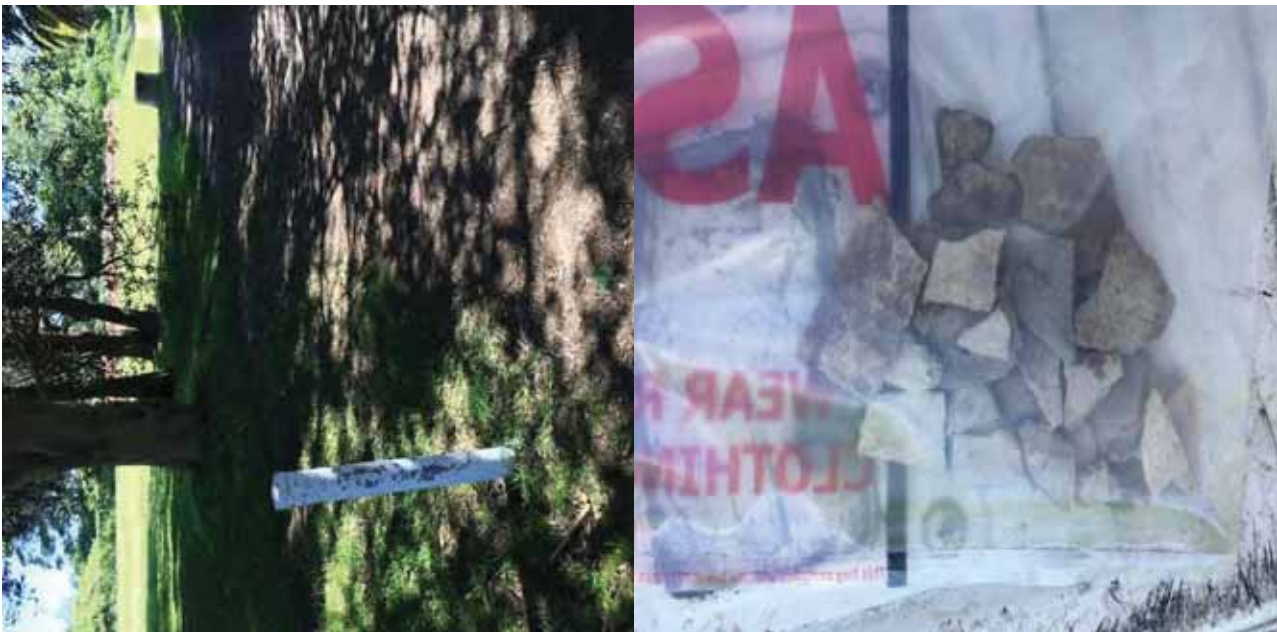
Addiscombe Rd

Few small pieces of asbestos found at start of track the rest in middle section of pathway. 300g worth of fragments spread along track.

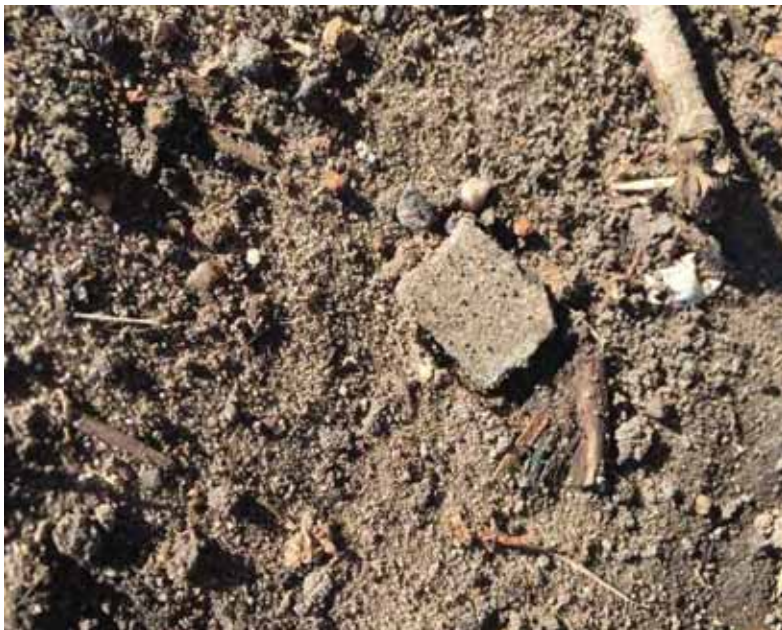
LM Graham Reserve

Only a few small pieces asbestos found around corner of field near green keepers shed

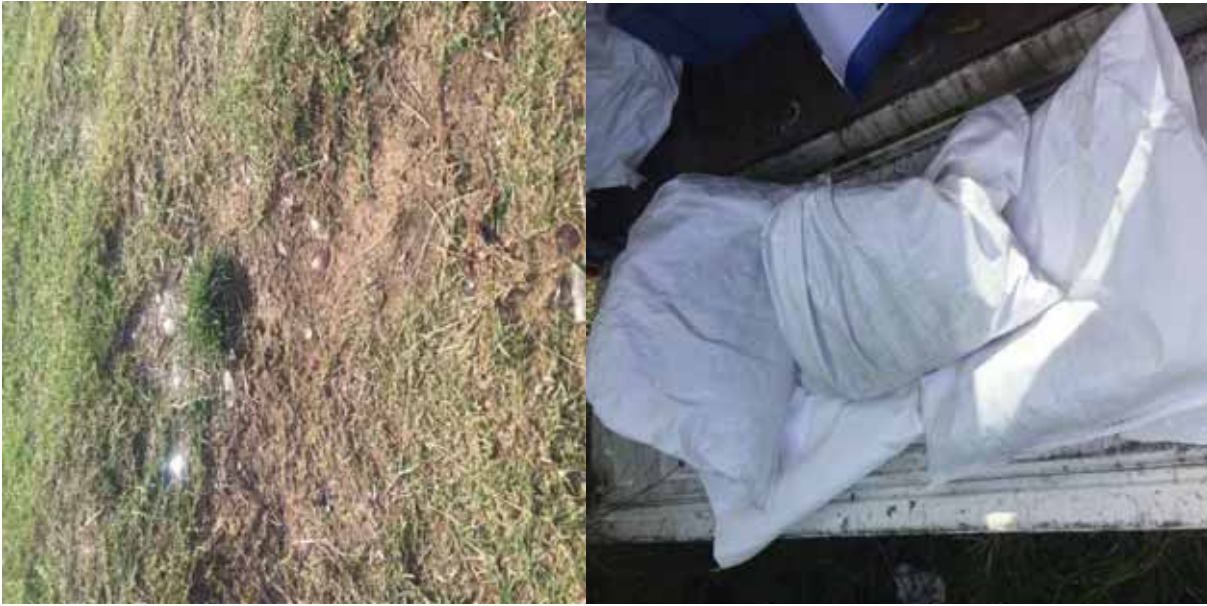
Curl Curl Dog Park

200g asbestos found spread well apart over Dog Park & lagoon. 15kg glass mix steel & rubbish picked from sandy areas of park & front of lagoon

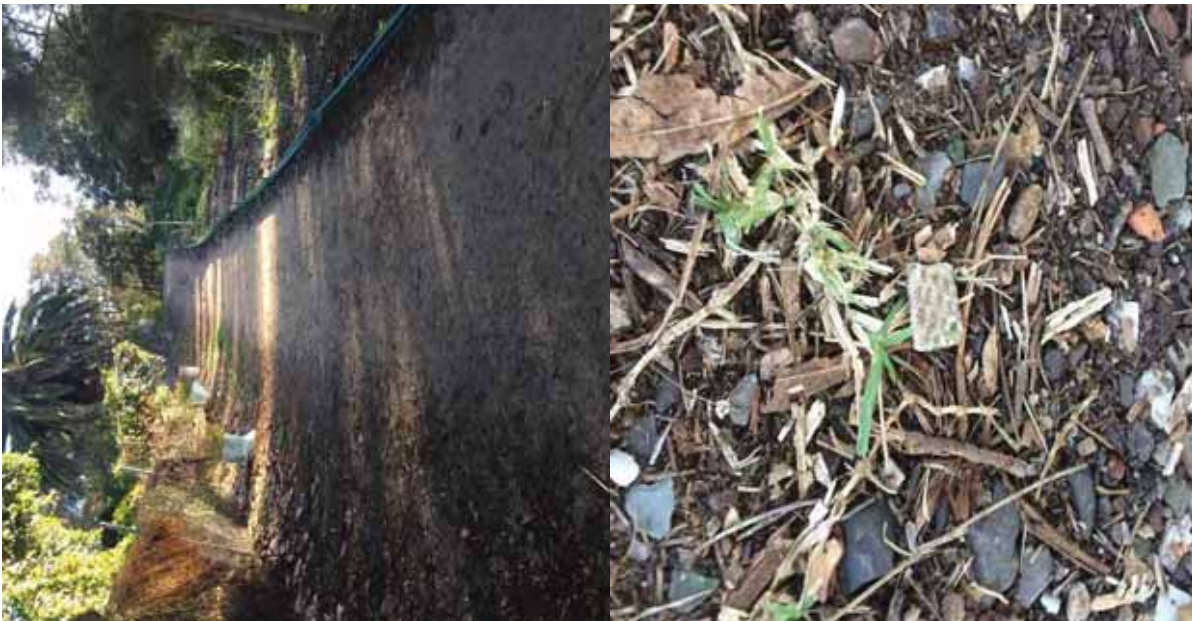
Addiscombe Rd

Handful of small asbestos fragments found at start and finish of pathways. Mostly in areas crushed tile & glass exposed

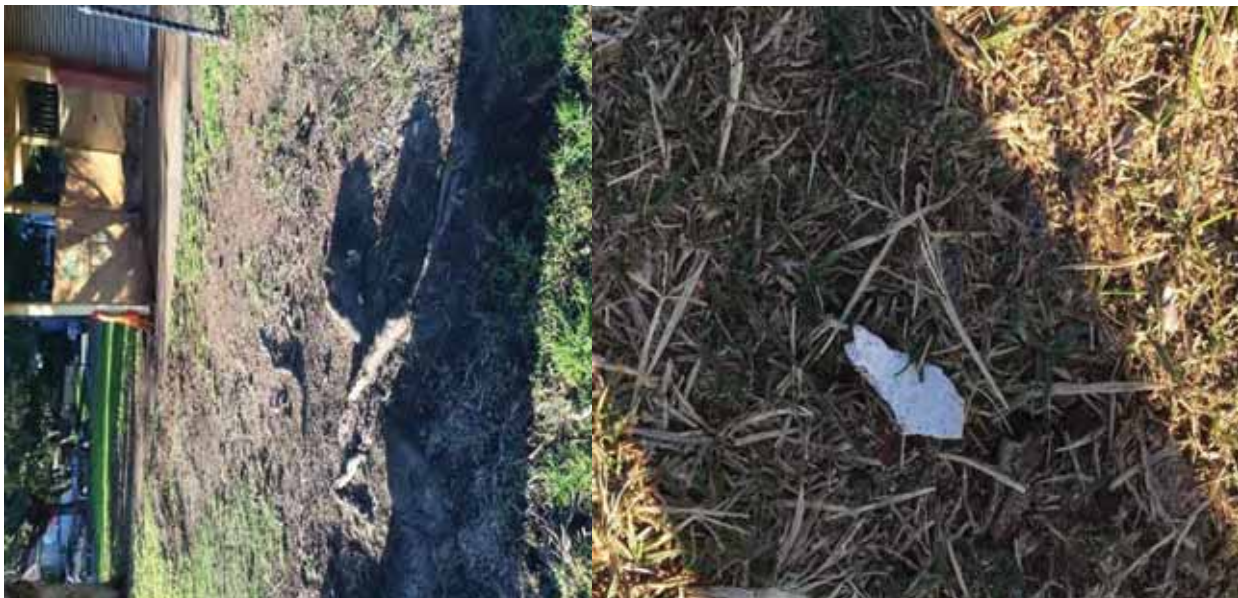
LM Graham Reserve

A few small pieces asbestos found around corner of field near green keepers shed

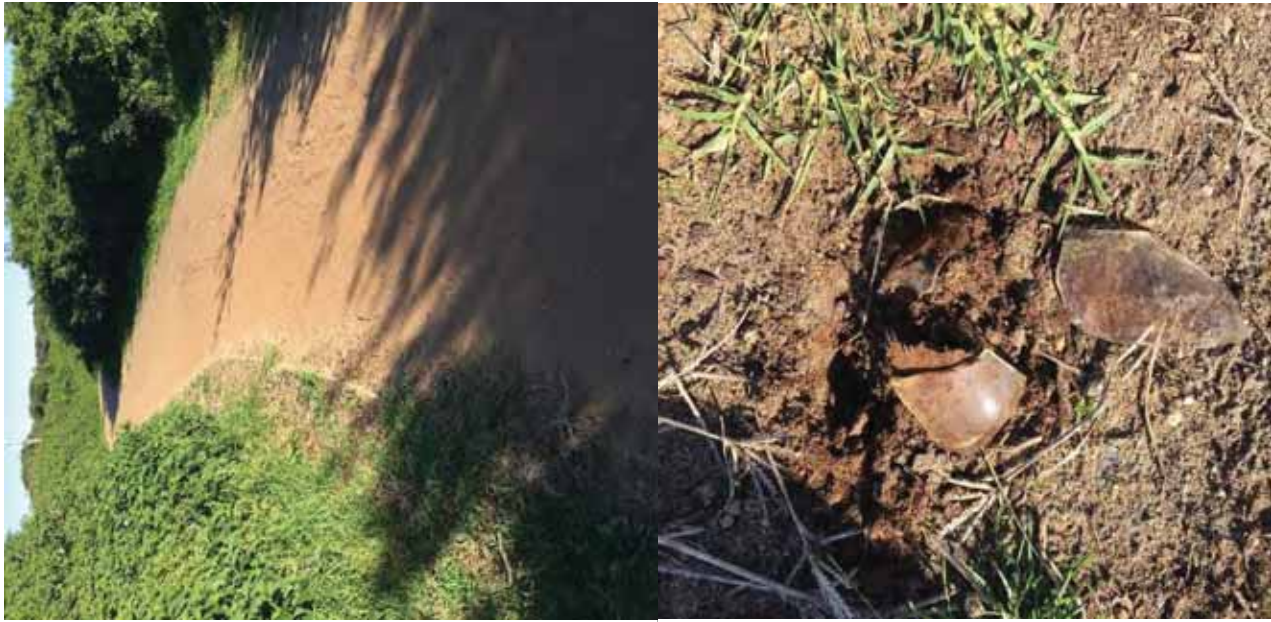
Curl Curl Dog Park

200-300g asbestos found spread well apart over Dog Park & lagoon. 20kg glass & rusted metal from various areas in park & sand in front of lagoon.

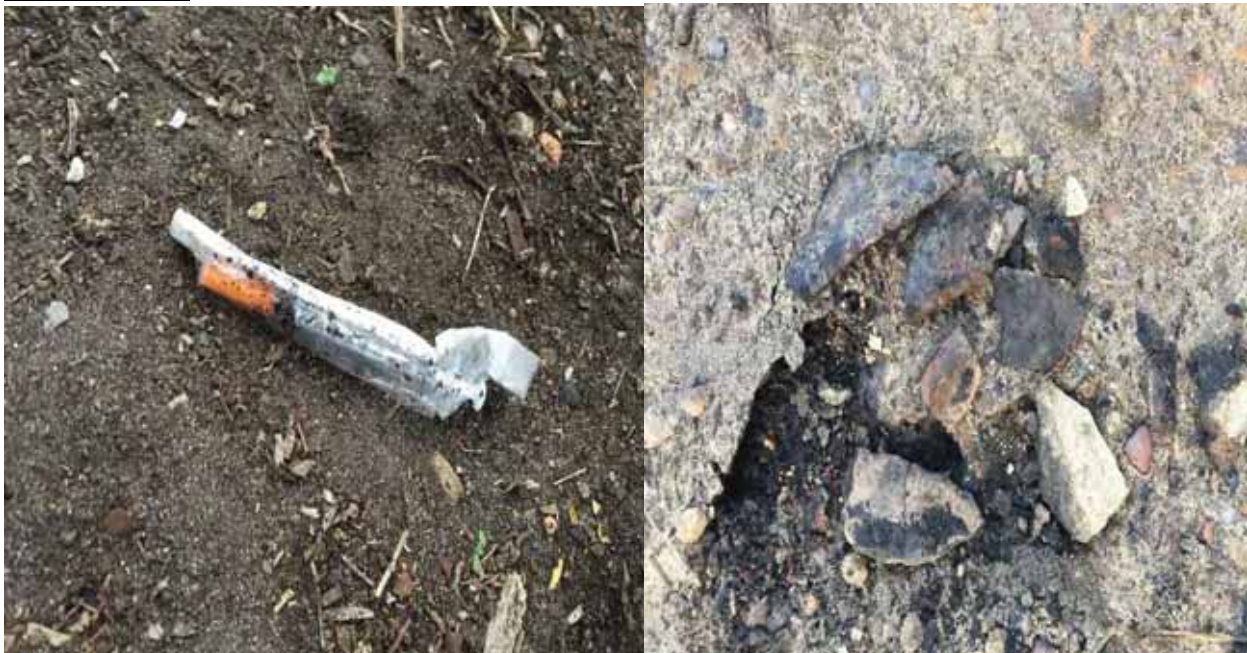
Addiscombe Rd

A few small asbestos fibro pieces. A syringe. Mostly in areas crushed tile & glass exposed.

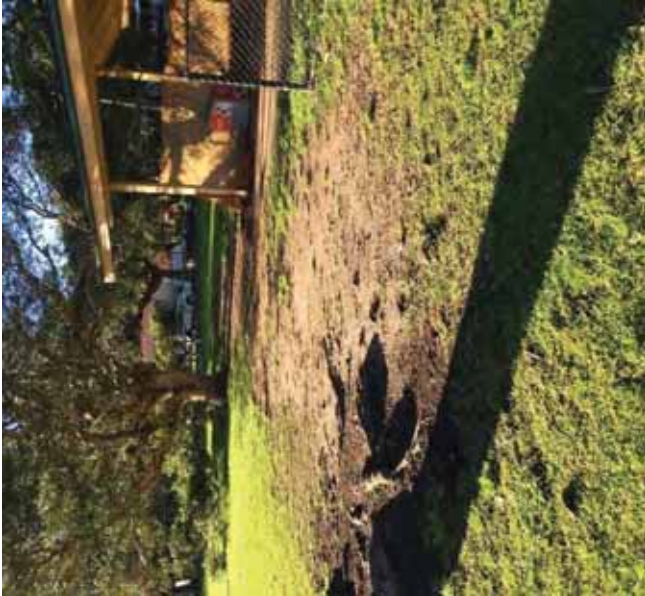
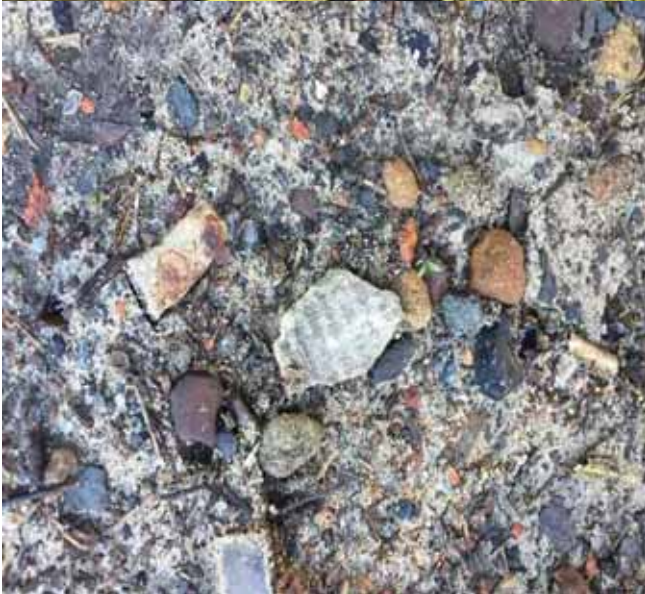
A few small pieces asbestos found around corner of field near green keepers shed as usual

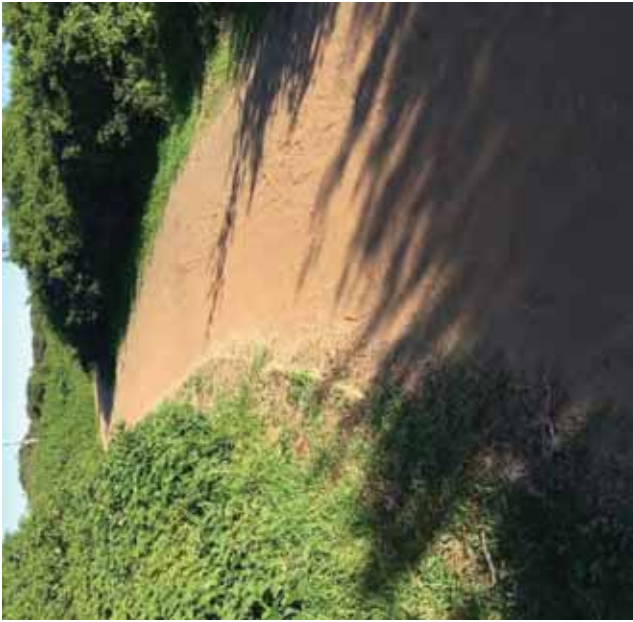
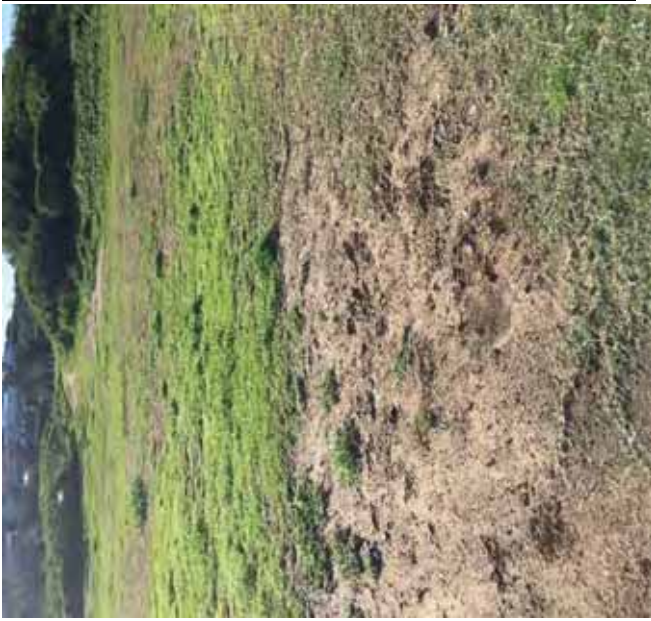
Curl Curl Dog Park

Only few pieces of asbestos found spread apart. Approx. 25kg glass & rusty metal picked threw out usual dry patches of Dog Park & in front of lagoon.

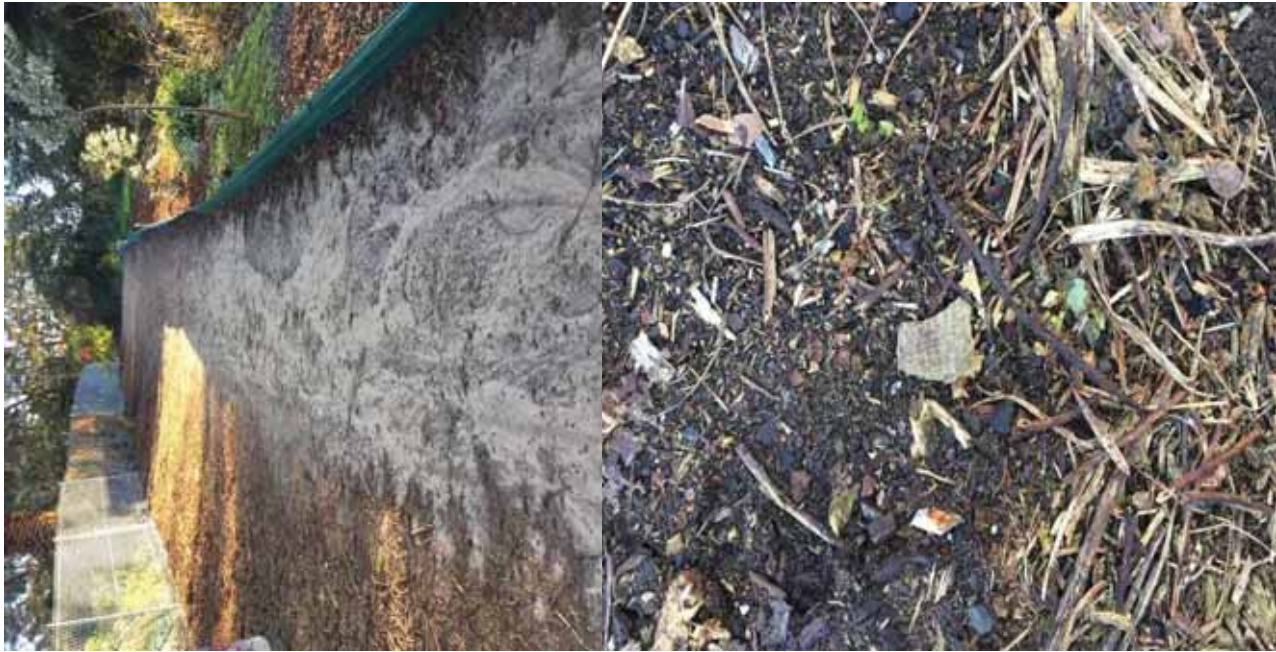
Approx. 500g asbestos picked spread far apart mostly from pathway & embankment next to the bark piles.
Heavy weather would have exposed majority.

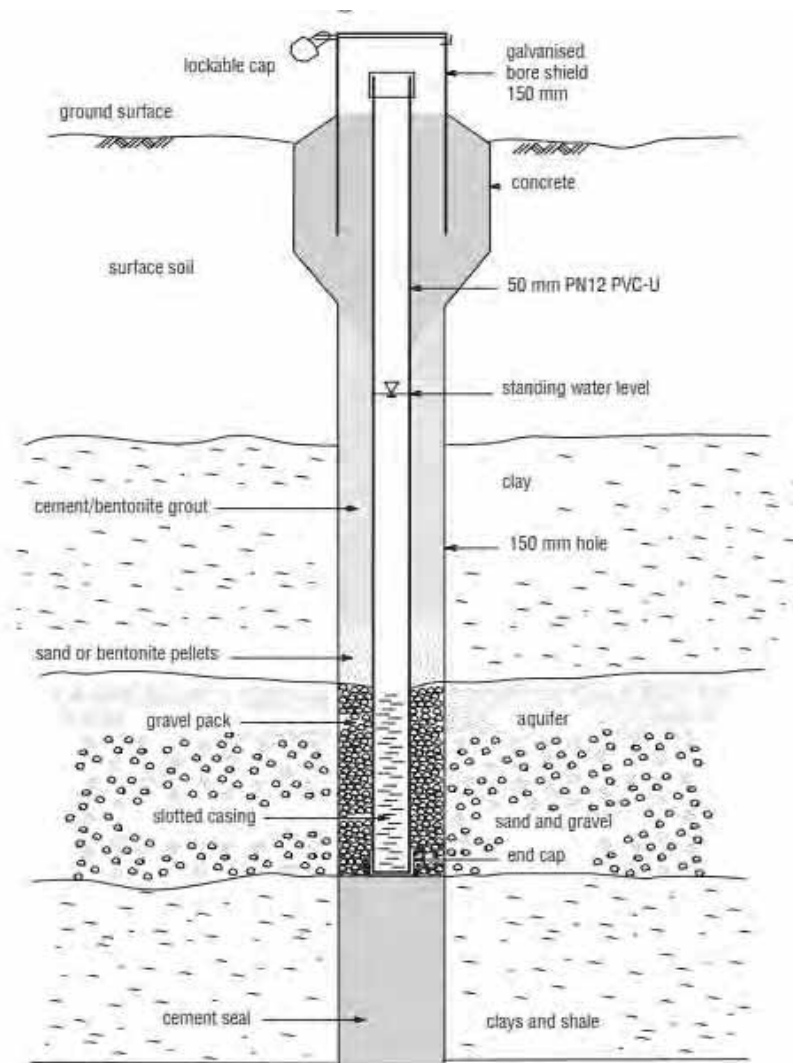
The groundwater monitoring wells should be constructed with 50 mm diameter class 18 threaded PVC pipe with factory slotted PVC screen. The screens will be isolated within a single geological strata encompassing the shallow aquifer system so that they are suitable for the purposes of groundwater assessment. Where possible, consideration of possible future landfill gas (LFG) monitoring should be considered in the screen interval design and use of 'ex-caps', which is further discussed in Section 3.4.

An example of a groundwater monitoring well design is shown in Figure 3-1 (NUDLC, 2012). Grout and bentonite pellets are shown to be used as backfill around the PVC pipe, which are necessary to ensure the geological layer being monitored remains isolated. Drilling spoil is not to be used as backfill. Additionally, it is essential to ensure that no contaminants are introduced that may affect any future monitoring or sampling results. The gravel pack should extend at least 0.3 m above the screen interval.

Figure 3-1 General design of a groundwater monitoring bore (NUDLC, 2012)

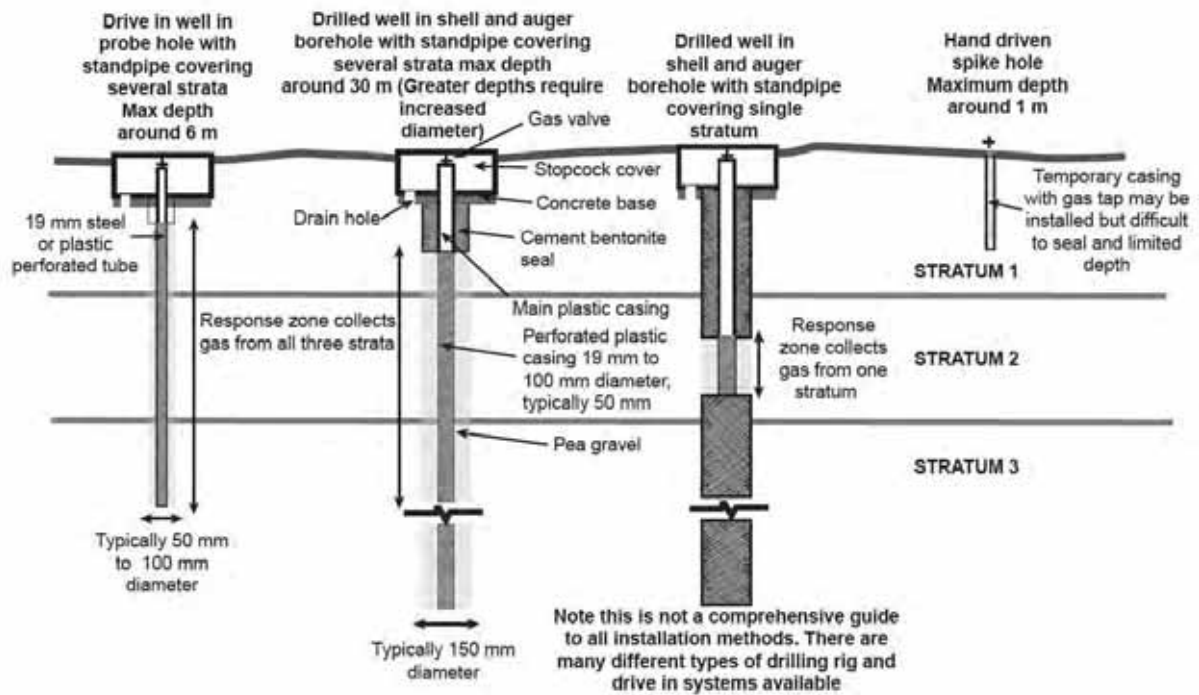
- It is likely that LFG monitoring will be required as part of future management actions for the site. As such, the newly installed groundwater monitoring wells may be able to be designed to be dual purpose in some locations (i.e. also able to be used to monitor for landfill gas). The installation of combined groundwater and landfill gas monitoring wells as part of the groundwater triangulation investigation could reduce future landfill gas bore installation costs by creating efficiencies, and could result in the provision of monitoring bores suitable for ongoing LFG monitoring and risk assessments. Typical design features of a LFG bore is shown in Figure 3-2, and can be compared against groundwater well features shown in Figure 3-1. It is noted that the screen interval design is the primary component that must be considered for both purposes prior to installation, and that it is unlikely that any of the existing groundwater monitoring wells can be converted into fully suitable LFG bores (logs would need to be sighted to fully confirm this though).

Figure 3-2 Key features required for a gas monitoring well (Wilson et al 2009)
