Manly Dam Link Trail Upgrade King Street, Manly Vale

Traffic Safety Assessment

Ref: 128/2021
Date: November 2021
Issue: B

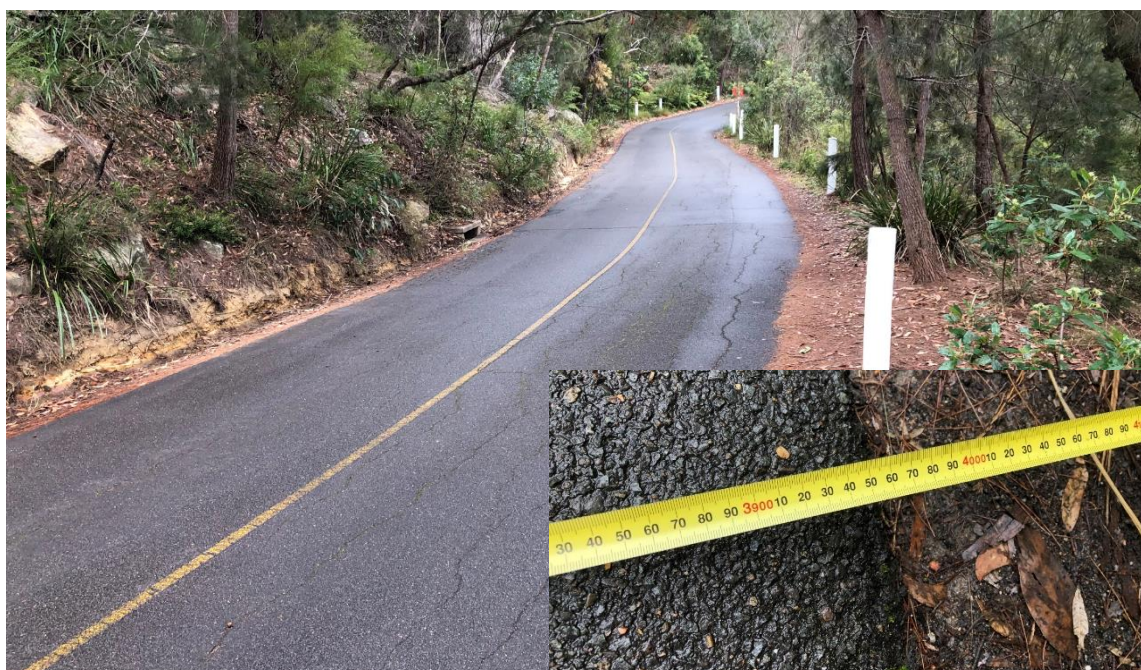
Figure 2 Existing road condition

The Trail is curvilinear, bitumen-sealed, carries two-way traffic (Figure 2), and has a narrow carriageway of varying widths between 3.8m and 5m.

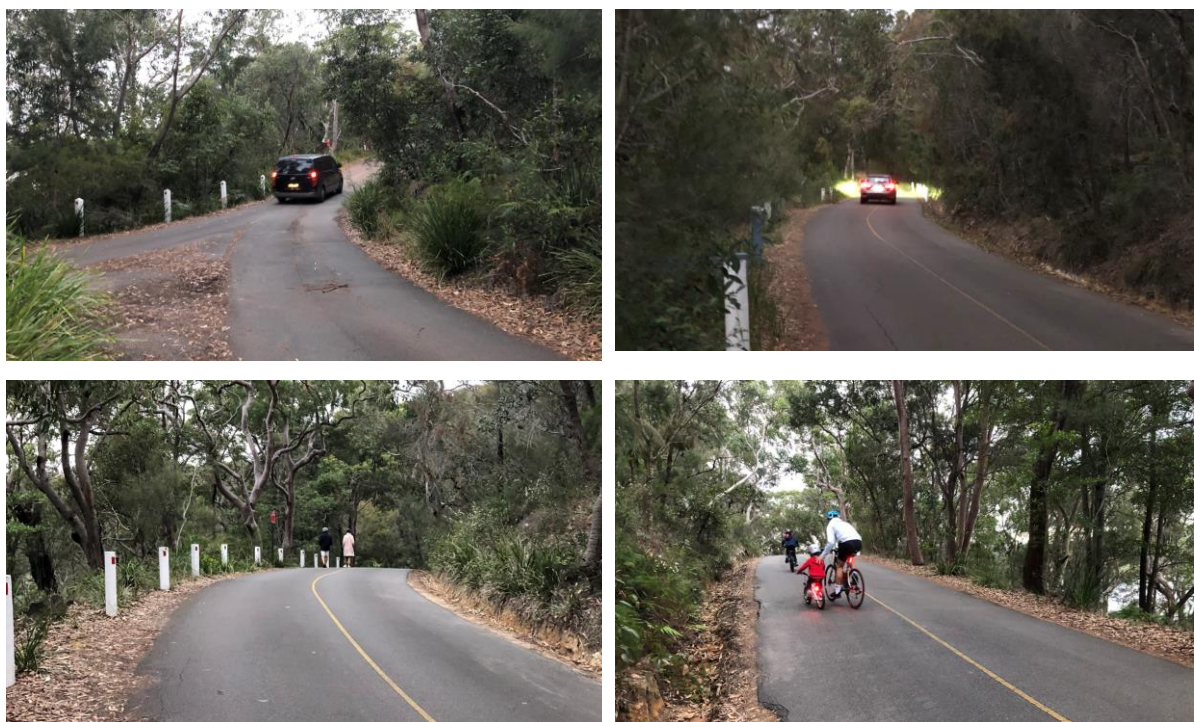
Figure 3 Vehicles driving on centre of road with other user groups

The Austroads Design Guide provides a minimum two-way road width of 5.5m to 6m. On this basis, the roadway is substandard for two-way traffic flow. Onsite, vehicles were observed to have a tendency to straddle on the road's centreline (Figure 3), presenting considerable traffic risk as the roadway was also seen to be frequently used by cyclists and pedestrians (including children, 'skateboarders', elderly persons, as well as mobility-impaired user groups). Figure 3 also provides an indication of their interaction with the roadway.

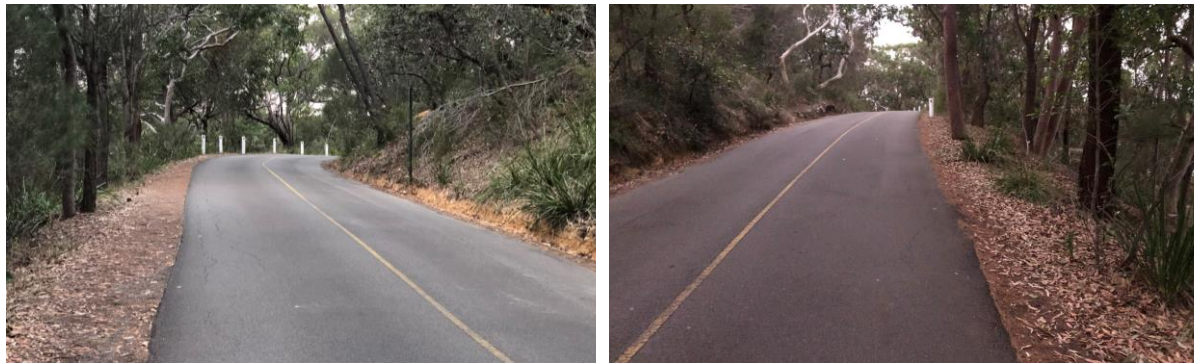
Figure 4 Substandard driver sightlines

The roadway presents with numerous vertical and horizontal curves, and there were substandard sightlines noted in numerous locations along the Trail. Some of these are highlighted in Figure 4. When two cars in opposite directions met on the Trail, one of the cars must manoeuvre outside of the sealed road surface in order to pass one another. This is due to the substandard road width.

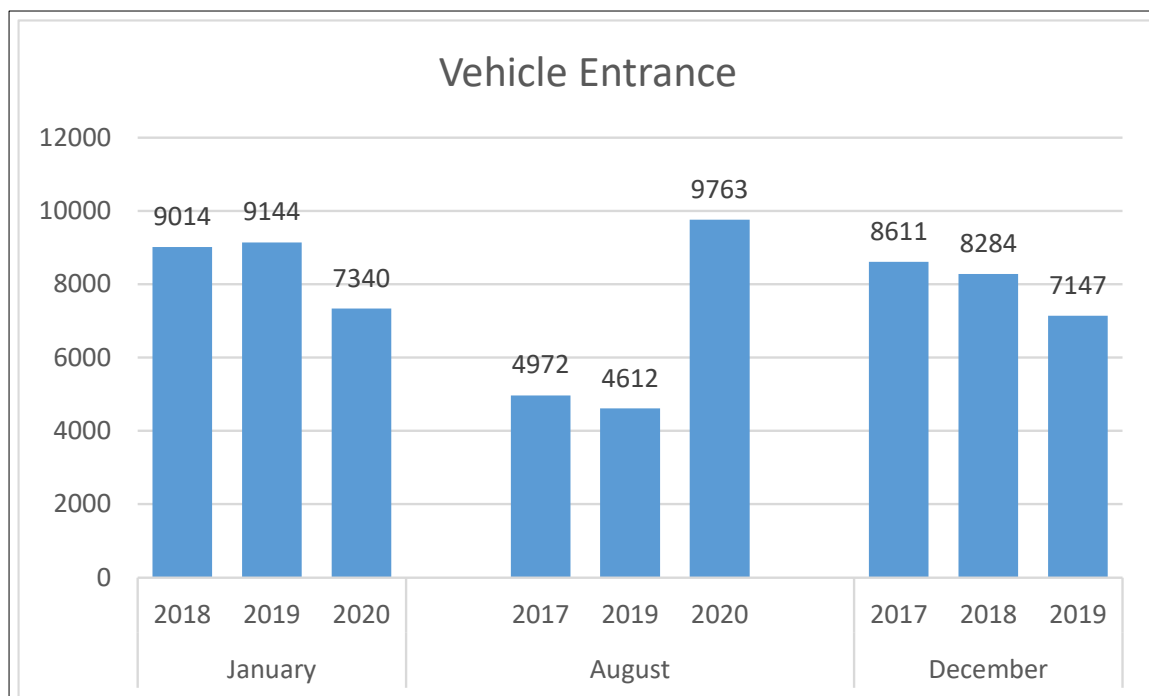
Figure 6 Vehicular traffic

The above information which is expressed diagrammatically in Figures 6 below provides an indicative 'trend' of the Trail's utility over a three-year period.

The recorded data indicates peak traffic movements in August (winter), consistent with typical park visitation pattern i.e., more pedestrian and cyclist activities in the summer months and vice versa. Relevantly, the level of vehicular traffic has increased significantly in August 2020 (following uplift of the State's lockdown). This is expected to be the forward trend as the pandemic effect 'pushes' towards outdoor activities.

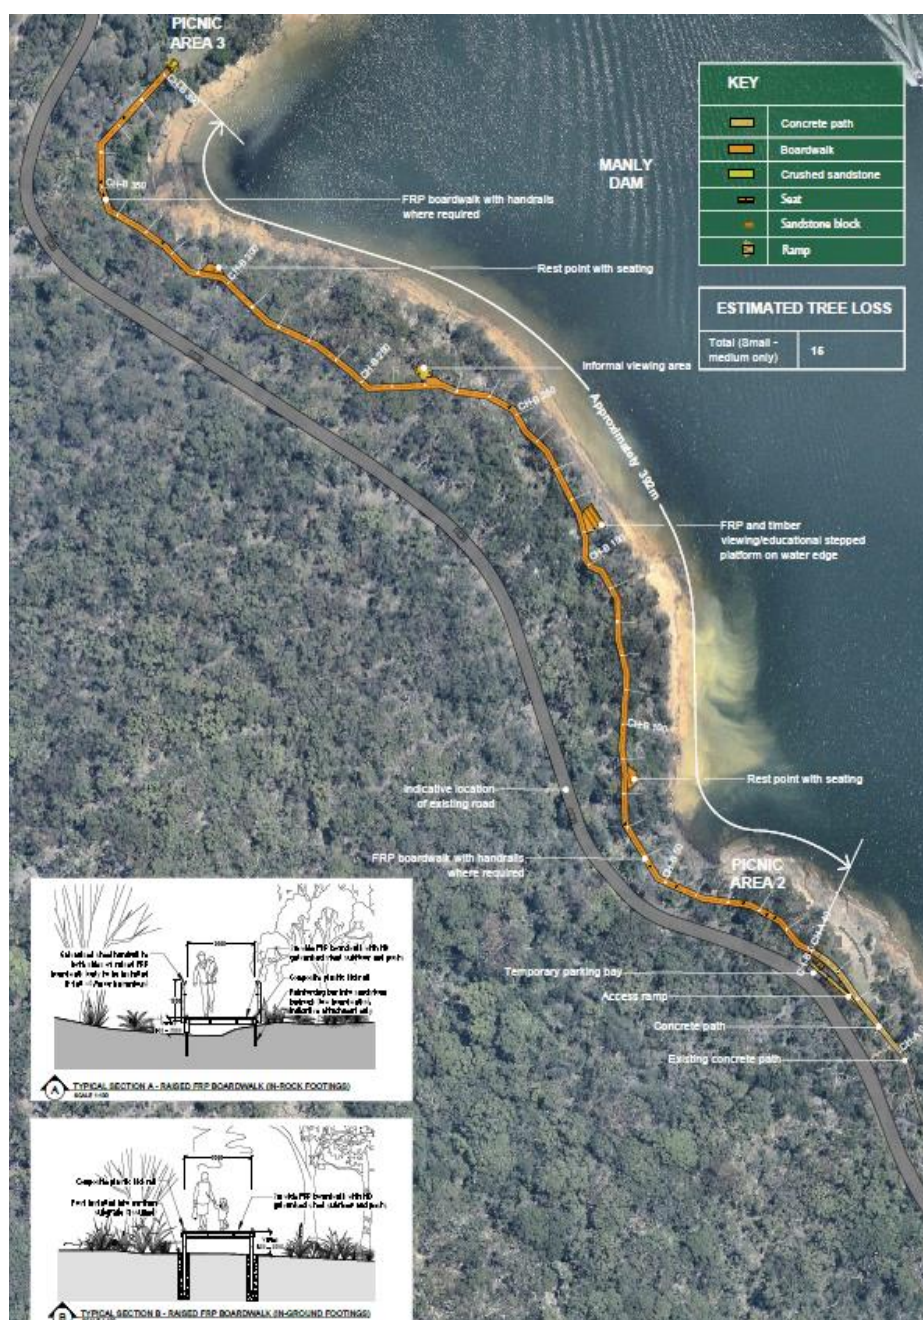
Figure 7 Option 1

Option 1 involves the provision of a new off-road track with a 2m wide 'boardwalk' bypassing the existing roadway between Picnic Area 2 and Area 3, as shown in Figure 7 below.

The assessment finds Option 1 to be highly advantageous as it removes the most vulnerable user group from the currently substandard roadway. It is acknowledged that cyclists will not be able to use the proposed boardwalk. While it is desirable for the boardwalk to also accommodate cyclists, it is recognised that there are geometrical constraints that will preclude this provision. Instead, Council may consider a partial upgrade of the existing roadway to provide a safer cycling environment (this is not a scope of this assessment).

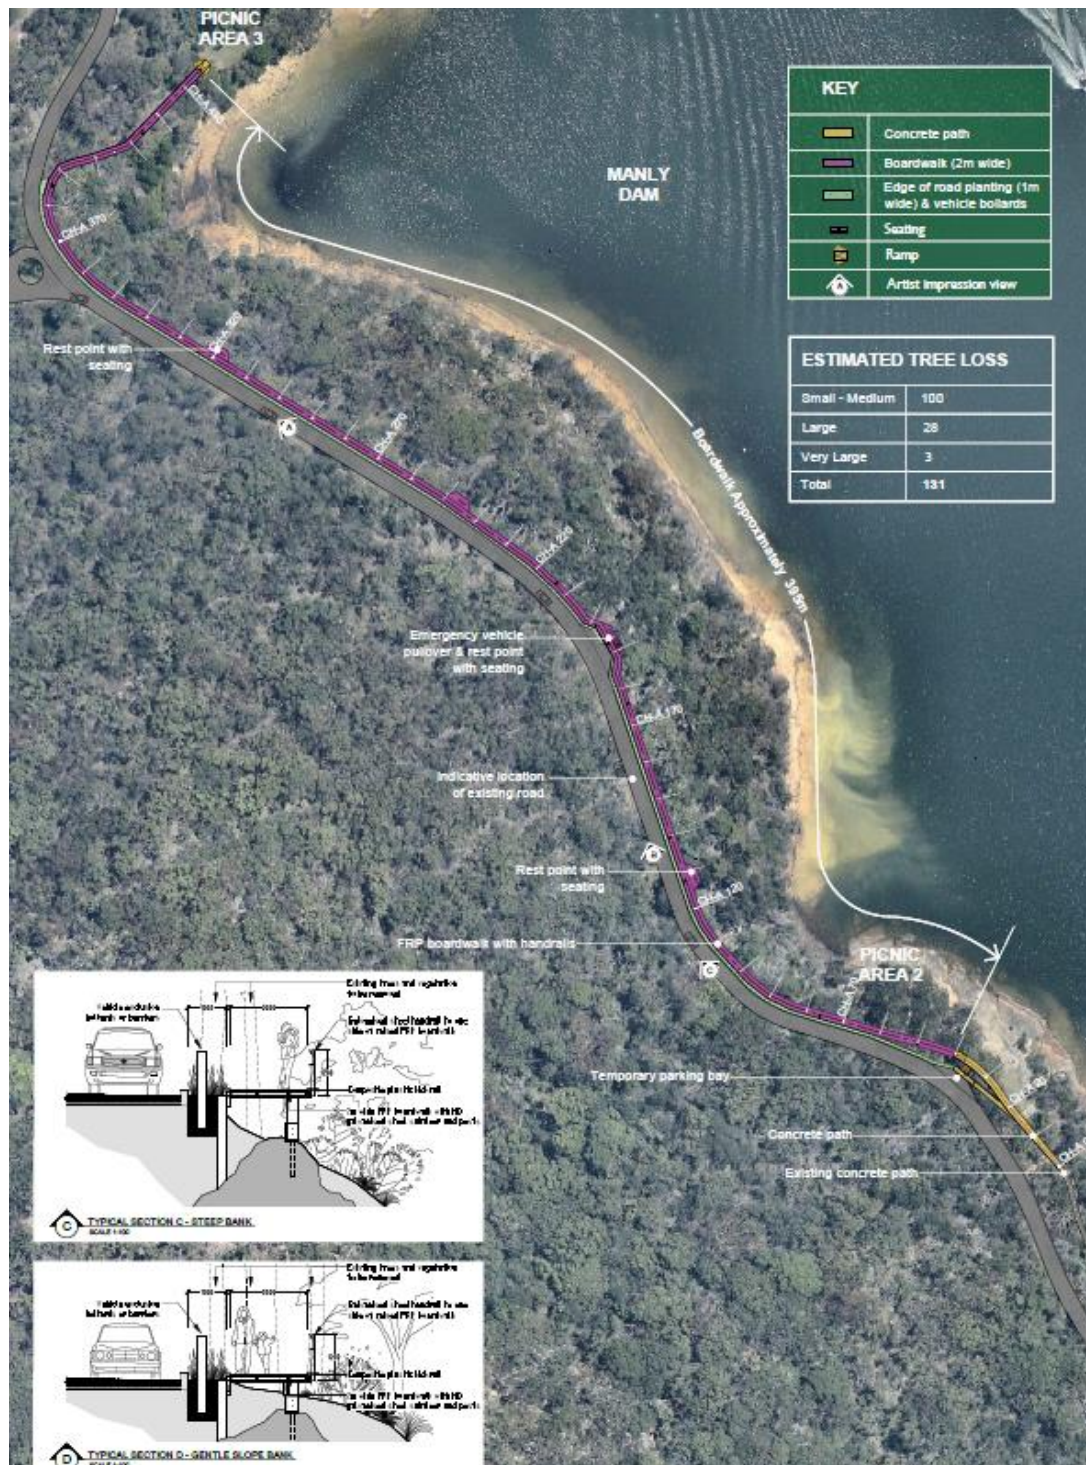
Figure 8 Option 2

Option 2 involves the construction of a roadside footpath 2m wide with associated barrier and be generally aligned to follow the existing Trail, as shown in Figure 8.

Option 2 presents as a less desirable outcome for pedestrians when compared to Option 1. This is largely due to the footpath having to follow the roadway's alignment and terrain. As such, it will 'inherit' the already substandard sightlines and grades. As the Trail is frequently used by wheel-chair dependent user-groups, they will not be able to negotiate these grades easily, thus rendering the proposed option inadequate.

Because the footpath and an additional safety barrier will abut the roadway, the carriageway will need to be widened further to provide additional safety buffer zone (barrier-dependent) that is essential for pedestrian safety as well as for vehicle passage. The envisaged civil works will be quite significant and will be potentially cost-prohibitive in comparison to Option 1.

Furthermore, because of the required road widening, Option 2 (in its current form) will also necessitate the removal of 131 established trees along the Trail. Any further widening (as identified above) will potentially result in more tree loss.

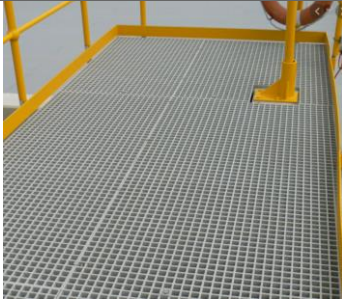
No.	Category	Description of Risk	Photo / Diagram	Likelihood	Severity	Risk Rating	Other Notes / Comments
1	Pedestrian	Specific shoes (i.e. with thin heels) might be trapped by the grates leading to foot injuries.

Improbable	Moderate	Low	
2	Pedestrian	Small items might fall into the small grate holes and result in personal property loss		Improbable	Minor	Low	
3	Pedestrian	Pedestrians might accidentally step outside the boardwalk without fence protection and result in injuries

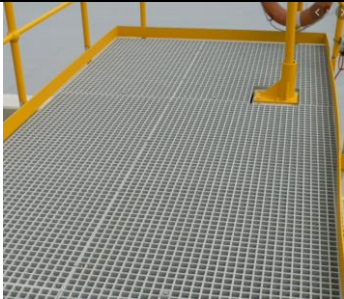
No.	Category	Description of Risk	Photo / Diagram	Likelihood	Severity	Risk Rating	Other Notes / Comments
1	Pedestrian	Specific shoes (i.e. with thin heels) might be trapped by the grates and leading to foot injuries.

Improbable	Moderate	Low	
2	Pedestrian	Small items might fall into the small grate holes and result in personal property loss		Improbable	Minor	Low	
3	Pedestrian	Due to the steep gradients of the existing roadway. The path, which will follow the roadway's terrain, could be too steep and unsuitable for wheelchair/pram access at certain sections.
