# Clontarf Tidal Pool Upgrade

Review of Environmental Factors

Northern Beaches Council

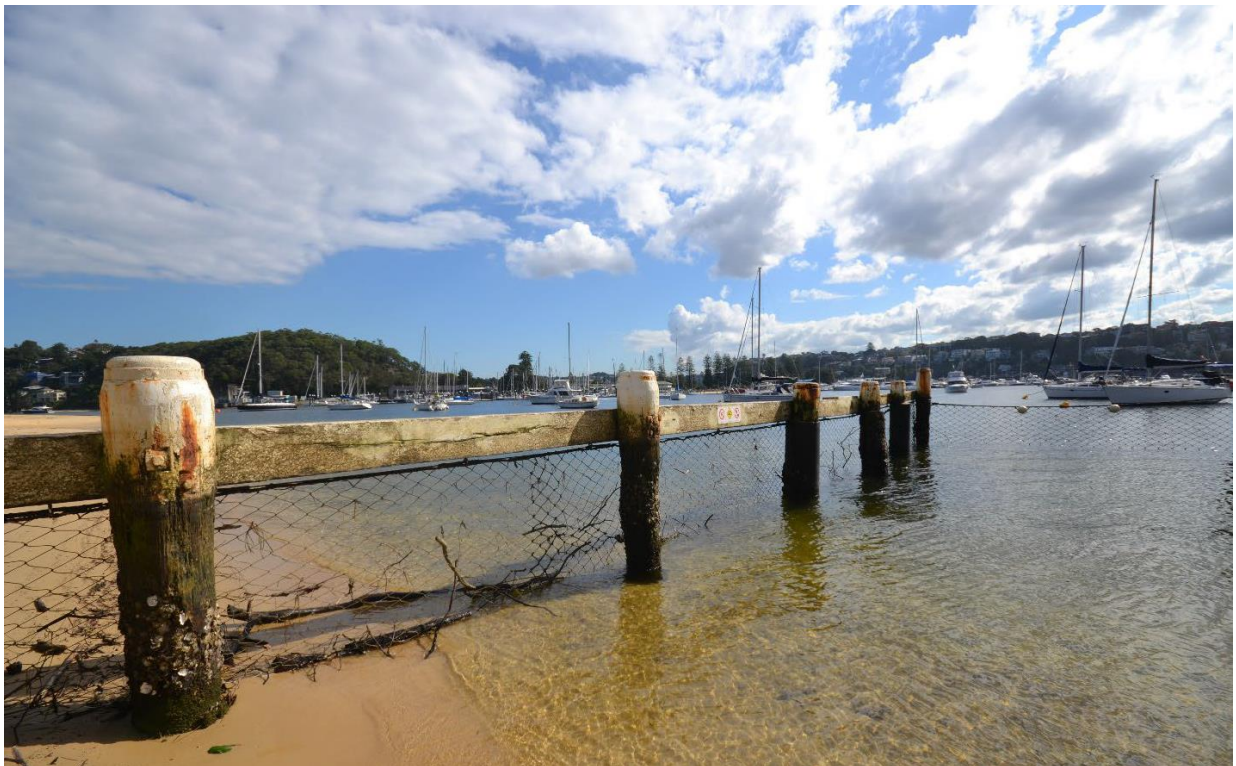
**Figure 3: Southern boundary of Clontarf Tidal Pool, showing the structure of timber piles, walers and netting (RPS, 2022).**

Clontarf Tidal Pool structure is in a poor condition, showing weathering and signs of rust (Figure 3), requiring removal of walers and temporary pile replacement at the rear of the structure. The pool in its current condition is considered a risk to public safety due to its condition. The risk posed by the pool currently includes reported injury from oysters built up on the timber piles, to the decaying timber and failing structure of the pool itself. Over time, the pool has become shallower in depth due to the movement of sediment along the beach. This sedimentation has previously been the subject of an REF prepared by ELA (2019) and subsequent dredging works, which moved sediment to another part of the beach. The proposed works seek to reduce the frequency of dredging works, extending the pool 3 m further into the harbour which will ensure continued access to deeper waters. The pool will also be extended along the shoreline, which will allow greater access for protected wading.

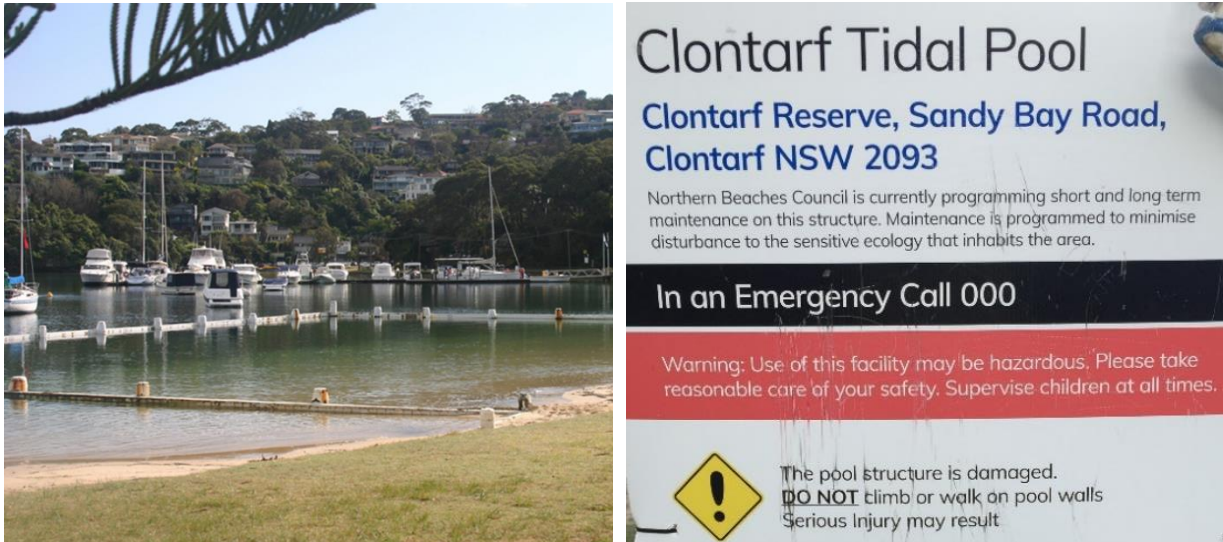
**Figure 6: Clontarf Tidal Pool at high tide (Northern Beaches Council) (left). Safety warning signage (ELA, 2019) (right).** The 'Do Nothing' approach was not considered as the pool is currently considered a safety hazard and is at risk of submersion due to sea level rise.

- **Risk to public safety.** The pool is at risk of being closed entirely as the degrading piles are not structurally sound. Figure 6 shows signage at Clontarf Tidal Pool, which warns that 'use of this facility may be hazardous' and 'the pool structure is damaged'.

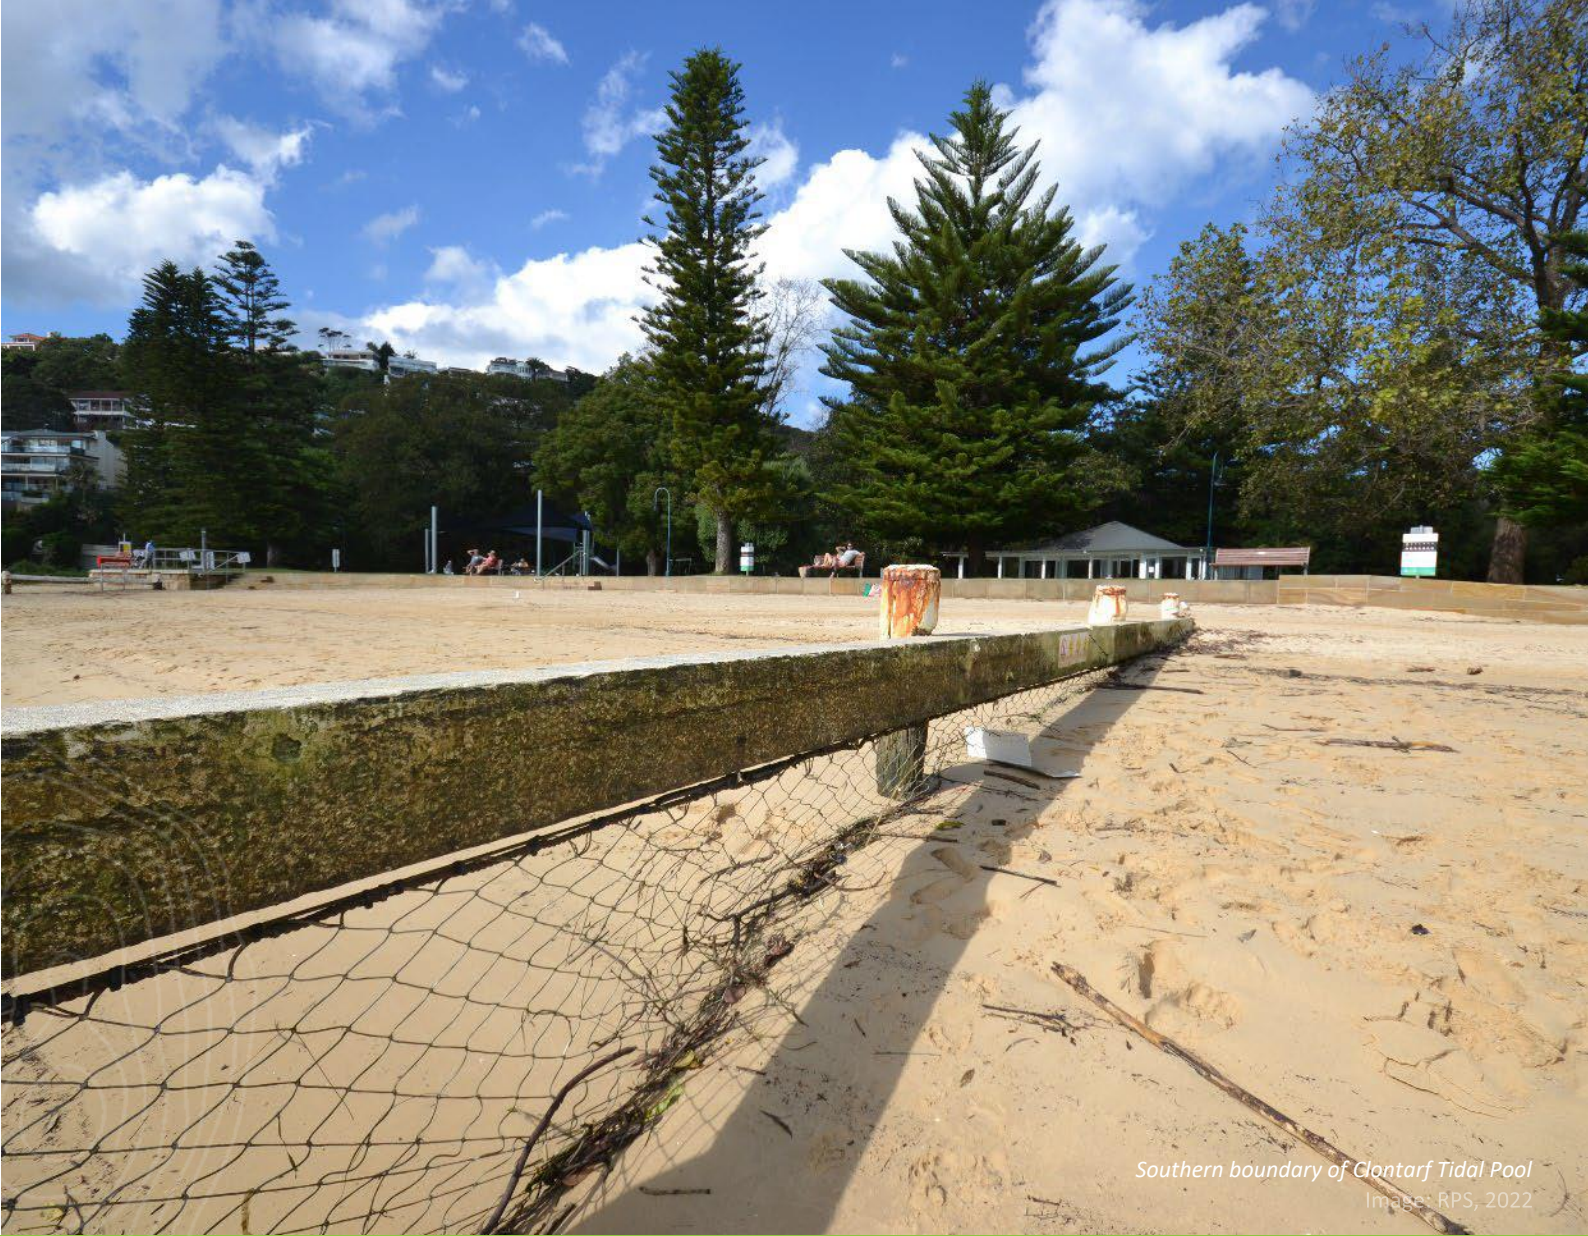
*Southern boundary of Clontarf Tidal Pool  
Image: RPS, 2022*

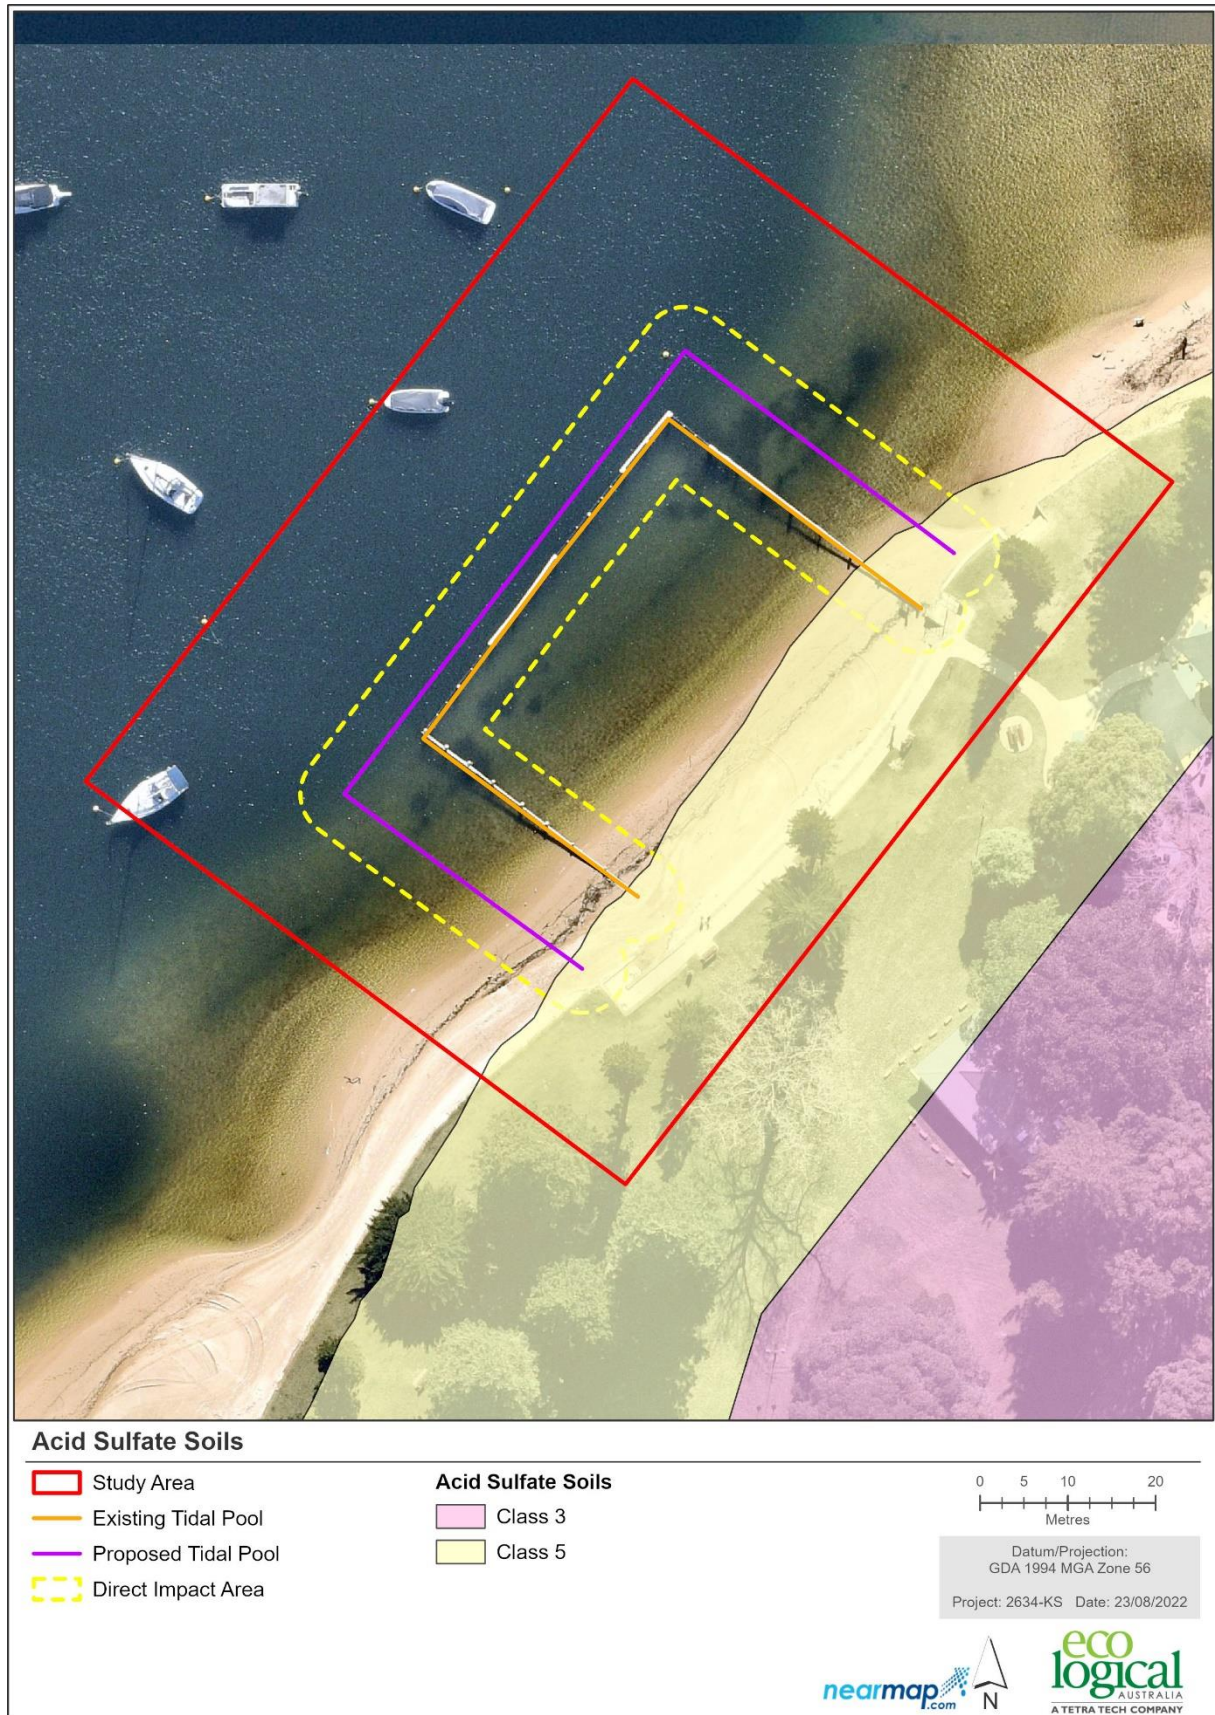
Figure 10: Acid Sulphate Soils in relation to the study area (Manly LEP 2013)

In accordance with Clause 6.1 of the Manly LEP, the study area is partially mapped as having Class 5 Acid Sulphate Soils (ASS) and in close proximity to an area mapped as having Class 3 ASS (Figure 8). ASS are generally not found in areas mapped under Class 5.

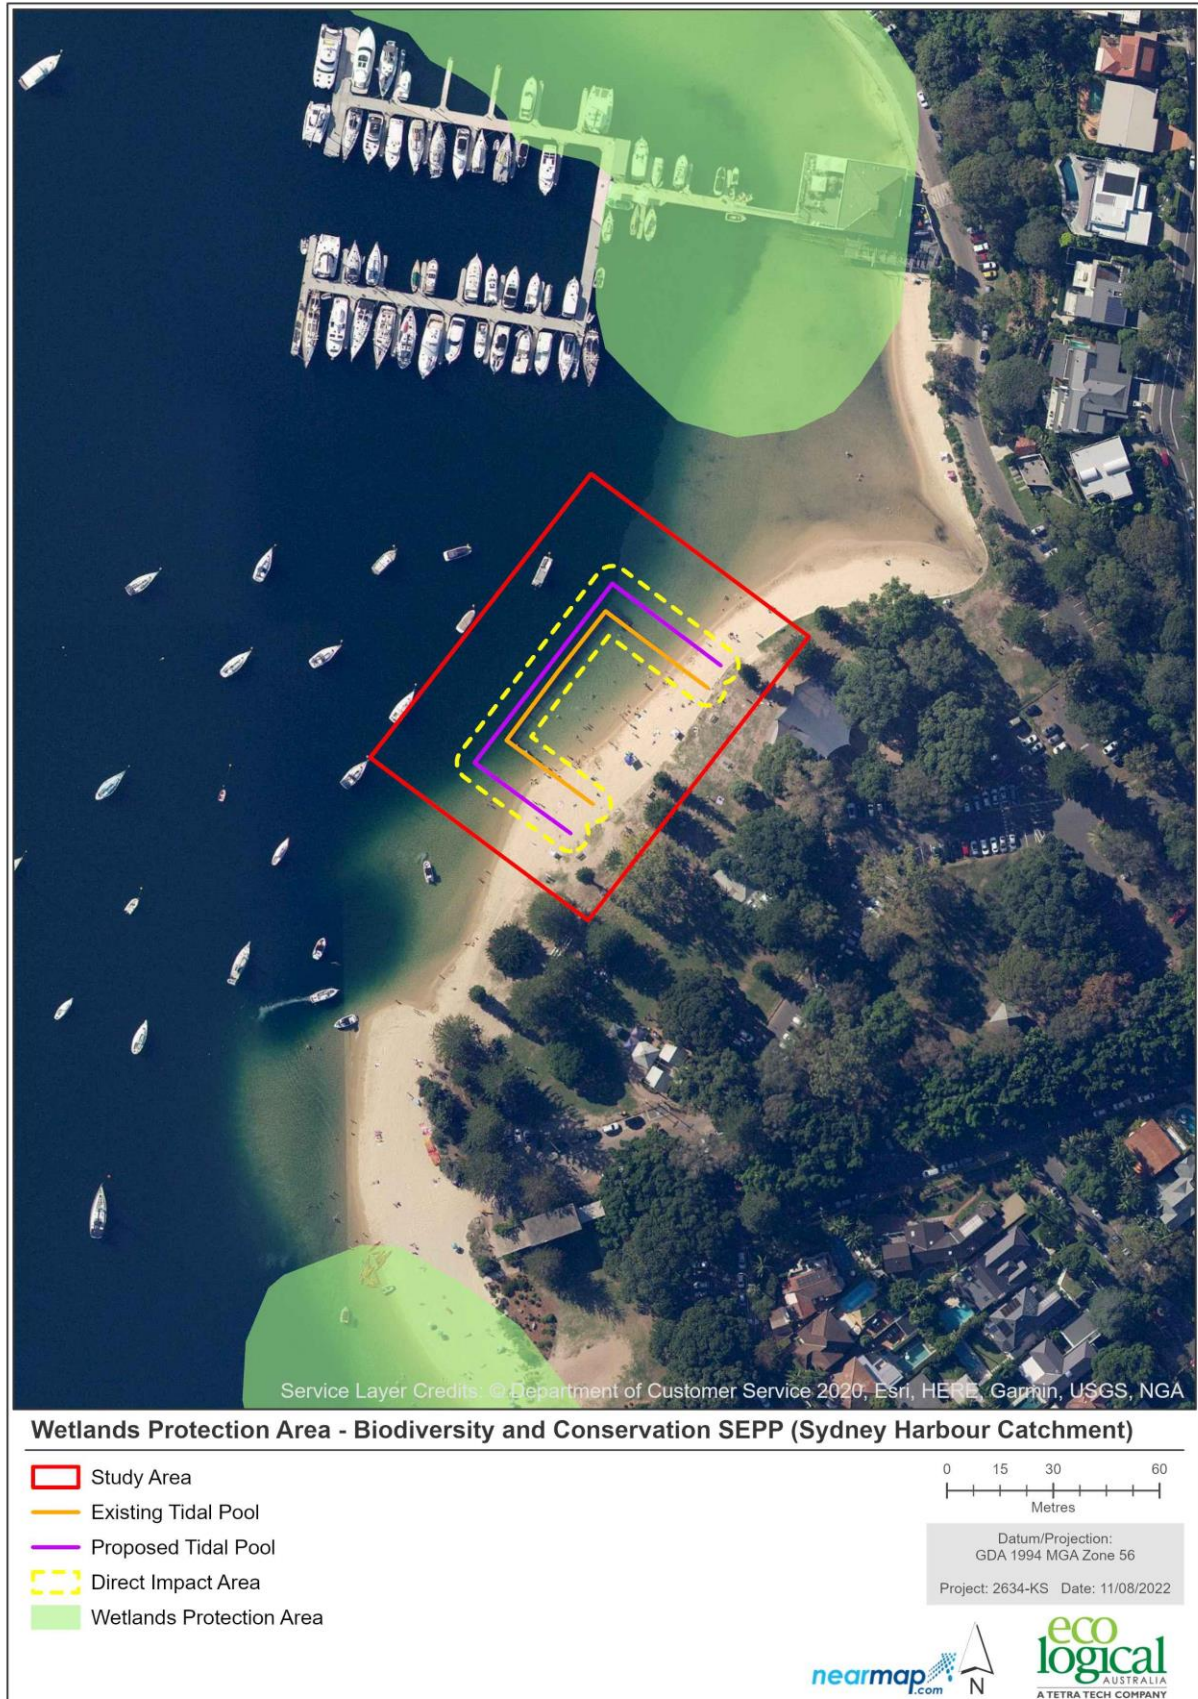
**Figure 11: Wetlands Protection Area in relation to the study area, under Chapter 10 - Sydney Harbour Catchment of the Biodiversity and Conservation SEPP**

Areas to the north and south of Clontarf pool are mapped as 'Wetlands Protection Area' under Chapter 10 of the Biodiversity and Conservation SEPP (Figure 11). Wetland protection provisions cover areas of seagrass and a 40 m buffer around the seagrasses to allow for movement, growth, and seasonal variation. While Clontarf pool is outside of the mapped Wetland Protection Area under the SEPP, patches of seagrass were found within and immediately adjacent to the pool.

Although the study area is not mapped as a Wetlands Protection Area under Part 10 – Sydney Harbour Catchment of the Biodiversity and Conservation SEPP (Figure 11), patches of seagrass were found within and immediately adjacent to the pool (Figure 15).

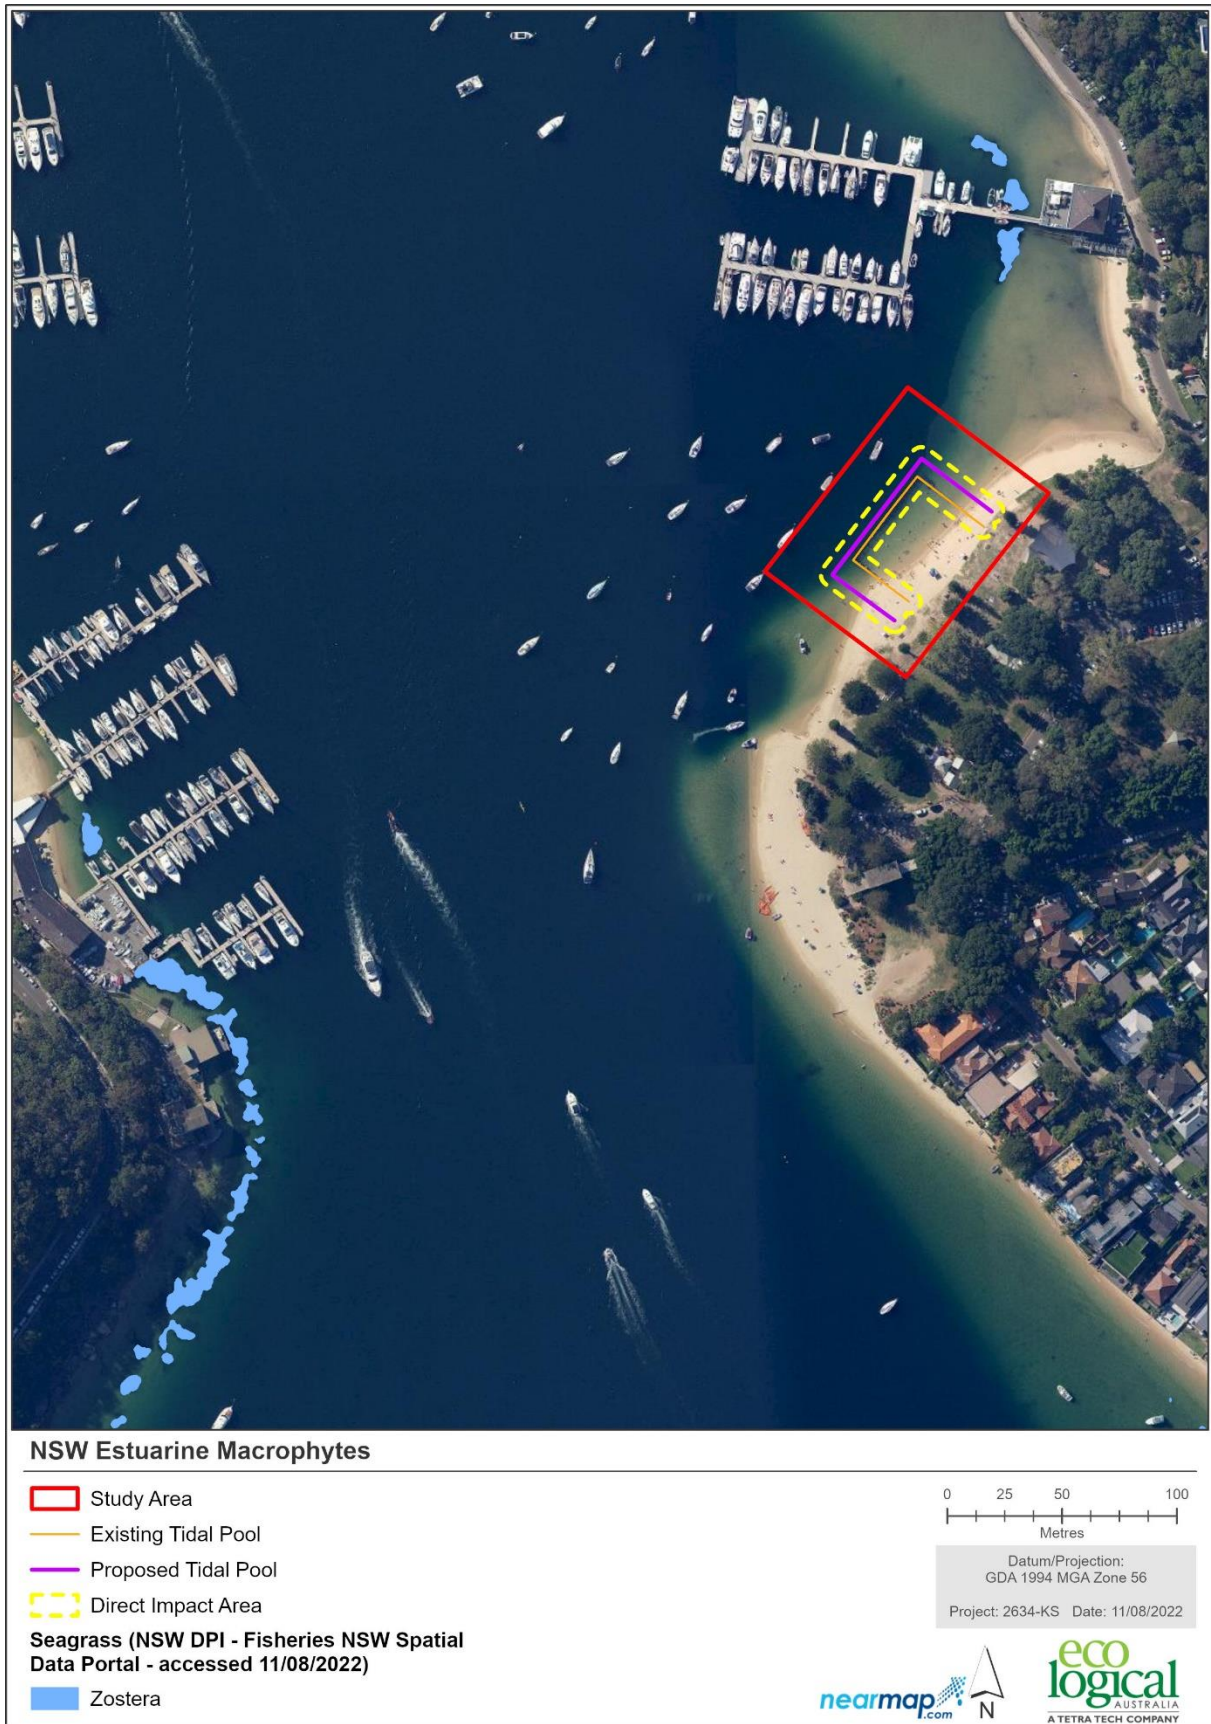
**Figure 14: Previously mapped seagrass occurrences in the vicinity of the study area (DPI Fisheries)**

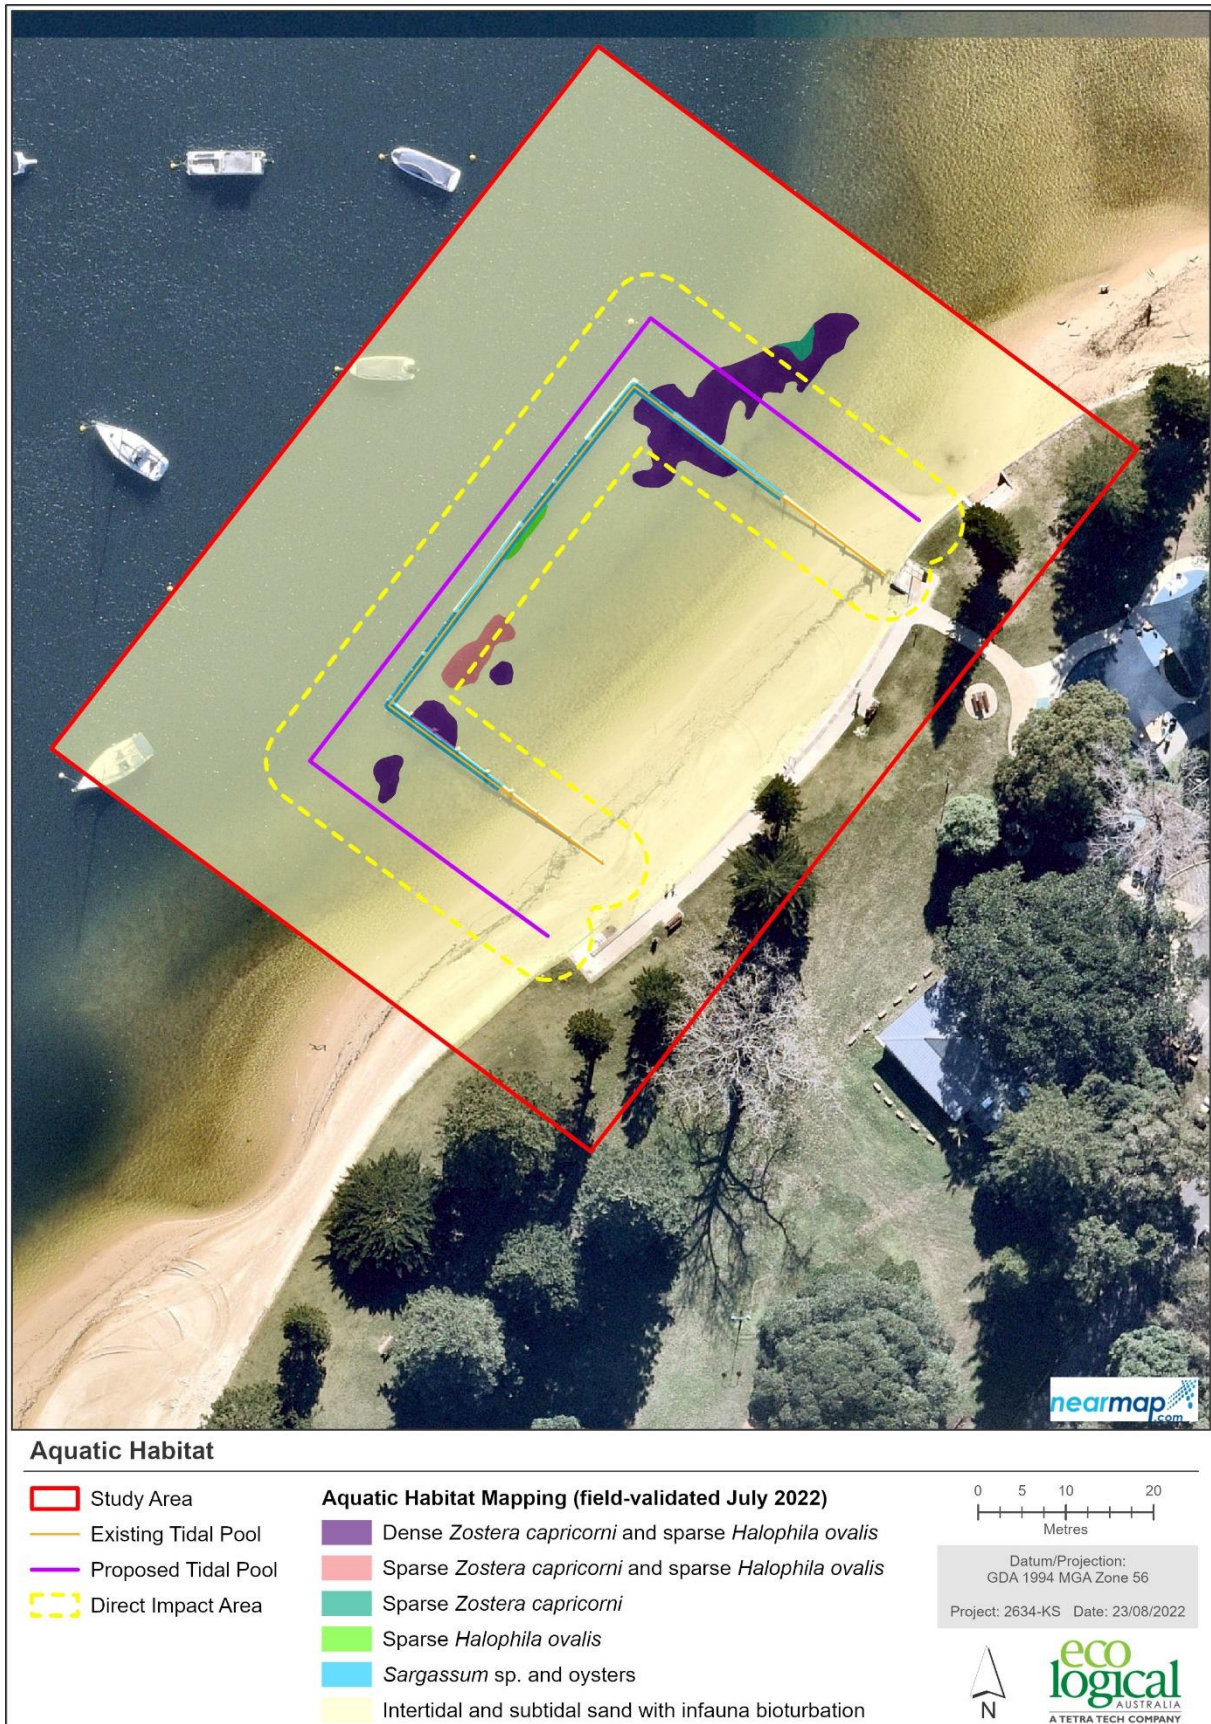
Figure 15: Aquatic habitat within the study area (ELA 2022)

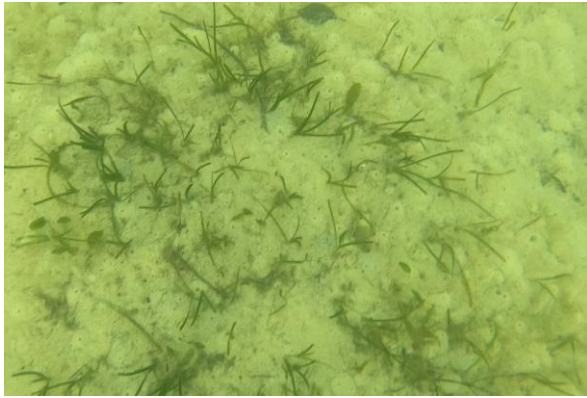
Figure 17: Sparse *Zostera capricorni* and *Halophila ovalis*

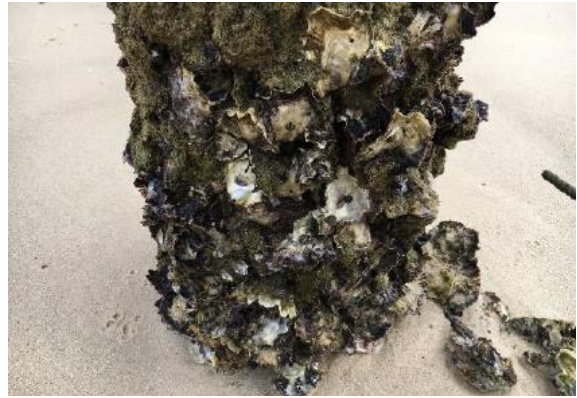
Figure 18: Dense growth of oysters on exposed pile

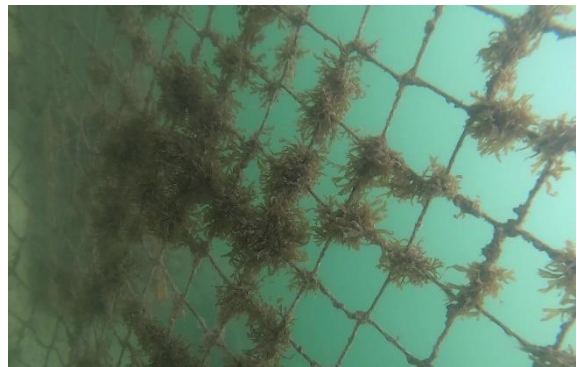
Figure 22: Macroalgae on enclosure net

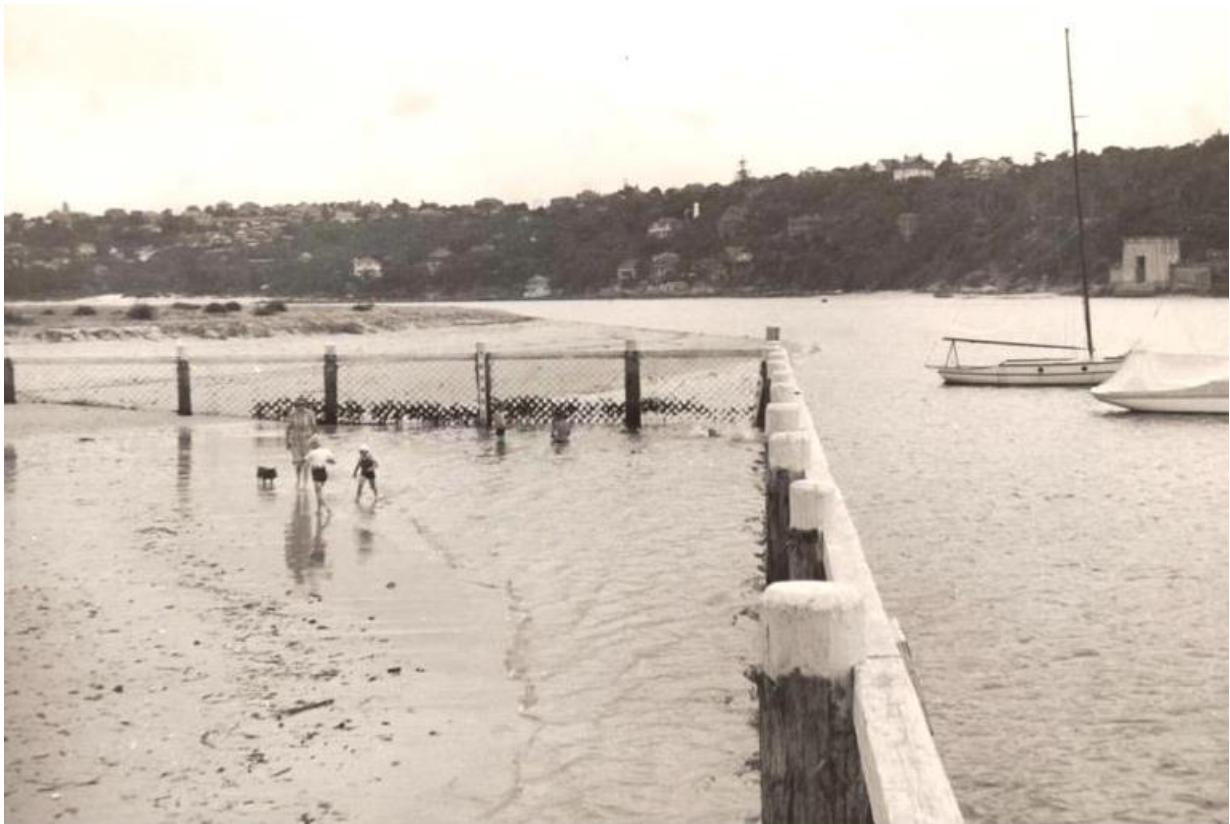
**Figure 24: Clontarf Pool at low tide 20 December 1949 (Source: Manly Library)**

extended in 1959. By 2009 it had filled with sand to the extent that at low tide the pool was only 20 to 30 cm in depth. Council agreed to dredge approximately 1,600 m<sup>3</sup> of sand from the pool which was used as beach nourishment behind properties at Monash Crescent (Manly Local Studies Library).

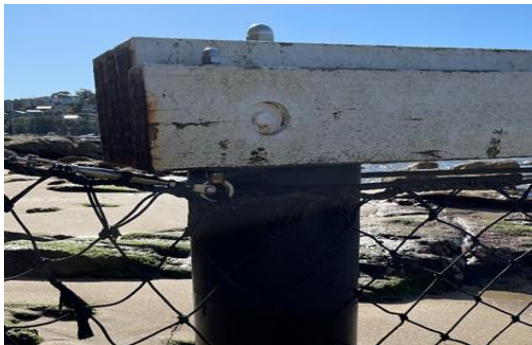
**Figure 26: Materials used for the upgrade works at 40 Baskets Tidal Pool (ELA, 2022)**

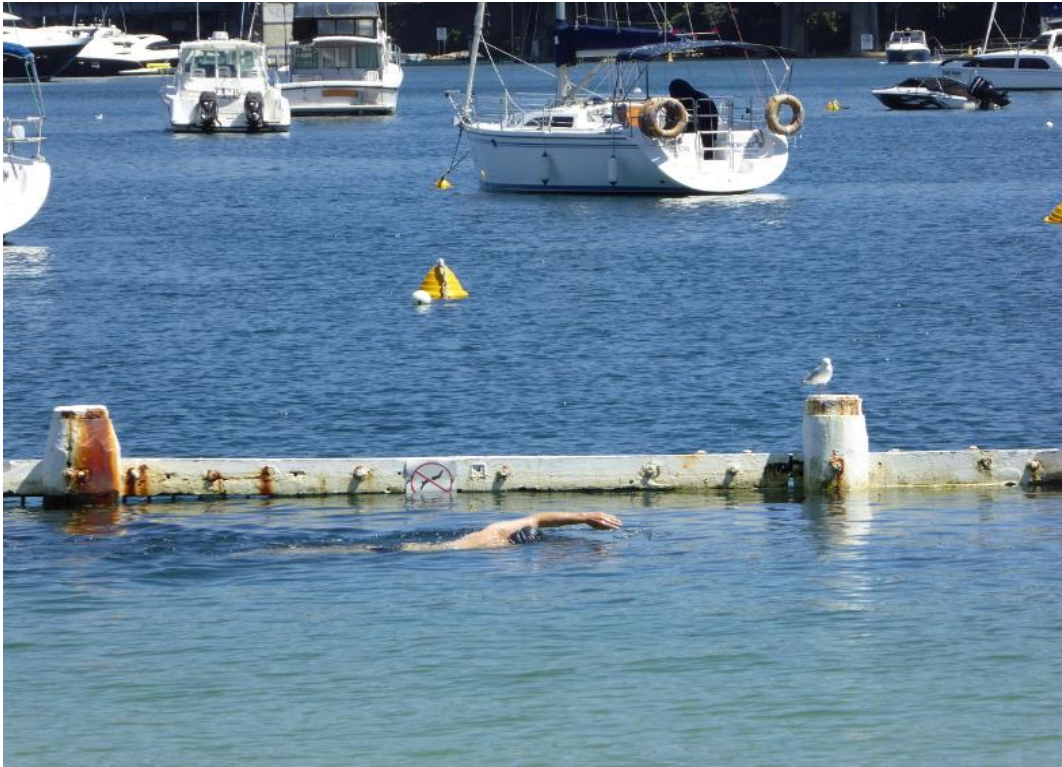
**Figure 28: A swimmer at Clontarf Tidal Pool, highlighting sea level and proximity to moorings (Ocean Pools NSW, 2016)**

The proposed pool renewal will have a positive impact for the local community and other pool users. The area, and as a result the depth, of the pool will be increased, allowing for higher volumes of people to use the pool at once. It will allow for more people to use the pool at greater depths for lap swimming, as well as in the shallows for family-friendly outdoor recreation. The height will be increased to account for sea level rise, ensuring ongoing protection from sharks as the high-tide sea level is expected to surpass the existing structure (Figure 28). This would otherwise compromise the effectiveness of the existing shark netting at high tide.
