2 Understanding Narrabeen Lagoon

2.1 Physical environment of the lagoon

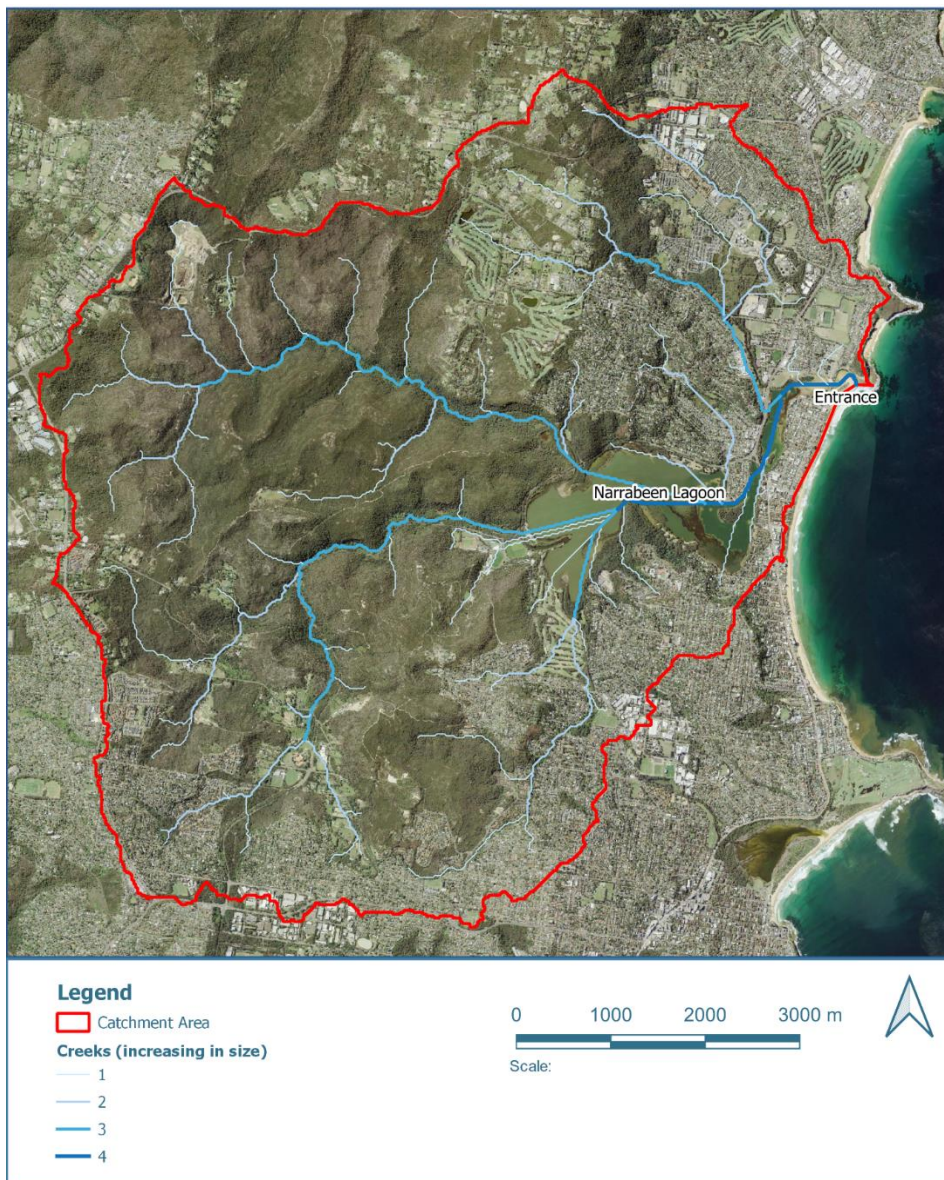
The Narrabeen Lagoon catchment area covers some 55 km², which includes 2.2 km² of water surface area (SMEC, 2011). The catchment area and major creeks is shown in **Figure 2-1**.

Figure 2-1: Catchment showing major creeks

The catchment can be separated into several major sub-catchments associated with five main creeks (Nareen, Mullet, Deep, Middle and South Creeks) that feed into the lagoon. From an elevation of around 200 m AHD in the north-west of the catchment around Terrey Hills and Ingleside, and 150 m AHD in the south and south-west of the catchment around Belrose and Frenchs Forest, the topography of the

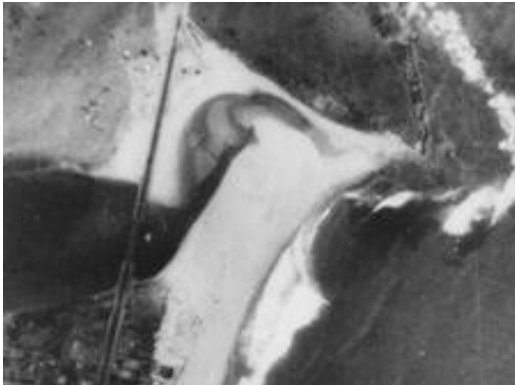
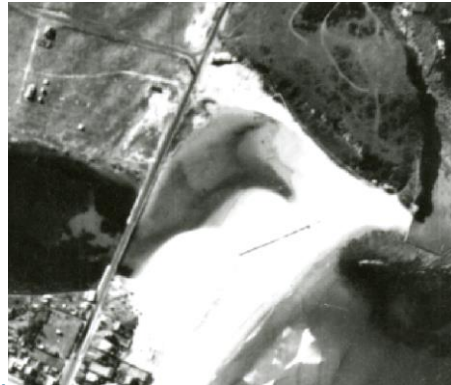
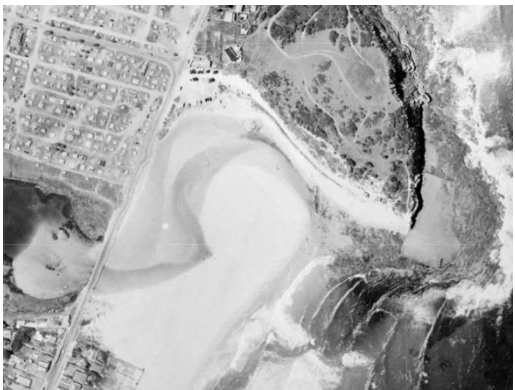
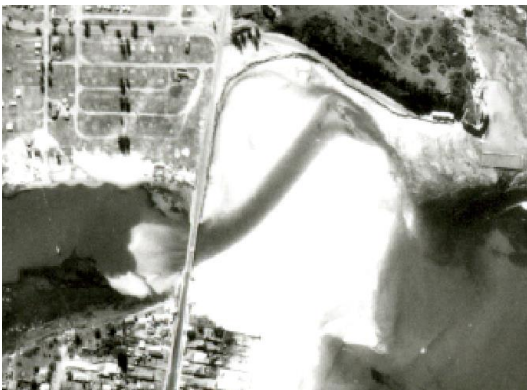
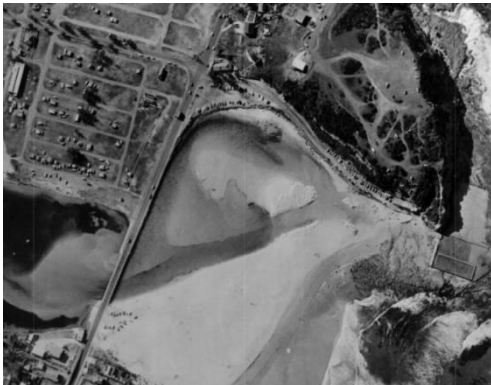
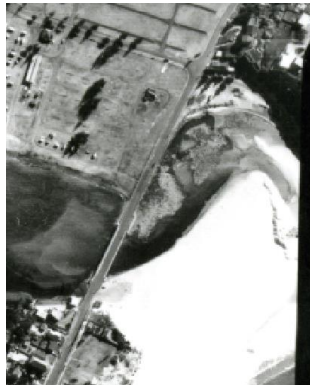
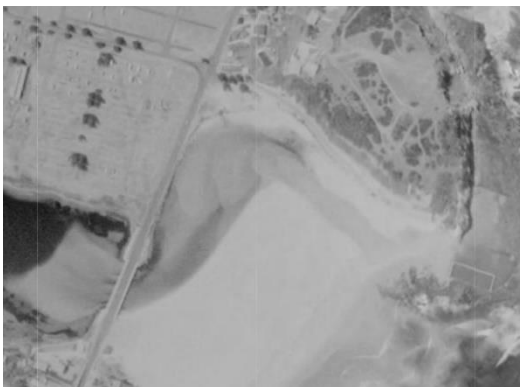
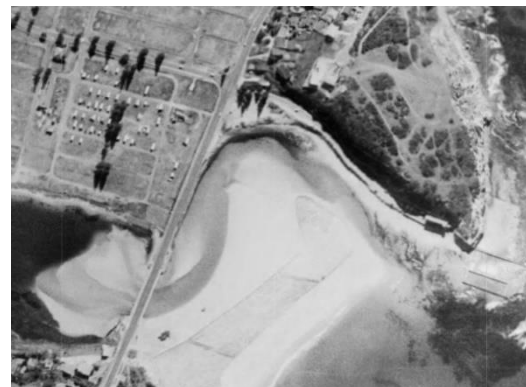
The historical photos below in **Figure 2-2** show aerial photos of the entrance up until 1975, with many showing a large degree of infilling with sand.

Figure 2-2: Historical photographs of Narrabeen Lagoon 1930-1975

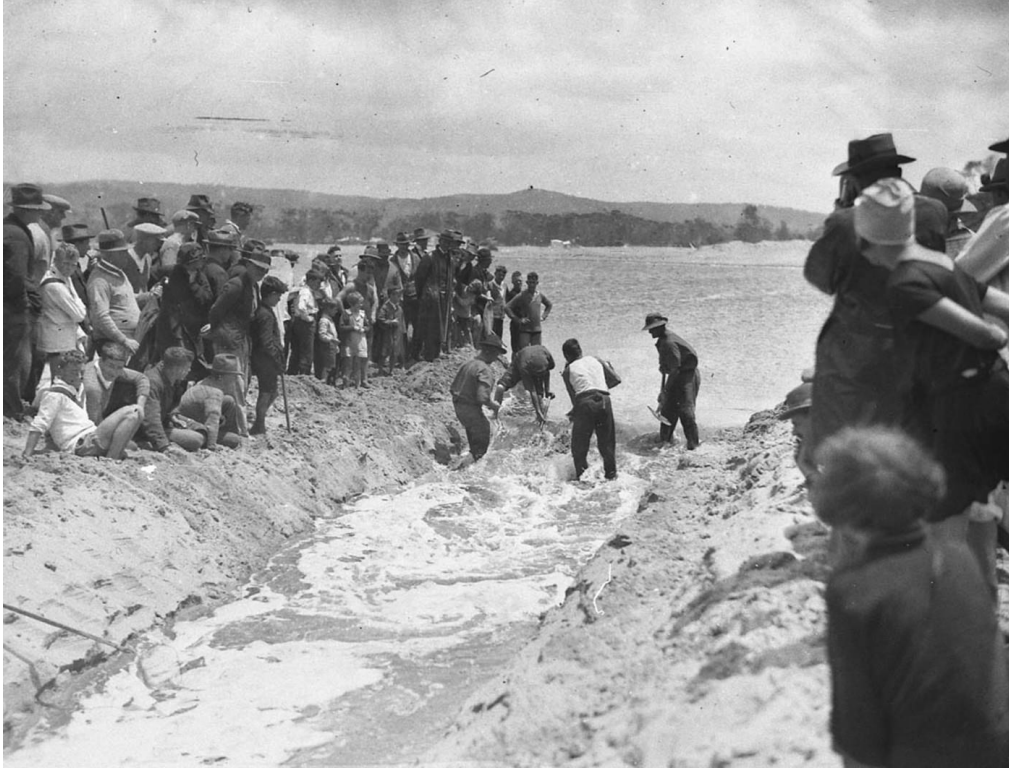
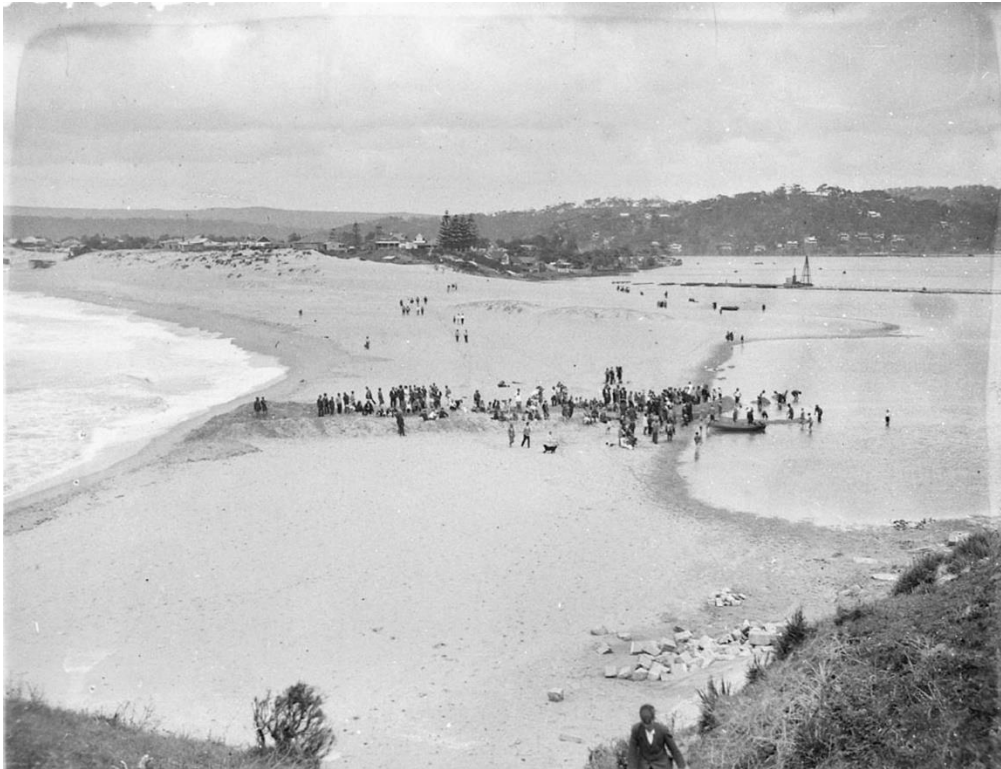
shovels when water levels got too high (refer **Figure 2-3** and **Figure 2-4**), to alleviate local flooding (Pittwater Online News, 2016).

Figure 2-3: Men digging flood mitigation channel, April 1927 (Source: State Library of NSW)

Figure 2-4: View of flood mitigation channel from Narrabeen Headland, April 1927 (Source: State Library of NSW)

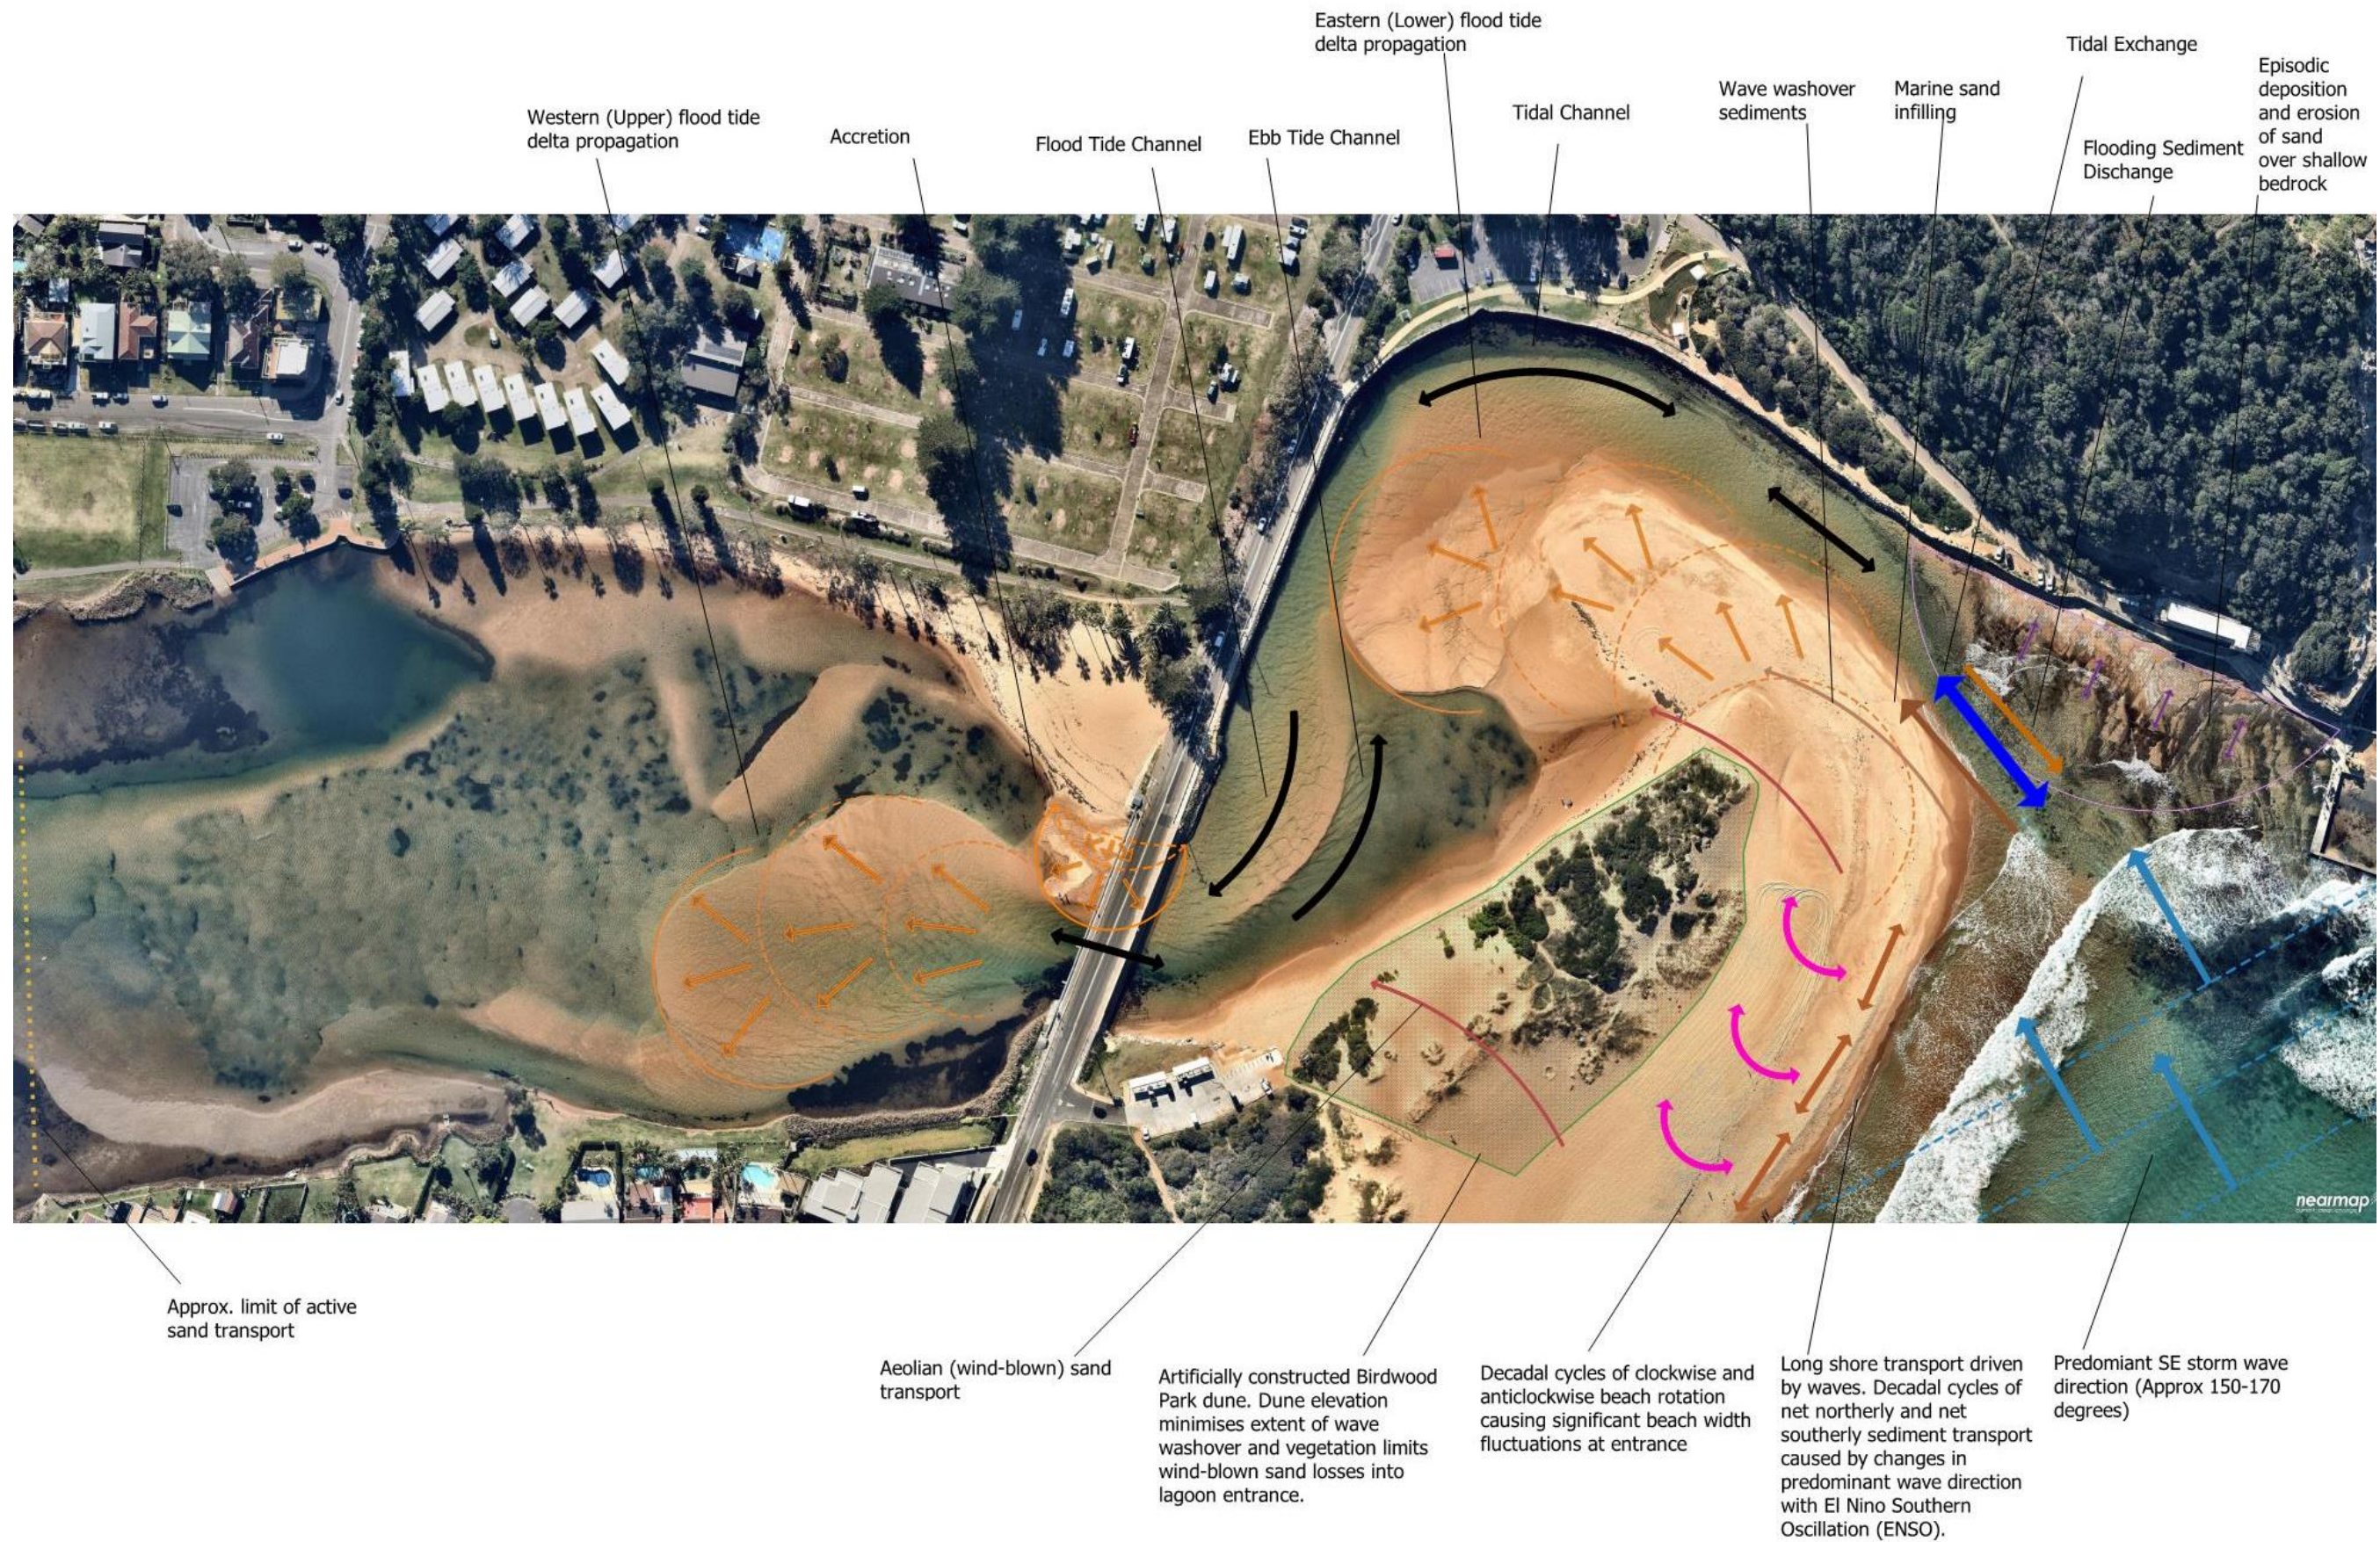
The conceptual understanding of coastal processes at the entrance of the lagoon is shown schematically in **Figure 2-6** and described below.

Figure 2-6: Conceptual understanding of coastal processes at Narrabeen Lagoon entrance

Flooding of areas surrounding the lagoon can be exacerbated when there is an accumulation of sand at the entrance, which creates a constriction that reduces the hydraulic efficiency of the entrance for discharge of flood flows. In simple terms, sand builds up in the entrance area and reduces the amount of water that can flow out of the lagoon. Several tens of thousands of cubic metres of sand can be accommodated within the lagoon entrance across two flood tide shoals on the eastern (lower) and western (upper) side of Ocean Street Bridge.

The lagoon has a flood dominated tidal current regime and the entrance is subject to progressive infilling as sand is transported into the entrance by wave action and flood tides and reworked further upstream to accumulate on the lower (downstream of Ocean Street Bridge) and upper (upstream of Ocean Street Bridge) flood tide shoals (refer **Figure 2-7**). Ingress of sand through the entrance is largely dependent on sand availability at the ocean entrance and available space within the lagoon entrance, that appears to have no direct connection to the long term sand transport rates; aside from during storm events (Morris, 2010). Following the 2006 entrance clearance operation, Morris (2010) observed a pattern of initial rapid infilling following entrance scour and then a slower rate of infilling as the system approached closure (Cardno, 2019).

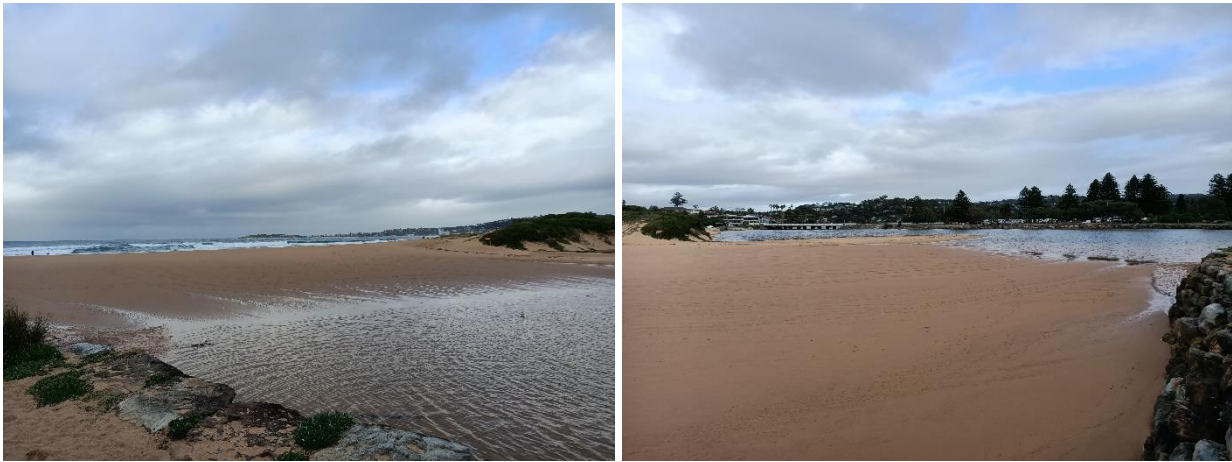
entrance alongshore within the swash zone by waves breaking and running up at an angle to the beach alignment. Other mechanisms for sand transport into the lagoon include wind-blown transport of beach sand over the dune and wave overtopping of the beach berm adjacent to the entrance channel, which can mobilise sand from the berm and deposit it into the entrance channel behind (so-called washover transport, refer **Figure 2-8**).

Figure 2-8: Overtopped beach berm following large swell (left), Sand washover into lagoon entrance (right) (May 2021)

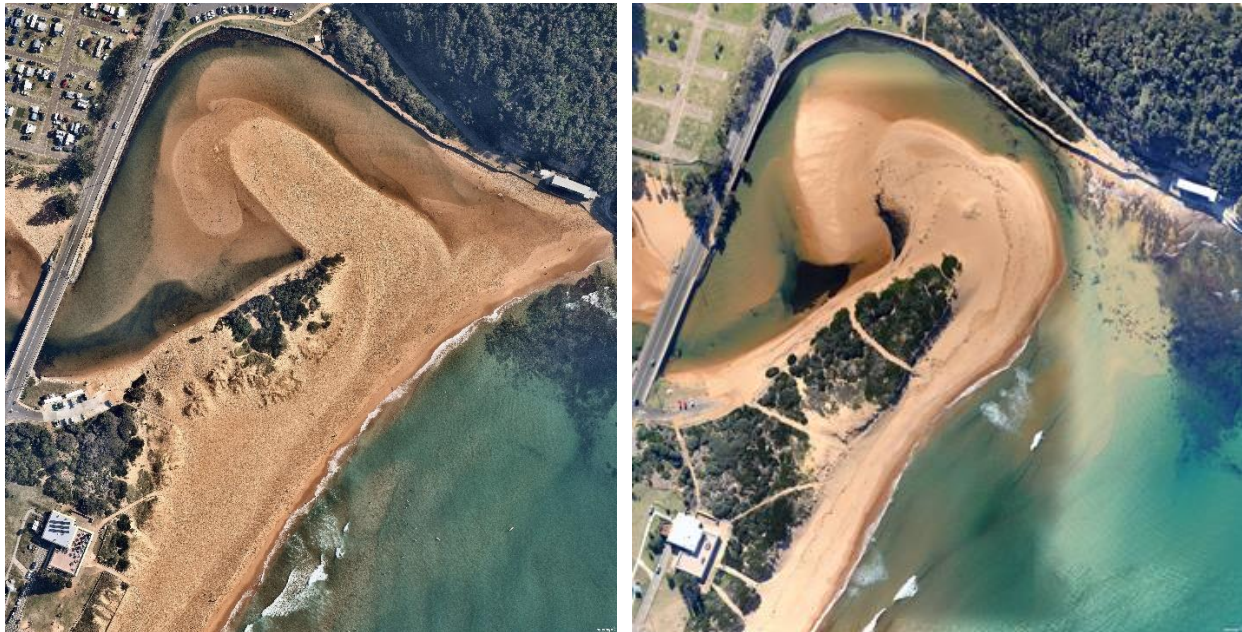
The clockwise beach rotation in recent times has increased beach berm sand volumes and width at North Narrabeen, resulting in an increased frequency of entrance clearance campaigns and an increased level of effort when undertaking mechanical opening of the entrance. As such, the future entrance management regime of entrance clearance campaigns will need to provide flexibility for more frequent entrance clearance campaigns to be completed during periods of clockwise beach rotation and less frequent campaigns to be completed during periods of anti-clockwise beach rotation.

Figure 2-9: North Narrabeen beach states (Left: October 2020 – clockwise rotation; Right: June 2010 – anti-clockwise rotation)

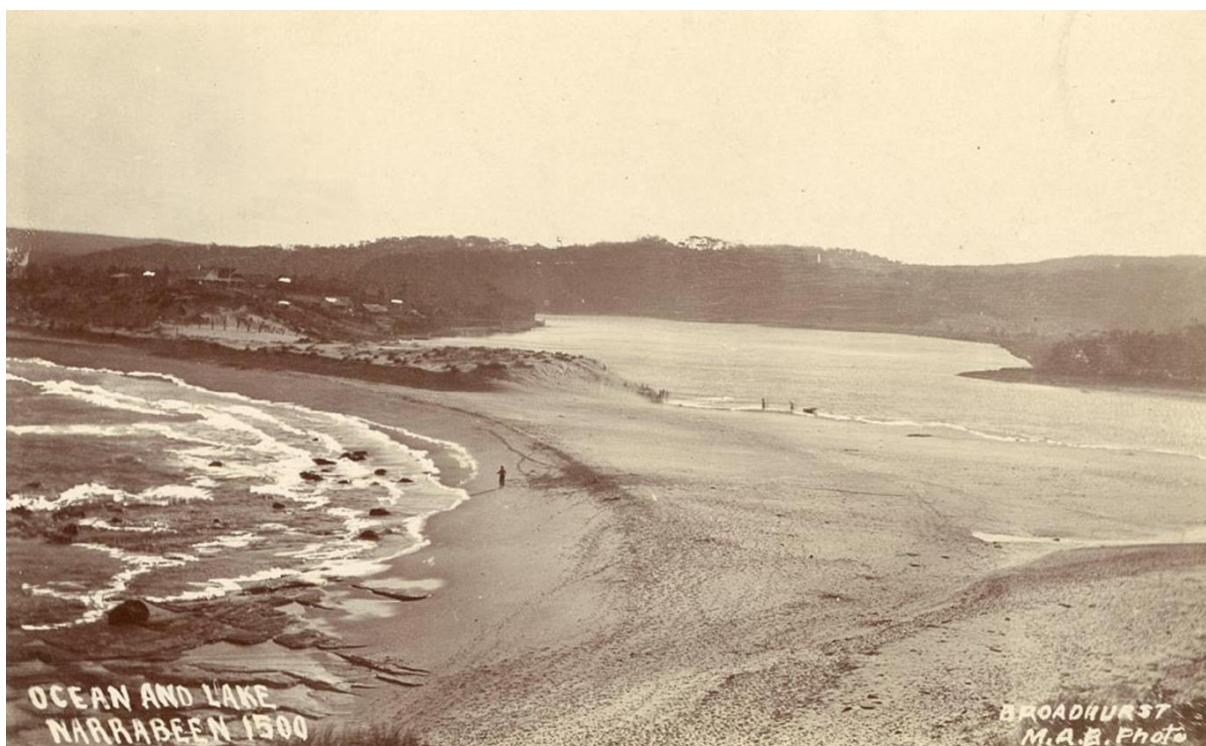
Figure 2-10: Narrabeen looking west – from Scenes of Narrabeen album, ca. 1900-1927 – Sydney & Ashfield, State Library

The Birdwood Park dune is part of the North Narrabeen beach dune system. Prior to 1974, it was a low dune spit at a height of approximately 3 - 4.5 metres above mean sea level, that would allow overtopping by large waves during severe storm events. Aerial photos of the entrance from 1930 to 1975 shown in **Section 2.1.1** of this report (refer **Figure 2-2**) show that it was quite common for the entrance area to be choked with a large volume of sand. Additional historical photos are provided in **Figure 2-10** and **Figure 2-11** below.

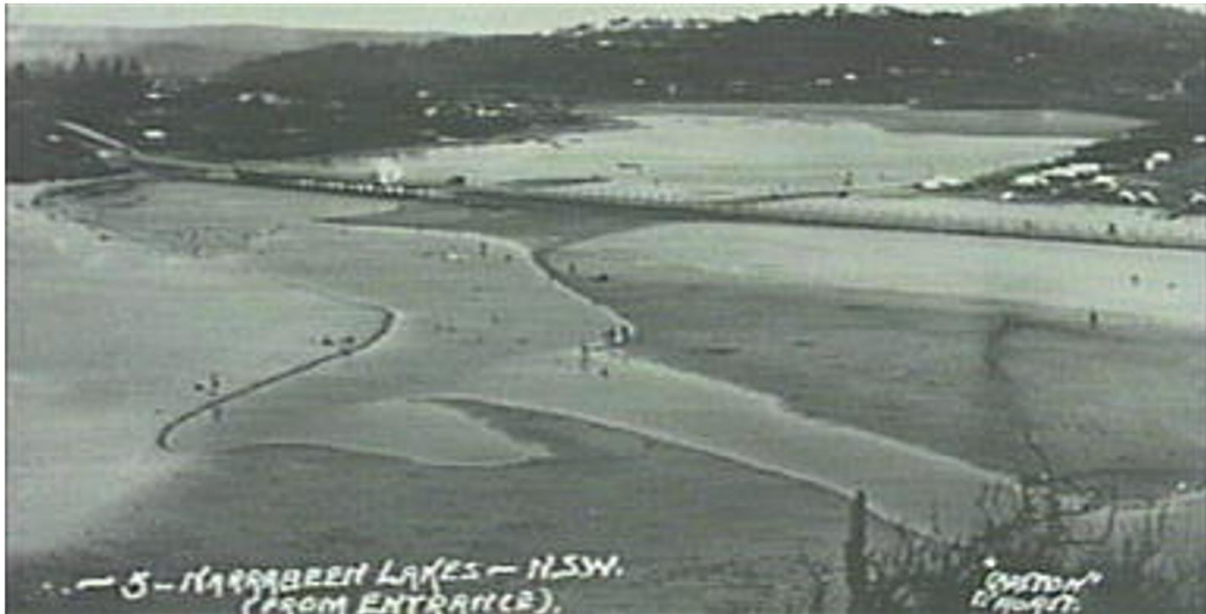
Figure 2-11: Narrabeen entrance – shortly after construction of the Ocean Street Bridge, ca. 1920s

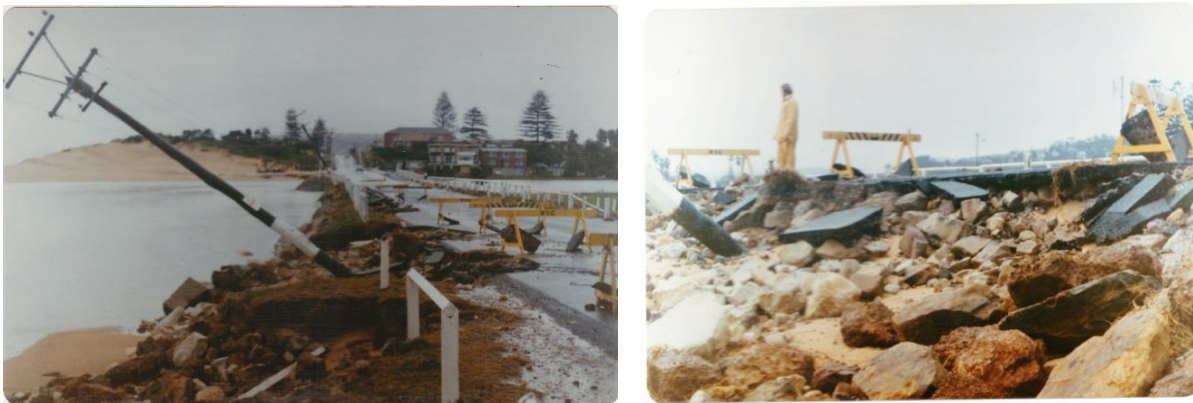
During the May 1974 storm, elevated ocean water level conditions and wave action resulted in washover of the entire sand spit in the Birdwood Park area, with sand completely infilling the channel downstream of the Ocean Street Bridge and also being transported into the channel upstream of the bridge. The Ocean Street Bridge was seriously damaged, as shown in the photos below (refer **Figure 2-12**).

Figure 2-12: Damage to Ocean Street Bridge in 1974

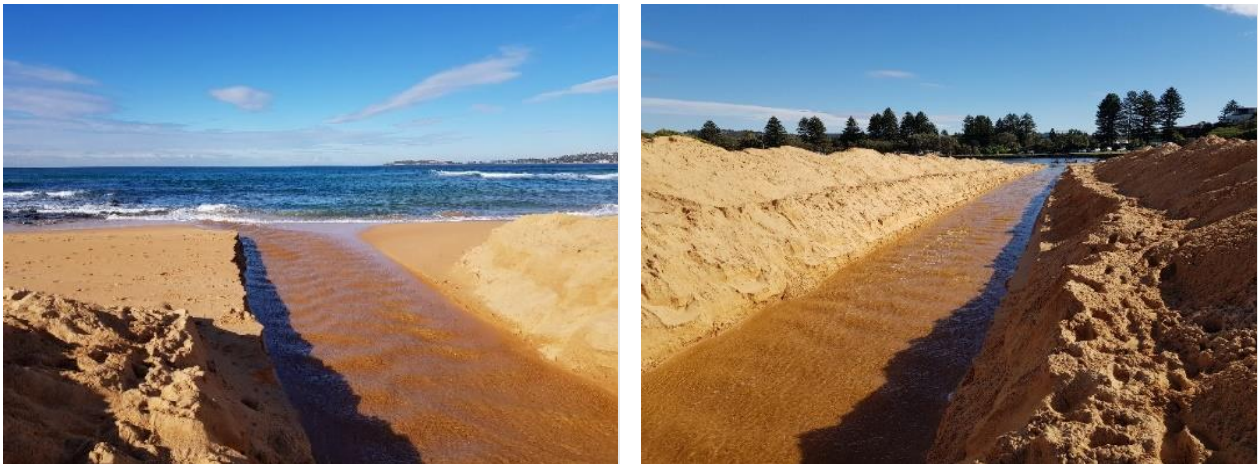
The short term emergency management activity undertaken by Council when the lagoon entrance is closed and certain trigger conditions are satisfied, is to complete what is called a mechanical opening. A mechanical opening involves the use of excavators to dig a channel through the beach berm to connect the lagoon to the ocean, allowing water to flow out of the lagoon into the ocean and ultimately lowering the lagoon water levels (refer **Figure 2-15**). The main aim of this activity is to reduce or prevent the flooding of low-lying areas around the lagoon foreshore in the event that lagoon water levels are elevated and moderate to heavy rainfall is forecast.

As is explained in more detail in **Section 4**, mechanical openings are most successful at draining the lagoon when the water level within the lagoon is higher than the ocean water level (lagoon water level at least at 1.0-1.3 m AHD). This provides the necessary water level height difference between the lagoon and ocean, called the hydraulic head, required for effective scouring of sand in the channel to result in the entrance remaining open for as long as possible.

Figure 2-15: Mechanical opening of the lagoon entrance (4 June 2021)

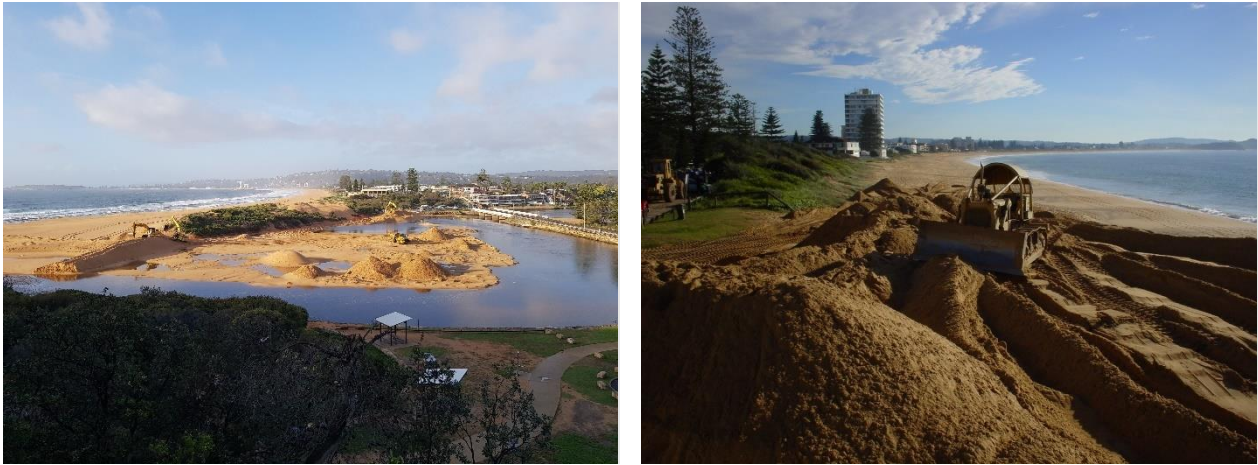
As opposed to the small scale, short term mechanical openings Council also periodically undertakes a larger scale operation to remove a much greater volume of sand from the lagoon entrance area (refer **Figure 2-16**). This keeps the entrance open for typically a few years, but even when the entrance does eventually close again, it means that short term mechanical openings can work when required for flood mitigation purposes. Entrance clearance operations have been carried out at relatively regular intervals (3-5 years) since 1975, removing approximately 30,000-50,000 m³ of sand per operation.

Figure 2-16: Excavators removing the entrance shoals (left), Unloading and regrading of sand for beach replenishment (right)
