### 3. AVAILABLE DATA

### 3.3. Topographic Data

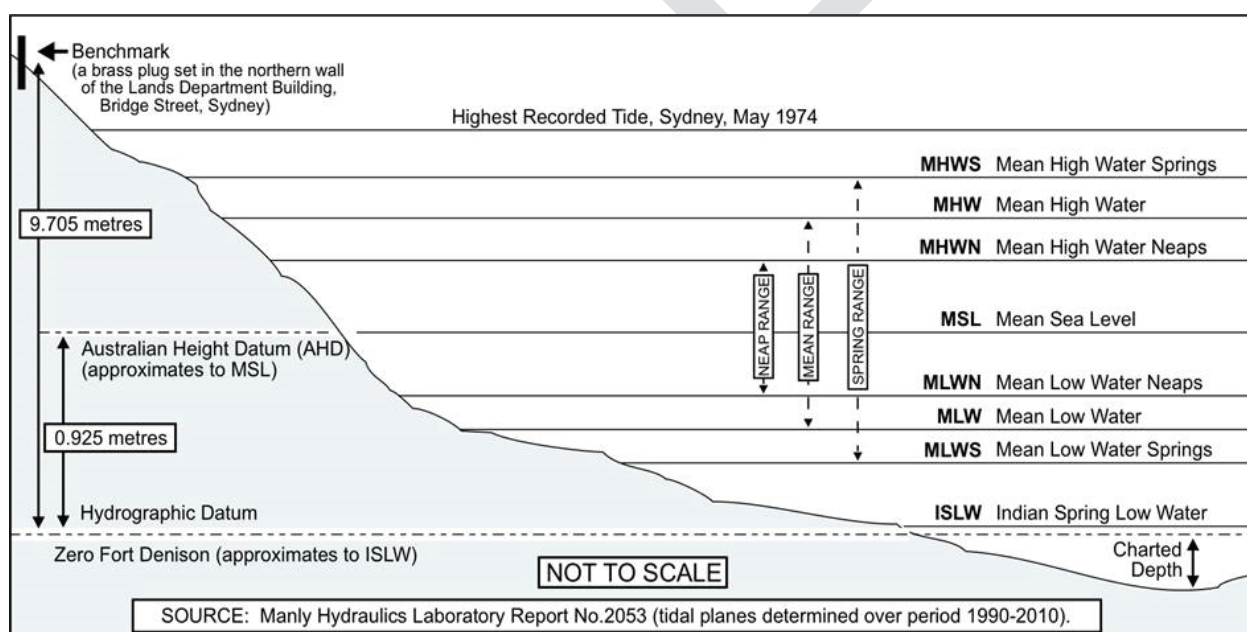
Diagram 1: Tidal Planes Diagram

Manly Hydraulics Laboratory prepared the *NSW Tidal Planes Analysis: 1990-2010 Harmonic Analysis* report on behalf of OEH (Reference 7). It was released in October 2012 and was based on data from 188 tidal monitoring stations from 1st July 1990 to the 30th June 2010. Data from the relevant stations are shown in Table 2 with a tidal plane diagram shown as Diagram 1. Curl Curl Lagoon may be subject to tidal influence in large flood events when lagoon breakout occurs however due to the elevation of the entrance berm, peak flood levels will not generally be affected by the tidal conditions, unless there is a major storm surge and wave action accompanying the rainfall.

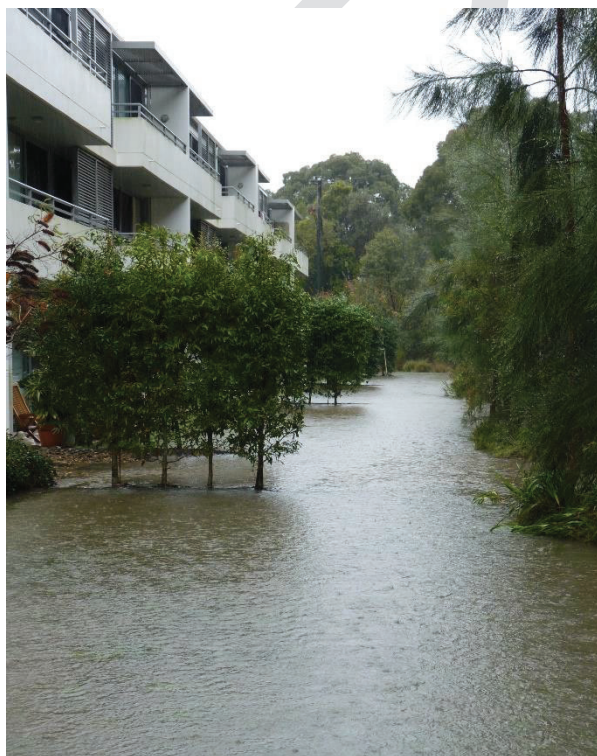
Photo 1: The Kilns (March 2013)

Community consultation responses indicate that flows exceeding the capacity of the channels around The Kilns occurred several times between 2013 and 2014 due to a landslide which caused blockage of a section of the channel. The rocks from this landslide were removed from the channel in early 2015, which the respondent suggests has lowered the flood risk in this area.

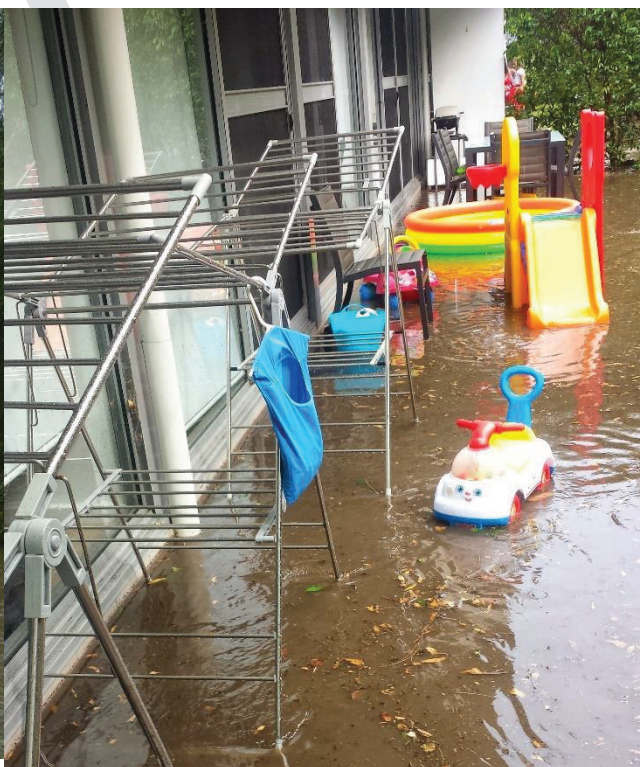
Photo 2: Flooding near Unit 6, The Kilns (2014)

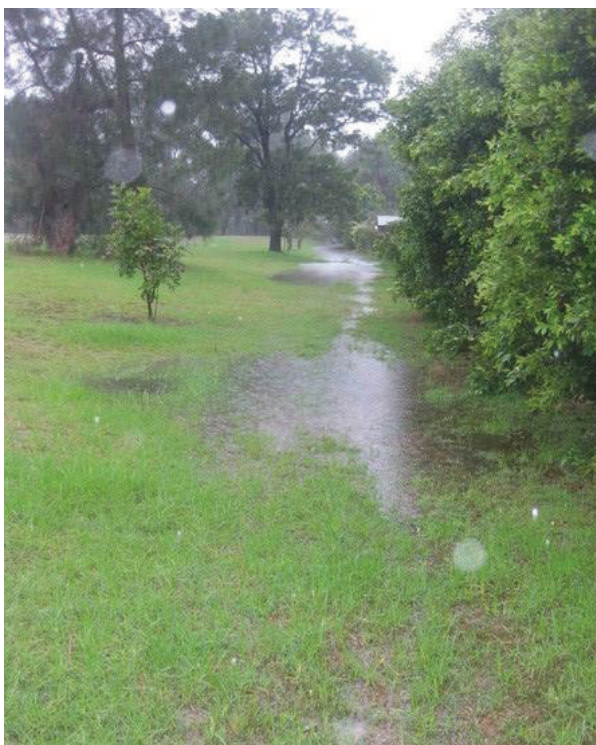
Photo 3: Stirgess Reserve (March 2011)

Photo 3 indicates that ponding of water in Stirgess Reserve is likely to occur relatively frequently.

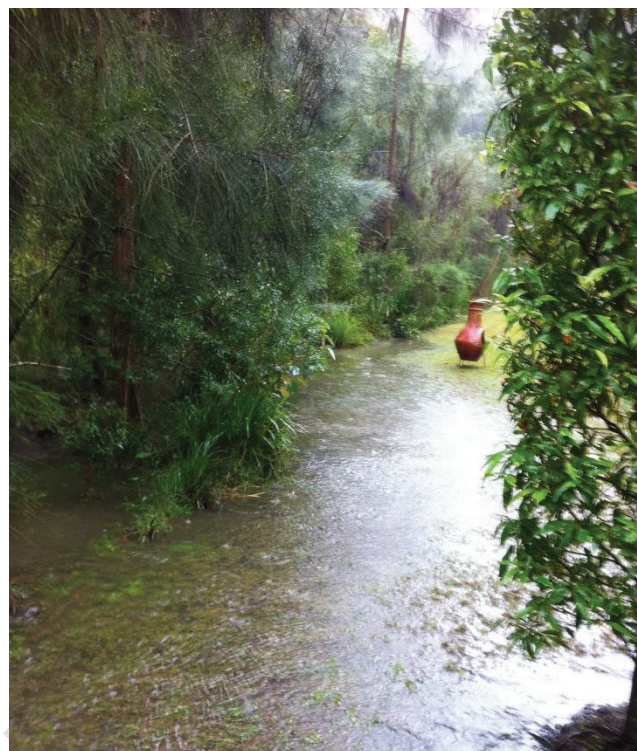
Photo 4: Flooding at The Kilns (September 2013)
