## **5. HYDROLOGIC MODEL**

## 6. HYDRAULIC MODEL

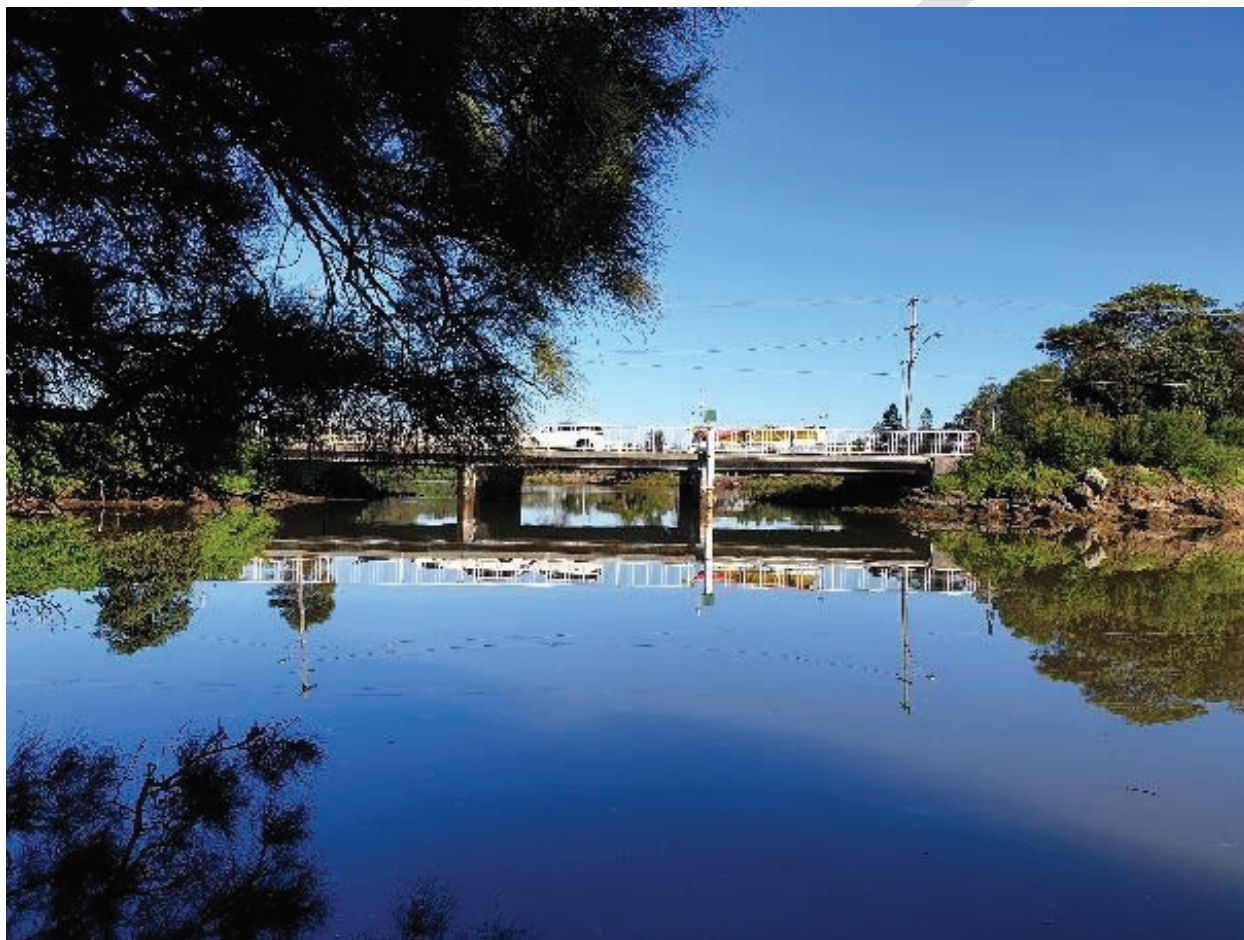
Photo 5: Griffin Road bridge (looking upstream)

Key hydraulic structures were included in the hydraulic model, at the locations indicated in Figure 12. Griffin Road Bridge, pedestrian crossing and Harbord Road GPT were modelled in the 2D domain to maintain continuity in the model and because the 2 m resolution was generally sufficient to resolve the waterway area accurately. Griffin Road Bridge (Photo 5) is a large relatively clear spanning structure with a large waterway area. Reference 2 stated that the structure does not cause significant afflux during large flood events.

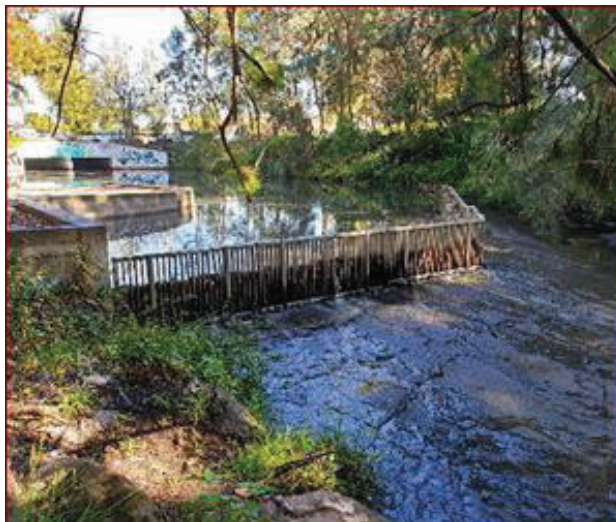
Photo 6: GPT (looking upstream at Harbord Road culverts)

this was incorporated into the model based on the cross-section data in the plans provided by Northern Beaches Council. The trash rack was modelled as an obstruction to flow with a high percentage blockage (100%) and a large form loss to account for the substantial amounts of debris which are likely to become lodged in this structure. Photographs of the GPT were obtained during the site visit and these are shown in Photo 6 and Photo 7.

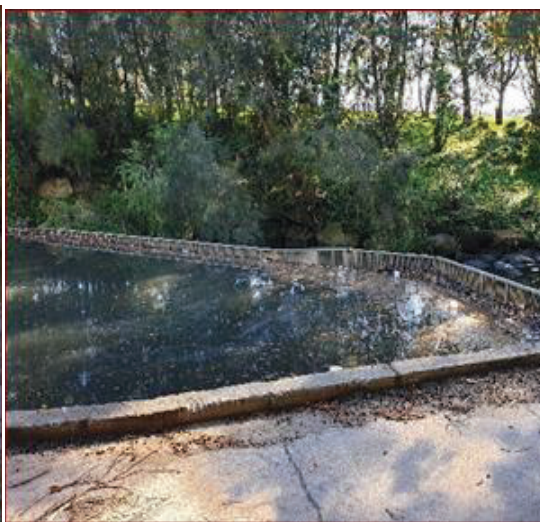
Photo 7: GPT trash rack (looking downstream)

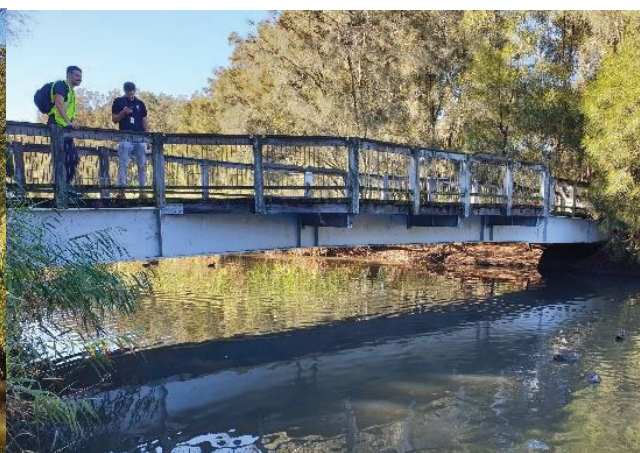
Photo 9: Western pedestrian footbridge (looking upstream)

Two pedestrian bridges cross Greendale Creek between Harbord Road and Griffin Road. The bridges are clear spanning with a large waterway area. A rock weir was constructed downstream of the eastern pedestrian footbridge circa 2000 as part of the Greendale Creek Rehabilitation Project for water quality control purposes.

Dimensions of the eastern footbridge over Greendale Creek were obtained during the site visit. Photographs of the rock weir and western footbridge were obtained during the site visit and these are shown in Photo 8 and Photo 9, respectively.

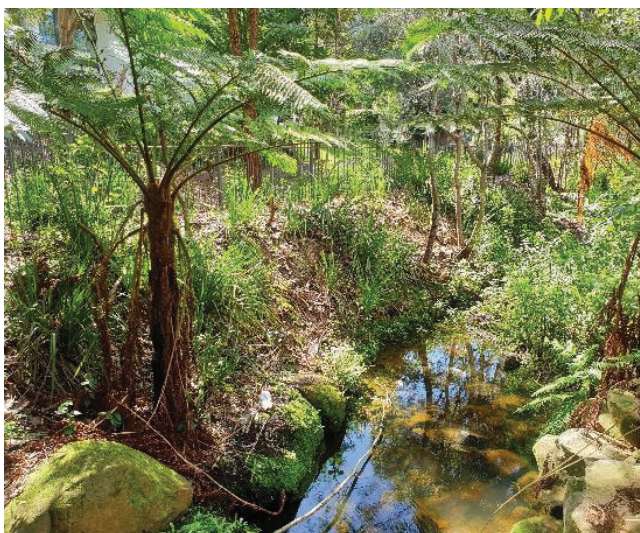
Photo 10: Typical semi-natural channel section at the Kilns (looking downstream)

The steep channels downstream of Governor Philip Lookout descend to 'The Kilns' development. A semi-natural channel to the west of the site directs flows from north to south, before meandering eastwards. Flows from the channel then enter into a culvert passing under several low lying properties on Consul Road. A concrete lined channel to the east of the site directs flow to a large grated inlet pit, with the piped stormwater system joining the semi-natural channel to the south-west of the site. The concrete wall for the eastern channel was included in the model as a raised 2D element which presents an impermeable barrier to flow.

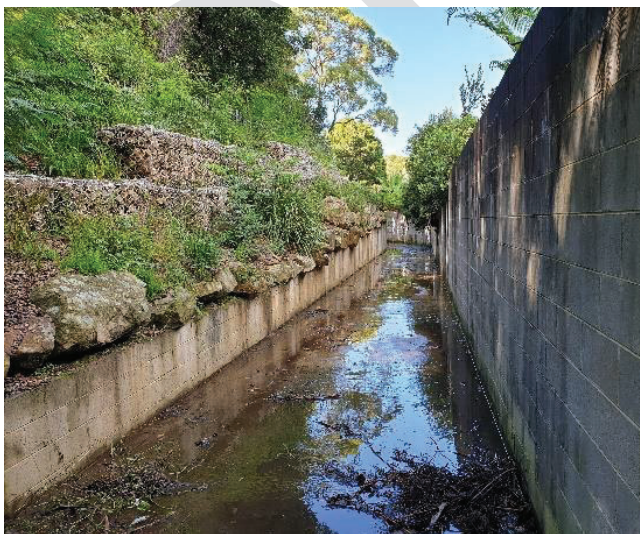
Photo 12: Western stormwater channel at The Kilns (looking downstream)

The exception to the above was a concrete wall in the Kilns development, which was clearly part of an overland flow management design (see Photo 12).

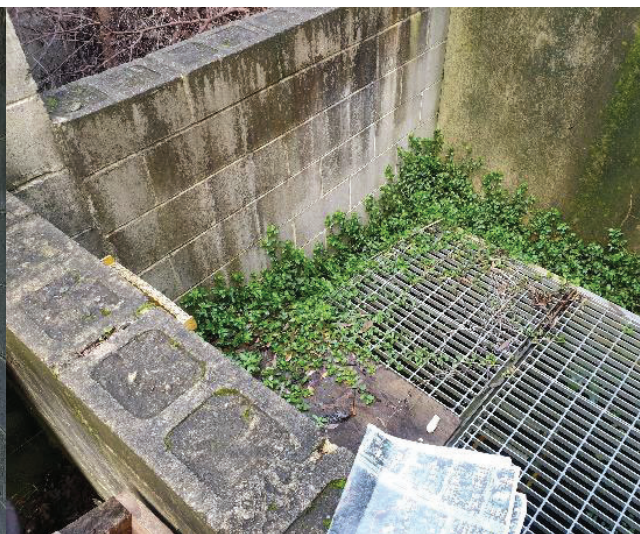
Photo 13: Inlet grate (The Kilns, western channel)

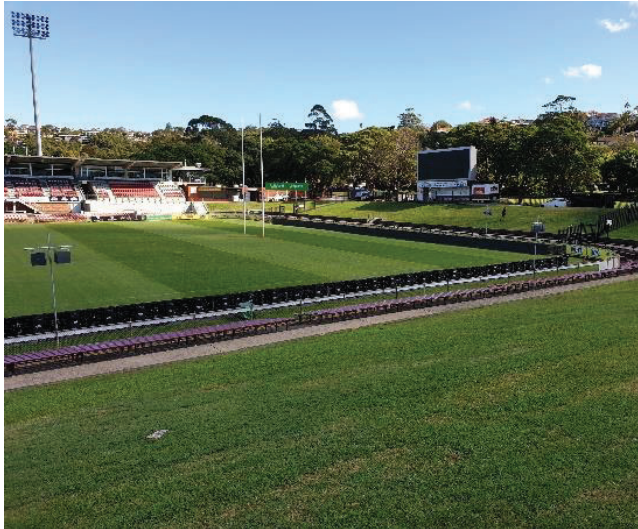
Photo 14: Brookvale Oval (eastern bund looking north)

The pit/pipe database provided by Northern Beaches Council contains stormwater drainage infrastructure information within Brookvale Oval. Three 375 mm pipes which connect to the Council's stormwater network service Brookvale Oval and these were included in the hydraulic model.

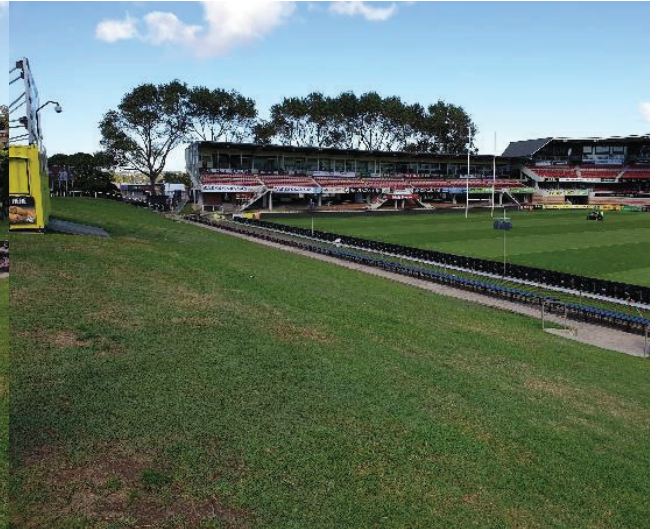
Photo 15: Brookvale Oval (eastern bund looking south)

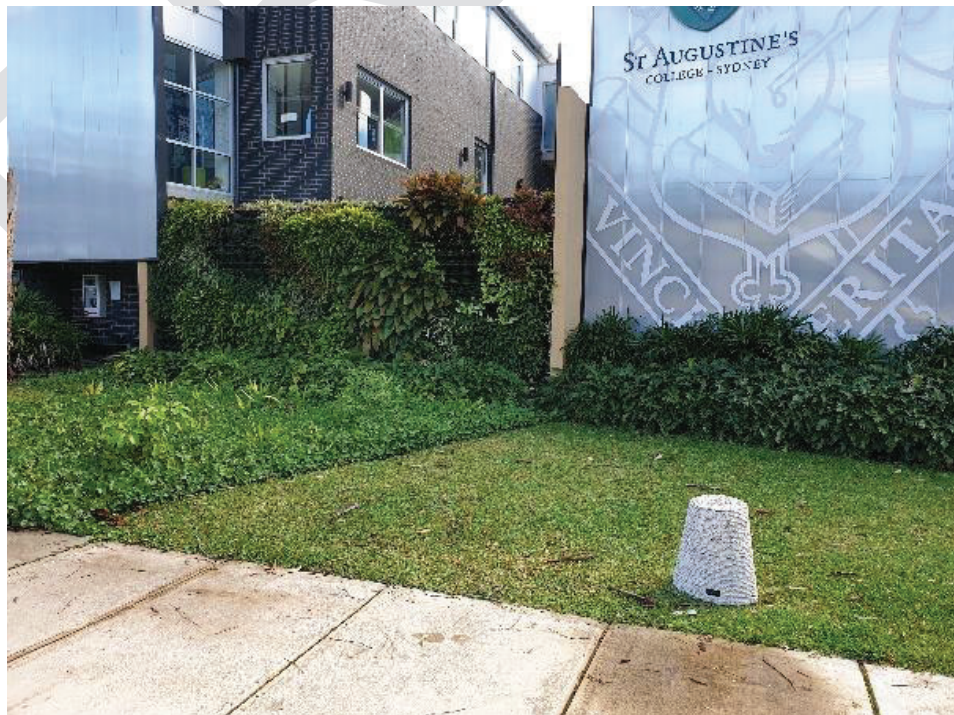
Photo 16: St Augustine's College flow path

The recent re-development of St Augustine's School at Brookvale involved modifications to the building footprints and ground levels around the school. The building footprints were incorporated in the model based on the most recent available aerial photography. Updated ground levels were incorporated based on plans provided by Northern Beaches Council. During the site visit it was noted that a planter wall had been constructed in the drainage easement passing between the new primary school and new senior science buildings which is likely to present a significant obstruction to overland flows through the site. This was modelled as a flow constriction with a large blockage factor (70%) applied.

The flow path through St Augustine's School was inspected during the site visit and photographs are shown in Photo 16.

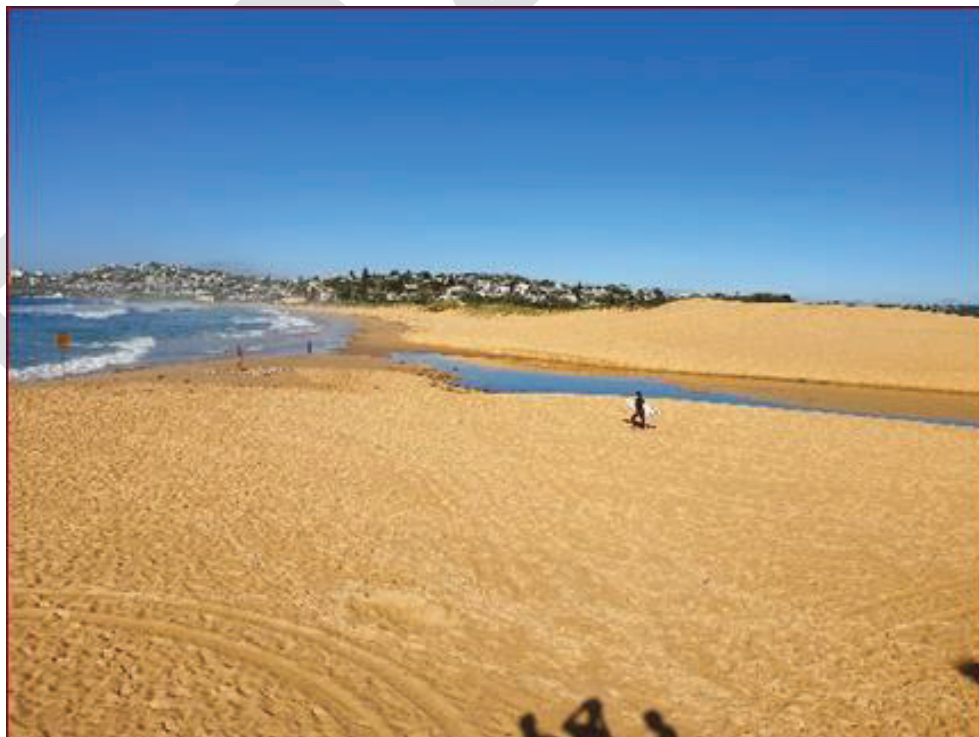
Photo 17: Curl Curl Lagoon entrance

Lagoon breakout is a complex process which involves constant changes to the geometry of the breakout channel during the lagoon opening. Closure of the channel rapidly occurs as a result of sand movement into the breakout channel via coastal processes including tide and wind action. A detailed description of these lagoon breakout and closure mechanisms is presented in Appendix A from Reference 2.

The changing geometry of the sand berm during the calibration event (November 2018) on Curl Curl beach was modelled using a variable Z shape with parameters as detailed in Section 8.8.
