Report on
Geotechnical Assessment

Dalwood Home Site
21 Dalwood Avenue, Seaforth

Prepared for
NSW Ministry of Health

Project 73029.01
May 2019

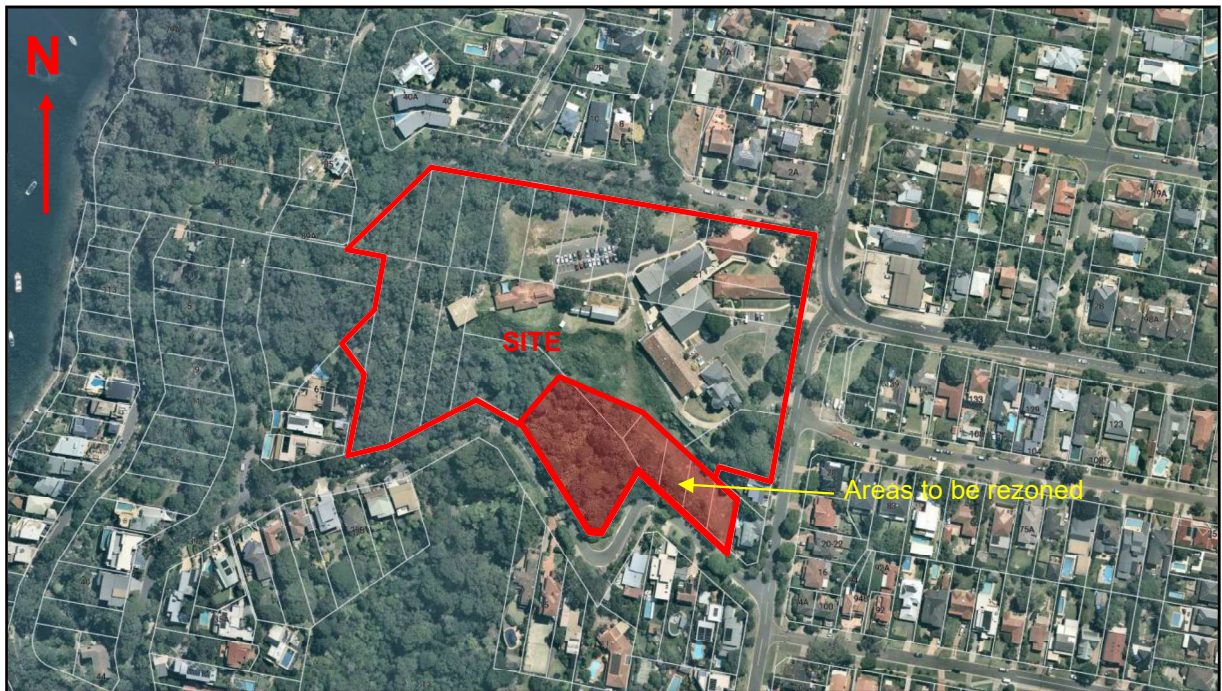
Figure 1: Site Setting (Reference: Nearmap image dated 4 March 2019)

The area to the south east corner of the site is the area subject to rezoning as shown on Figure 1 above.
