WRL Ref: WRL2021004 JTC LR20210514

## **DRAFT Newport SLSC coastal hazard peer review**

- Horton (2020a), "*Coastal Engineering Report and Statement of Environmental Effects for Buried Coastal Protection Works at Newport SLSC*", prepared by Horton Coastal Engineering Pty Ltd for Adriano Pupilli Architects, Issue 2 dated 16 November 2020.

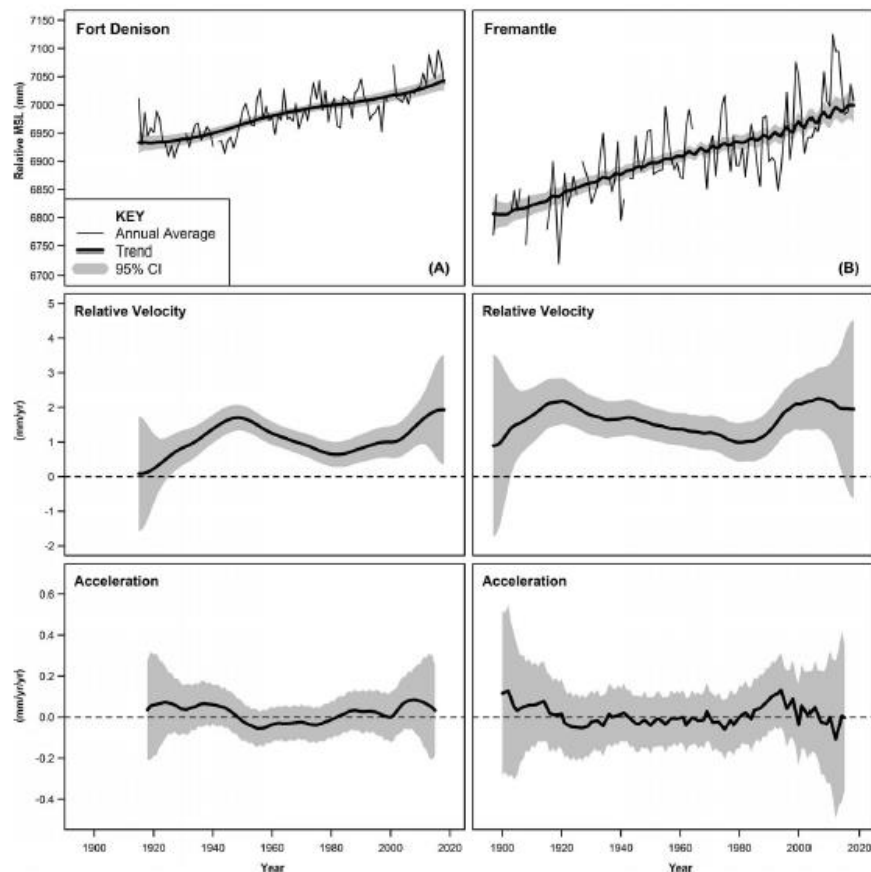
Figure 5. “Relative” mean sea level (trend), velocity, and acceleration for Fort Denison and Fremantle. The scales associated with each of the three panel charts for the respective tide gauge records are equivalent for direct comparison between records. “Relative” mean sea level (top panels) is based on revised local reference datum (PSMSL, 2019) with +200 mm offset applied to Fremantle to align graphic with the Fort Denison panel. See Figure 1 and Table 1 for station details.

**Figure 1: Observed sea level rise at Fort Denison (Watson, 2020)**

The analysis of long term change, which found that there is not a detectable trend is accepted by WRL. We note that during the analysis period of long term change (1941 or 1951 to 2018), mean sea level for Sydney has increased by 1 to 2 mm per year (Watson, 2020). Figure 5 of Watson (2020) is reproduced as Figure 1 in this WRL letter.

That is, Newport Beach has been broadly stable with sea level rise of 1 to 2 mm per year, therefore the predicted future response (recession) to sea level rise could be discounted by the quantum of sea level rise which occurred but produced no recession. Neither the Horton reports nor this WRL review are a detailed processes study, but an onshore or alongshore feed of sand has been postulated at other locations, noting that sea level rise may outpace this feed in the future.

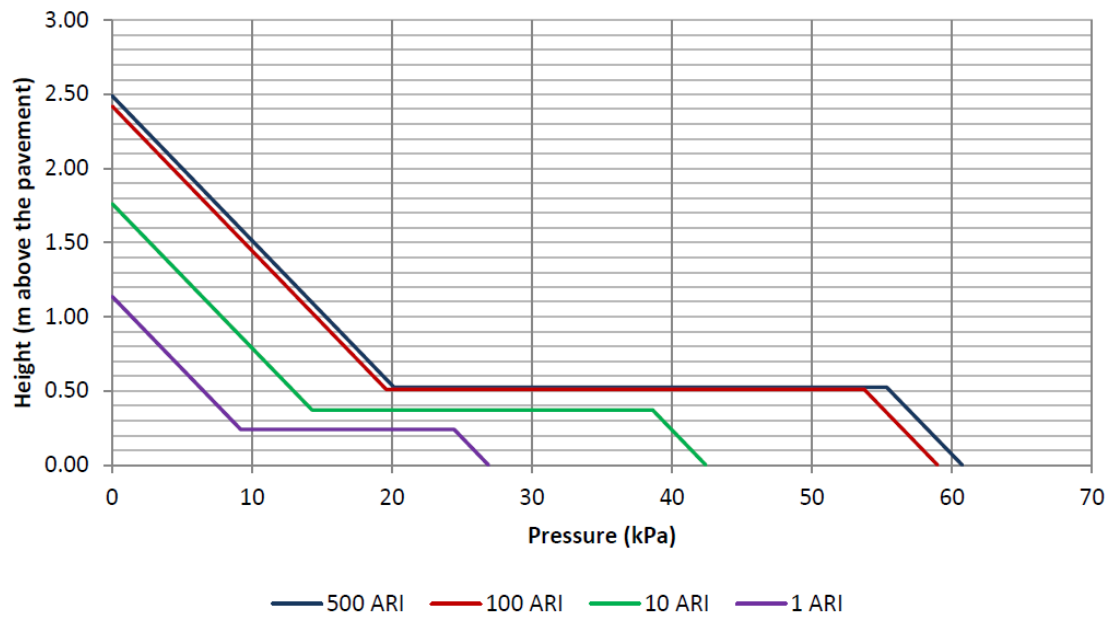
**Figure 5: Example of calculated wave forces on building behind seawall**

Furthermore, we recommend that estimates of wave overtopping and wave forces on the clubhouse be undertaken, as a scenario could arise such that the seawall prevents the clubhouse being undermined, but the building is damaged or destroyed through wave overtopping. Examples of buildings which were damaged/destroyed behind undamaged seawalls occurred in the June 2016 storm include Dee Why (café), Fairy Bower (toilet block and cafe) and Coogee (SLSC clubhouse).

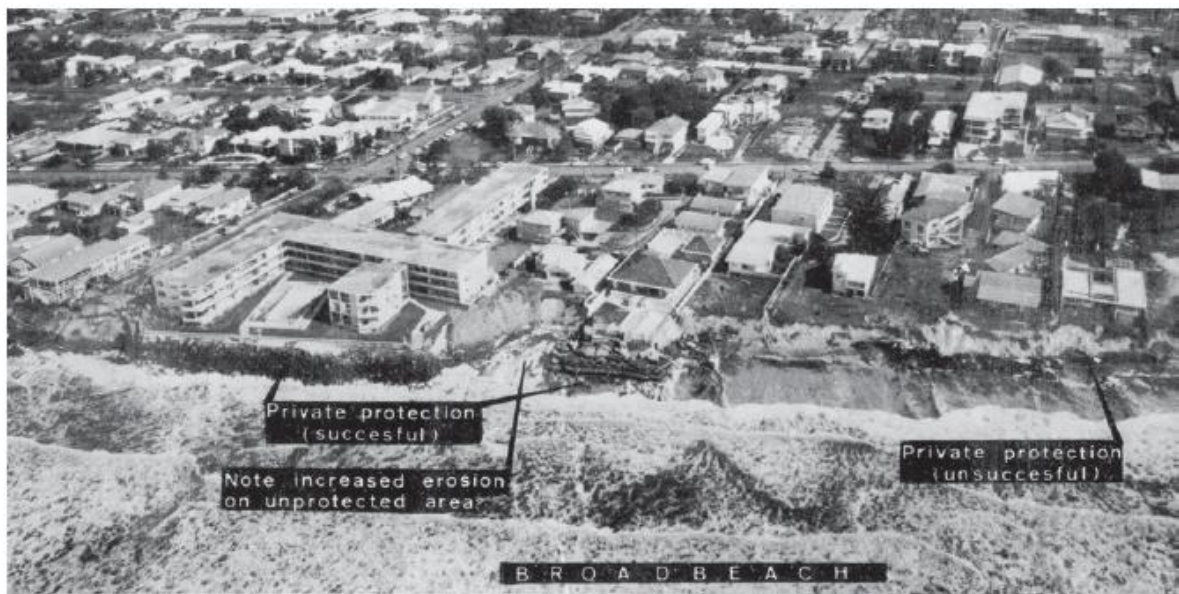
(Source: McDougal et al, 1987)

Gold Coast, 1967 (Source: Delft, 1970)

**Figure 6: Example of seawall end effect and calculation method**

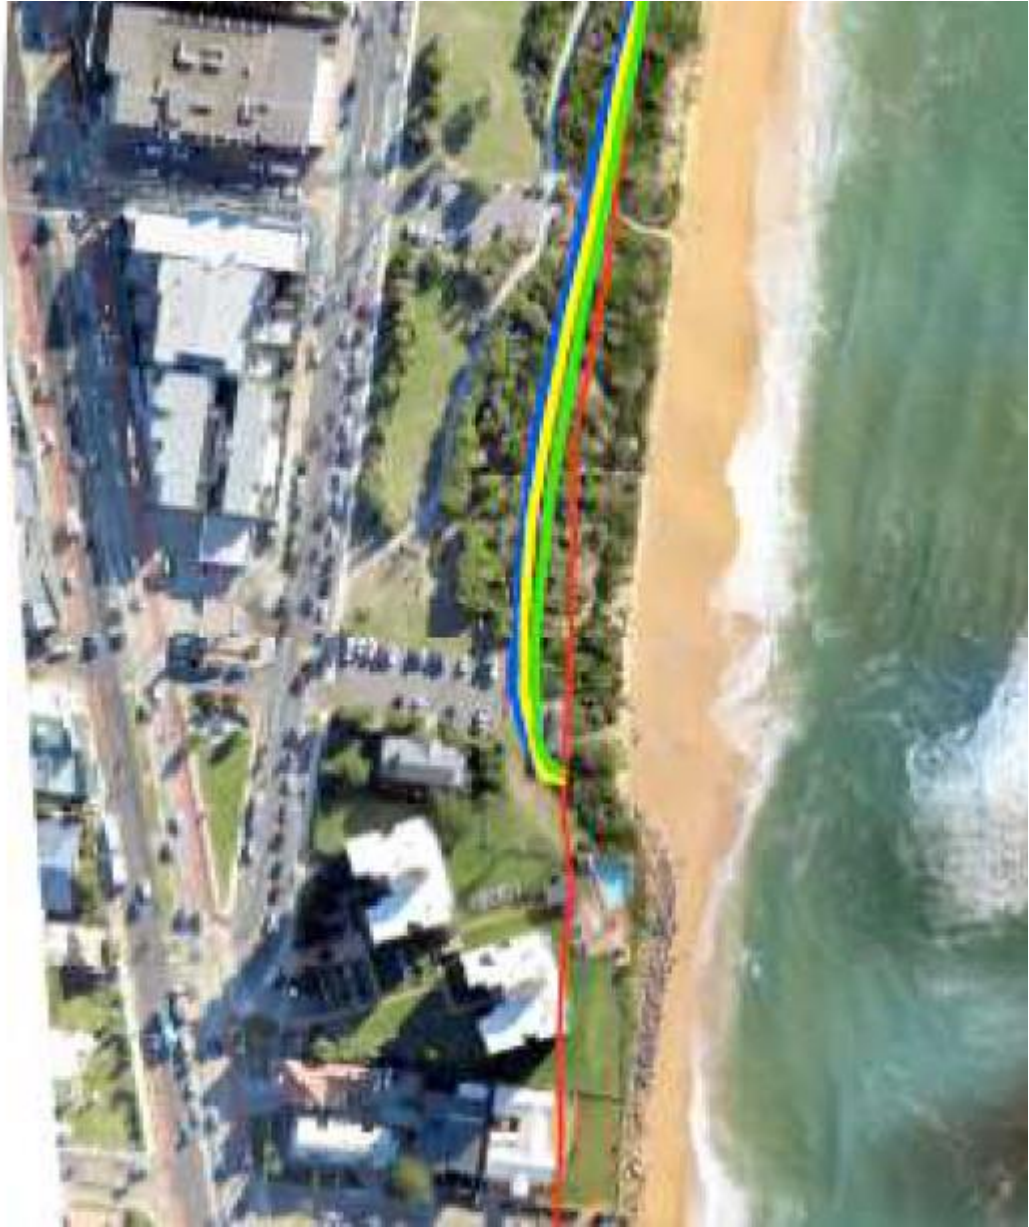
**Figure 7: Example of calculated seawall end effect (red line is erosion extent without seawall)**

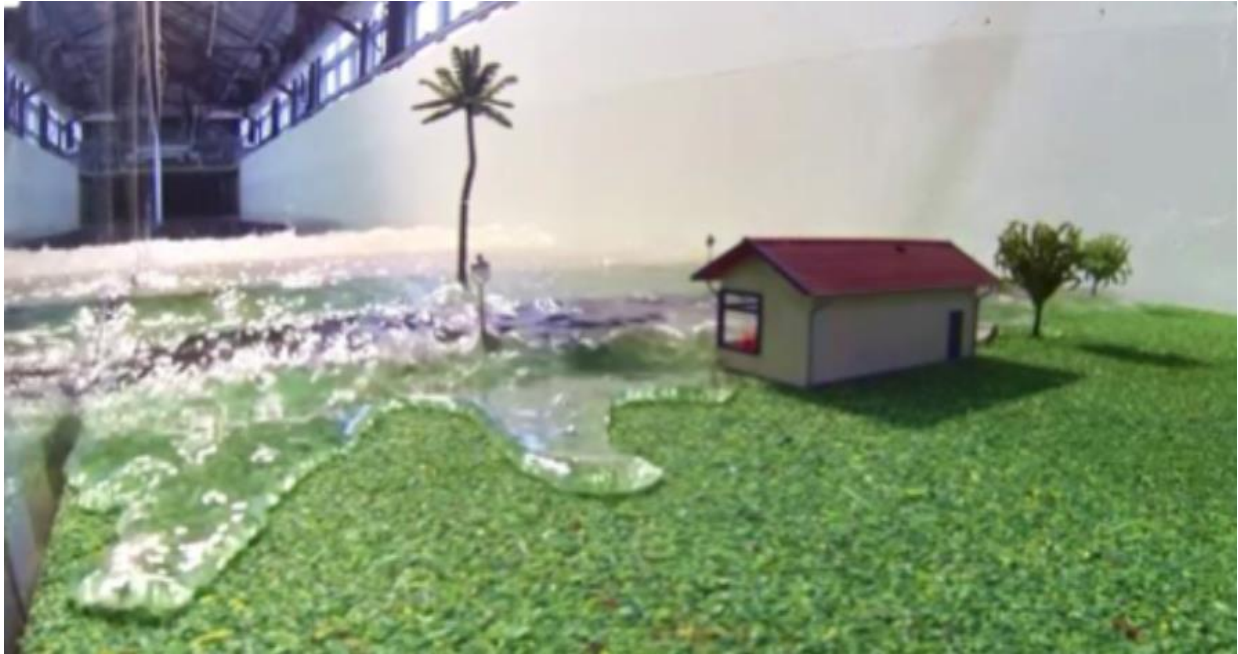
**Figure 8: Example of physical model examining wave forces on a building**
