northern
beaches
council

Options and Feasibility Report Long Reef Boardwalk & Bridge Replacement

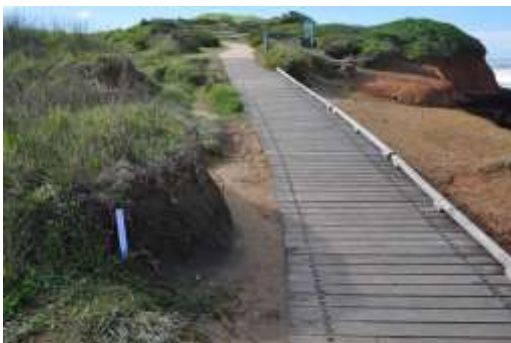
DSC-3237 area of midden

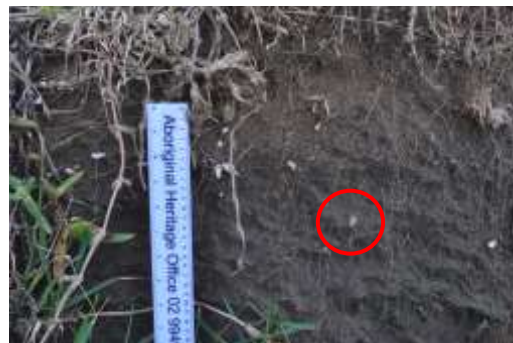
3238 shell and artefact (circled)

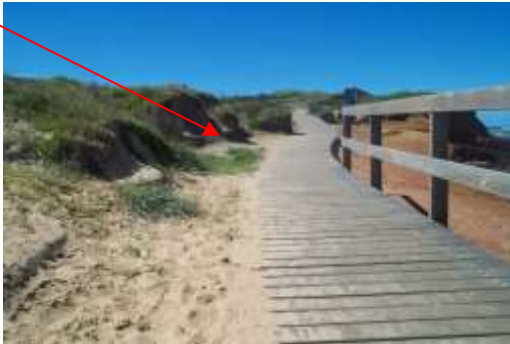
3386 Location, looking north – note beginning of rocky headland on right.

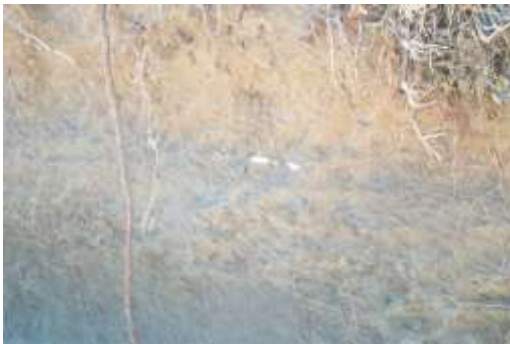
3382 low density shell in profile.

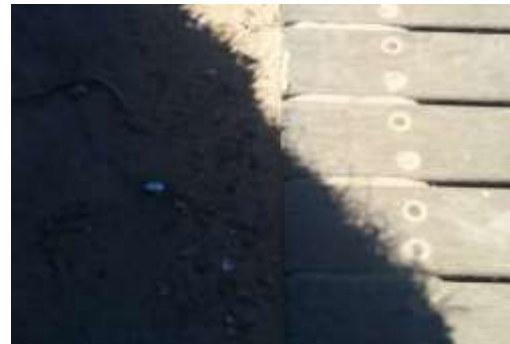
3383 Fragments by boardwalk.

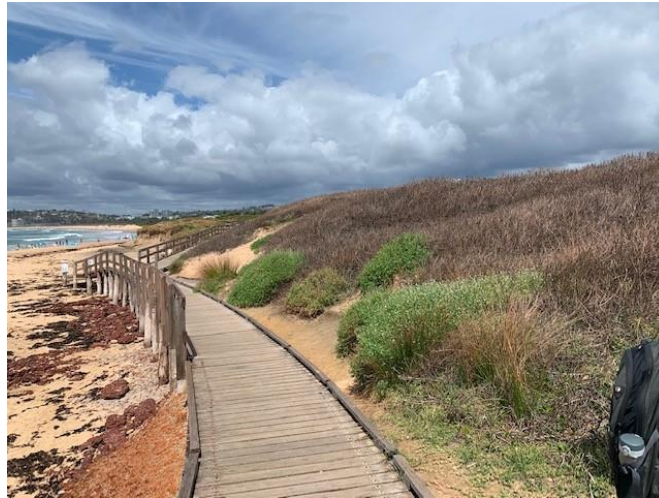
Photograph 1: Northern end of boardwalk, looking south

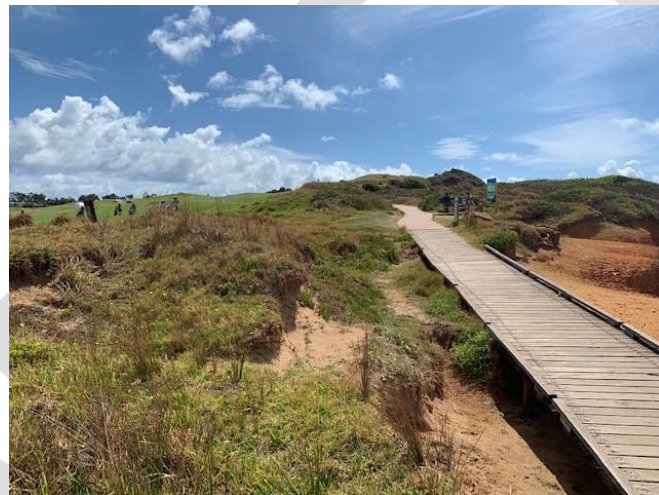
Photograph 2: Northern end of boardwalk

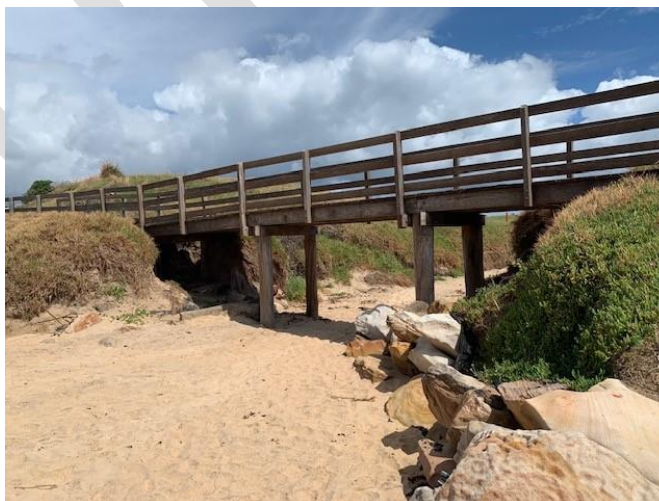
At the bridge area, we observed that some rocks have been placed around the base of the timber piles to provide protection.

Photograph 3: Bridge at southern end of boardwalk

For both options, we recommend that a revetment wall is constructed along the beach side to prevent future loss of ground material adjacent to and beneath the boardwalk. This revetment wall should be extended around the bridge embankments to prevent a similar loss of material to that observed currently at the southern end of the bridge.
